## **Final Report**

### **Field Performance Assessment of the Advanced Enviro-Septic Wastewater Treatment and Dispersal System in Missouri, 2022**

**Dr. Randall J. Miles, Soil Scientist, Emeritus Associate Professor**

**February 7, 2023**

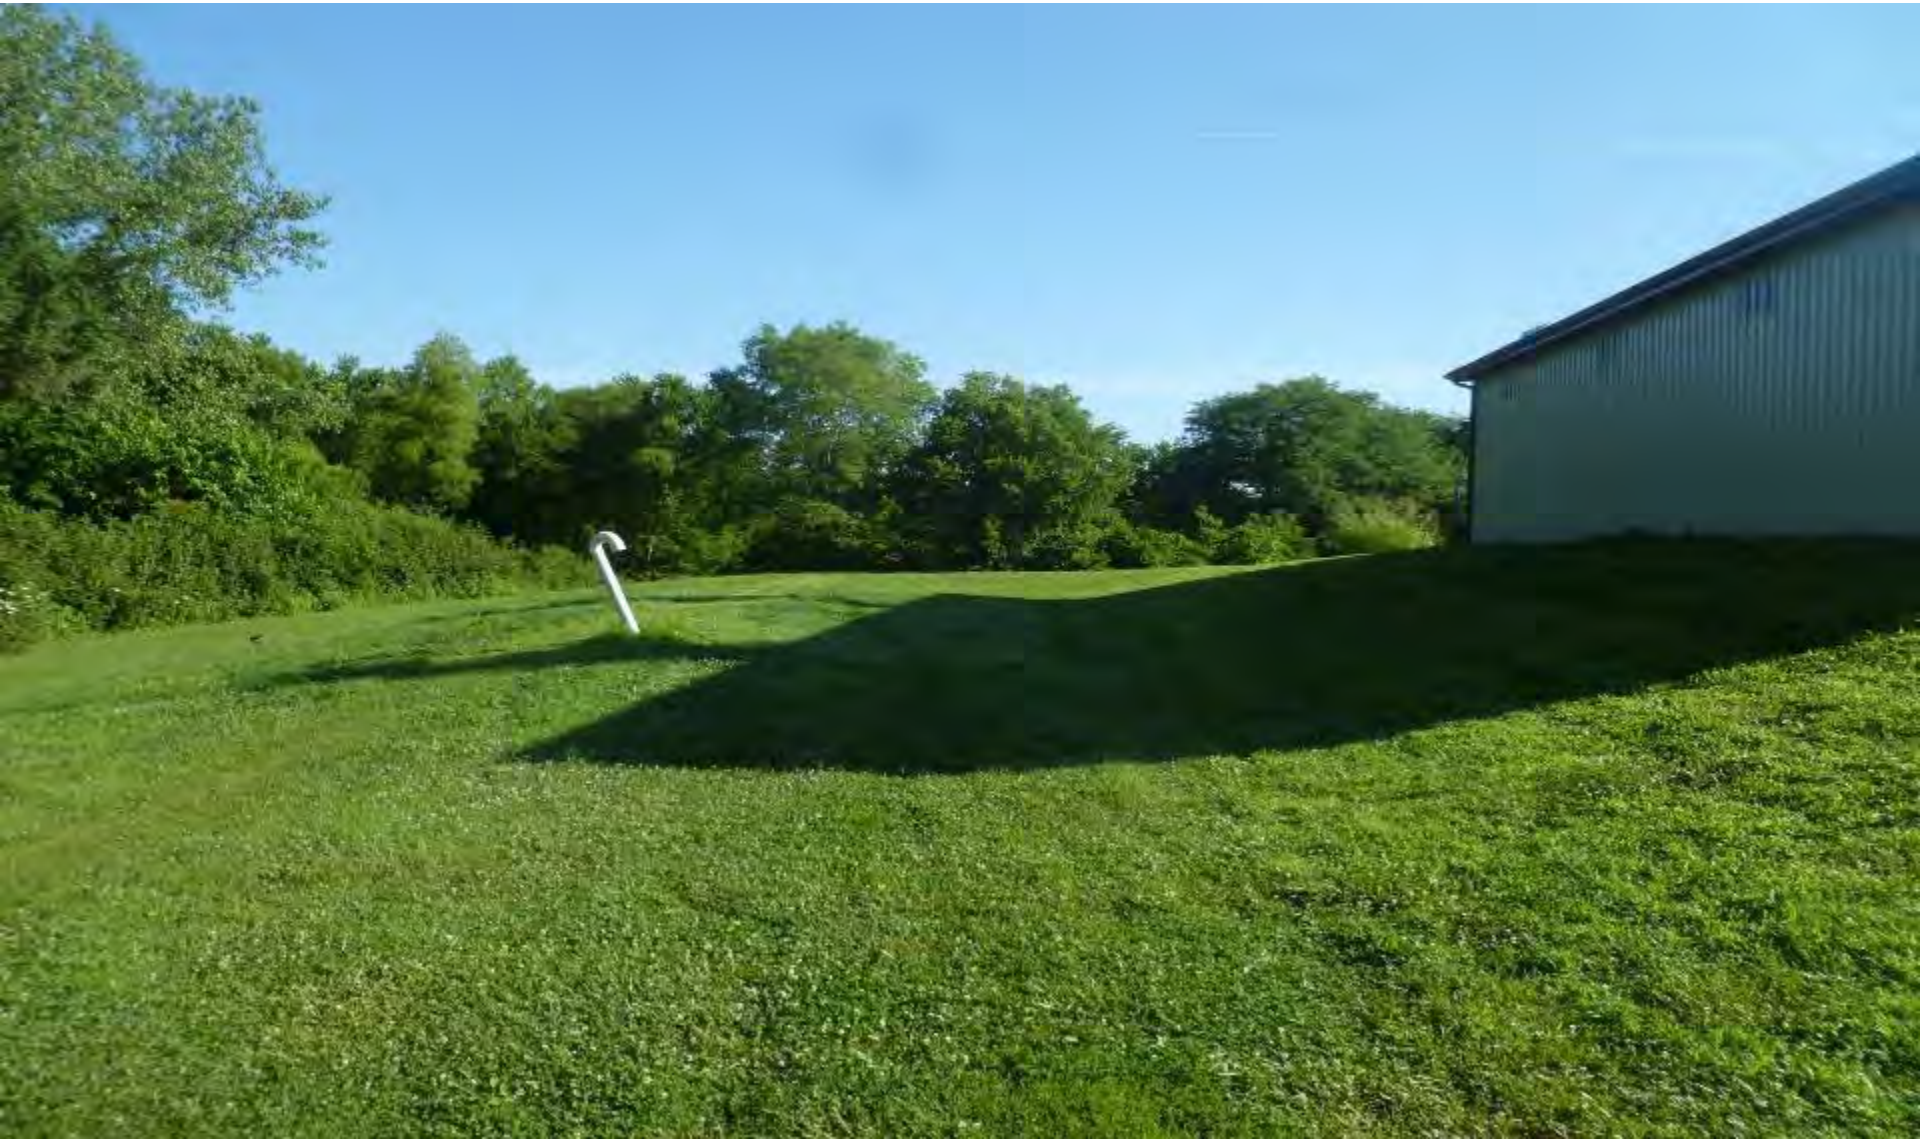
# Photo M1-1. AES System Behind Garage Area Lawson, MO

Site M1 located at 17708 N. Highway 69, Lawson, MO had a design soil loading rate of 0.20 gallons per day per square foot (gpd/sqft) and 210 linear feet (ft) of AES (3 lines of 70 ft of product) (Table 1). Photos of this site and system are provided in photos M1-1 and M1-2 (Appendix B). This system was installed in August 2014. The summary of the field evaluation observed no current surfacing effluent over any part of the system, nor evidence of past surfacing. There was no surfacing of sewage with pressure of footwear. No straight pipe discharges were found and no visible signs of malfunction were observed (Table 1 and Appendix A, Table M1). Additionally, site observations included consistent, even green vegetation, and no effluent odor within 10 feet of the system. The northwest surface outlet for the gutter could not be located, so it was not possible to determine if flow from this source intruded onto the AES system. The homeowners expressed that there were no problems with the onsite technology and were pleased with the system function (Appendix A, Table M1).

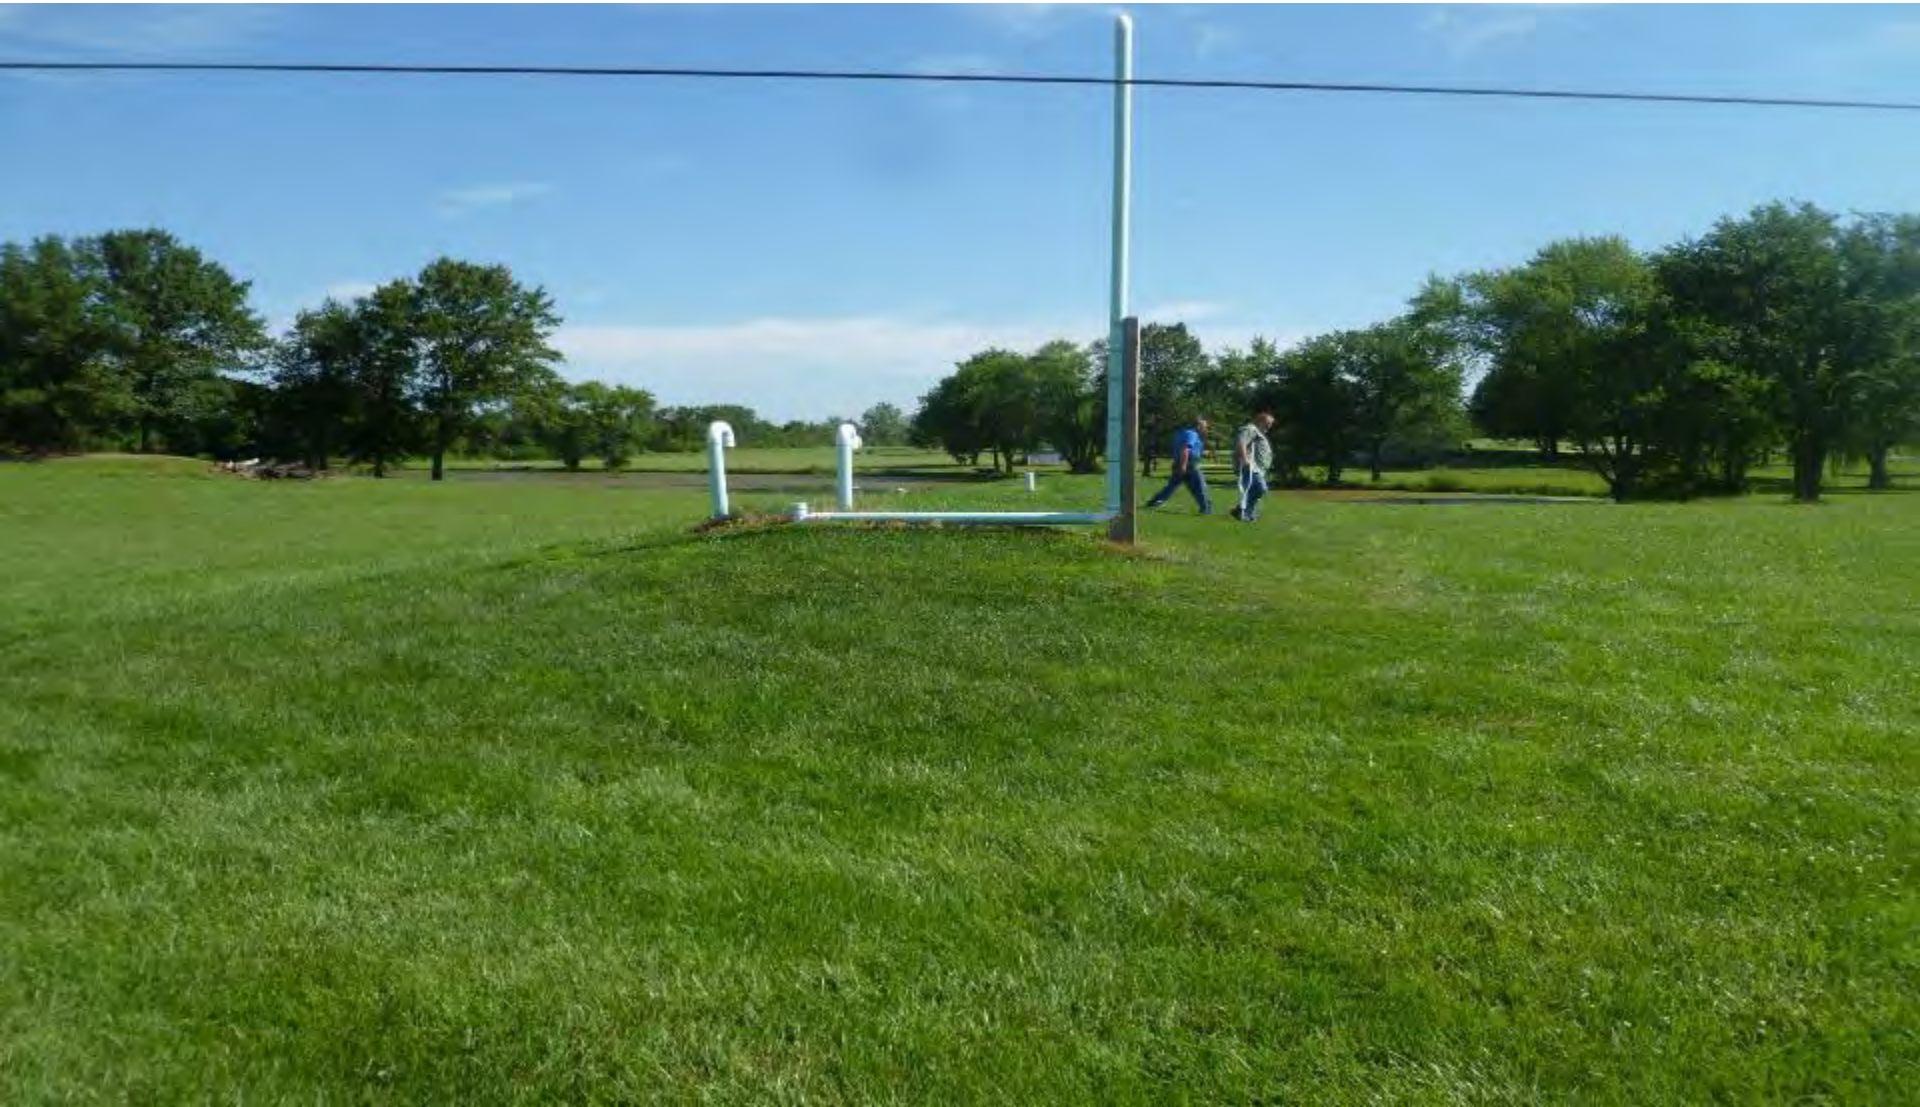
# Photo M3-1. AES Technology Lawson, MO

Site M3 located at 100 Shepherd Lane, Lawson, MO had a design soil loading rate of 0.20 gpd/sqft and 280 linear feet of AES (4 lines of 70 ft of product) (Table 1). Photos of this site and system are provided in photos M3-1 and M3-2 (Appendix B). This system was installed in August 2017. The summary of the field evaluation observed no current surfacing effluent over any part of the system nor evidence of past surfacing. There was no septic odor, and no green striping. Instead, a consistent green color was observed over the technology. Infiltrator was informed of a breakout in the northern end of the system in 2019, and in response made a site visit. It was determined that a lawn mower had created ruts from its tires on the downslope taper. Infiltrator placed cover material on the damaged areas. No evidence either of this damage or of a breakout was observed during the site inspection. No straight pipe discharges were found and no visible signs of malfunction were observed (Table 1 and Appendix A, Table M3). Additionally, the homeowner expressed that there were no problems with the onsite technology (Appendix A, Table M3).

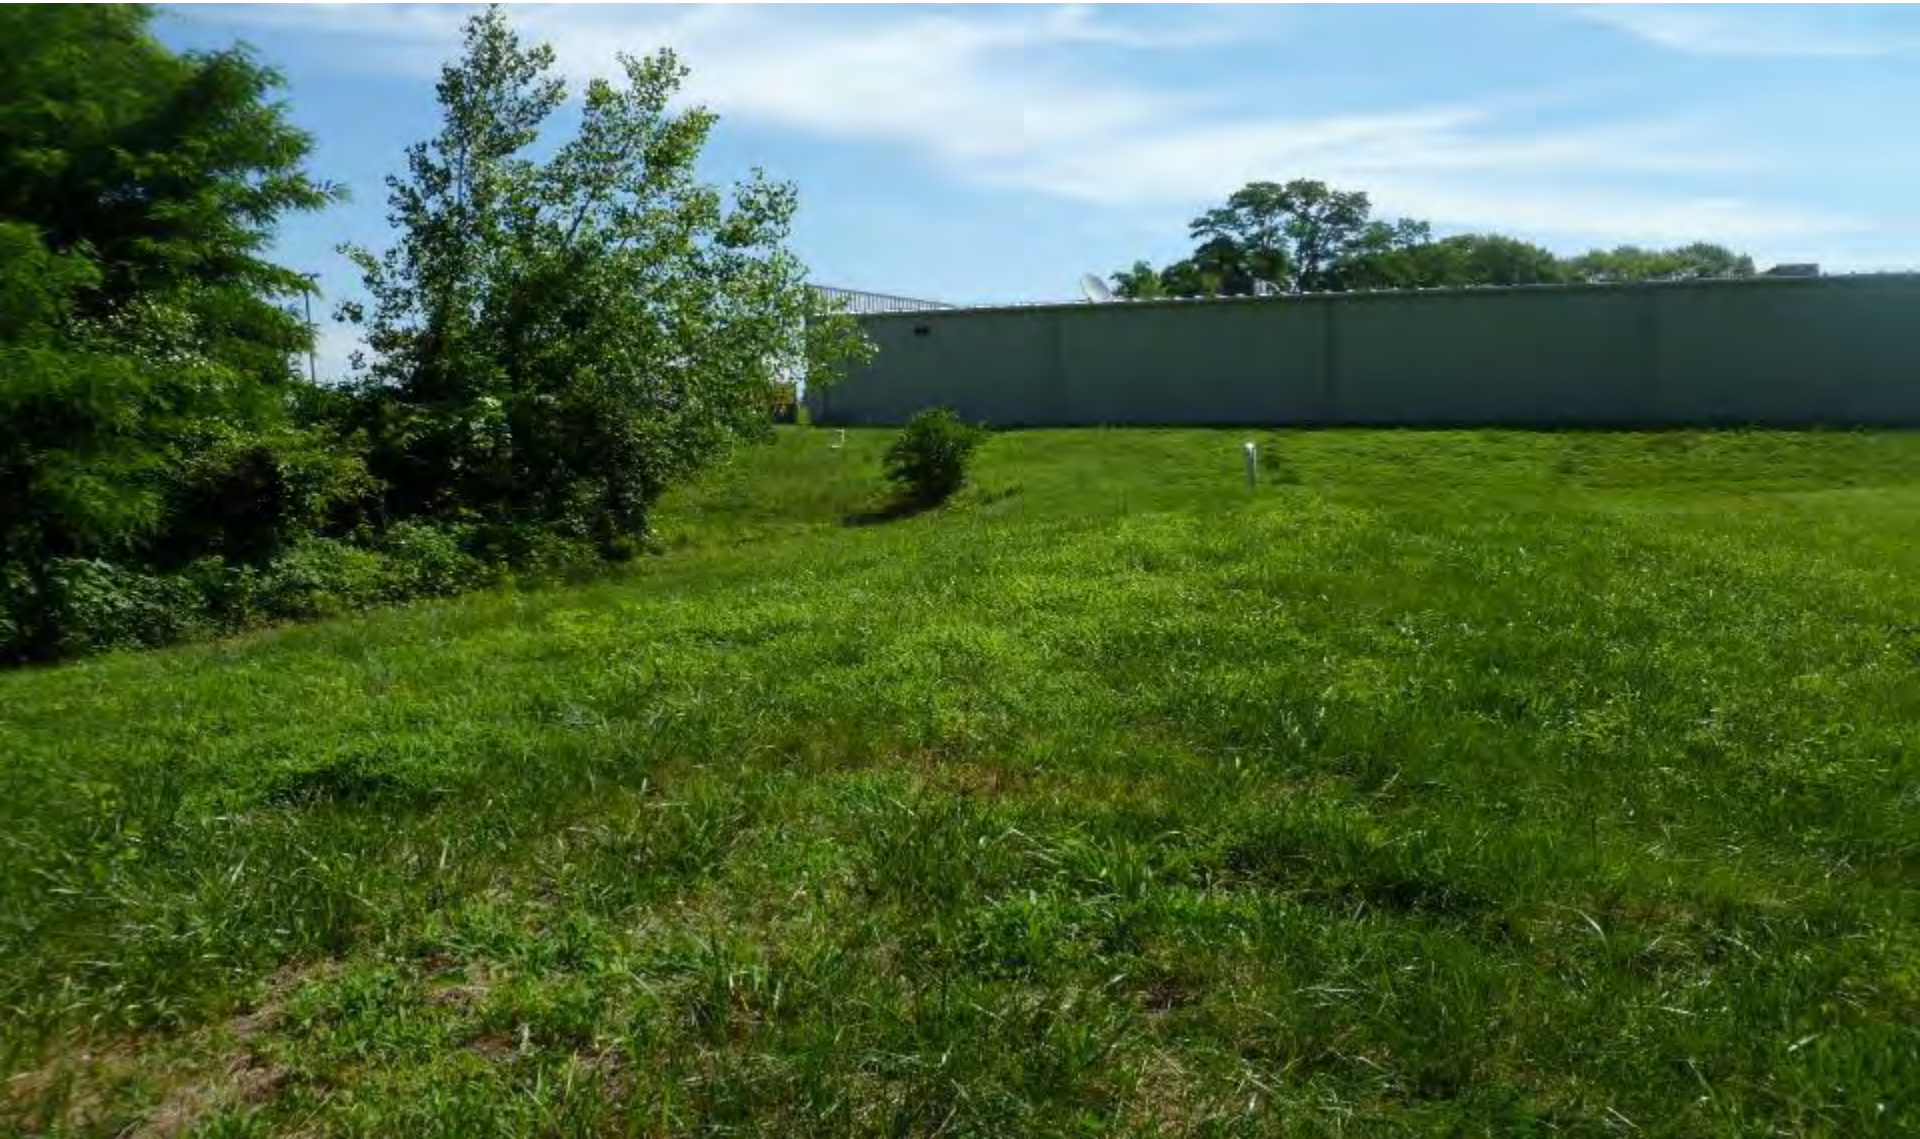
# Photo M4-1. AES Technology, Dollar General Store, Excelsior Springs, MO

Site M4 located at East Highway 10, Excelsior Springs, MO (Dollar General store) had a design soil loading rate of 0.40 gpd/sqft and 150 linear feet of AES (2 lines of 75 ft of product) (Table 1). Photos of this site and system are provided in photos M4-1 and M4-2 (Appendix B). This system was installed in August 2016. The summary of the field evaluation observed no current surfacing effluent over any part of the system nor evidence of past surfacing. There was no surfacing of sewage with pressure of footwear. No straight pipe discharges were found and no visible signs of malfunction were observed (Table 1 and Appendix A, Table M4). There was no effluent odor within 10 feet of the system and no seepage outbreaks observed. Some small brush existed, but did not appear to inhibit the system. The managers of the Dollar General store were not available for an interview (Appendix A, Table M4).

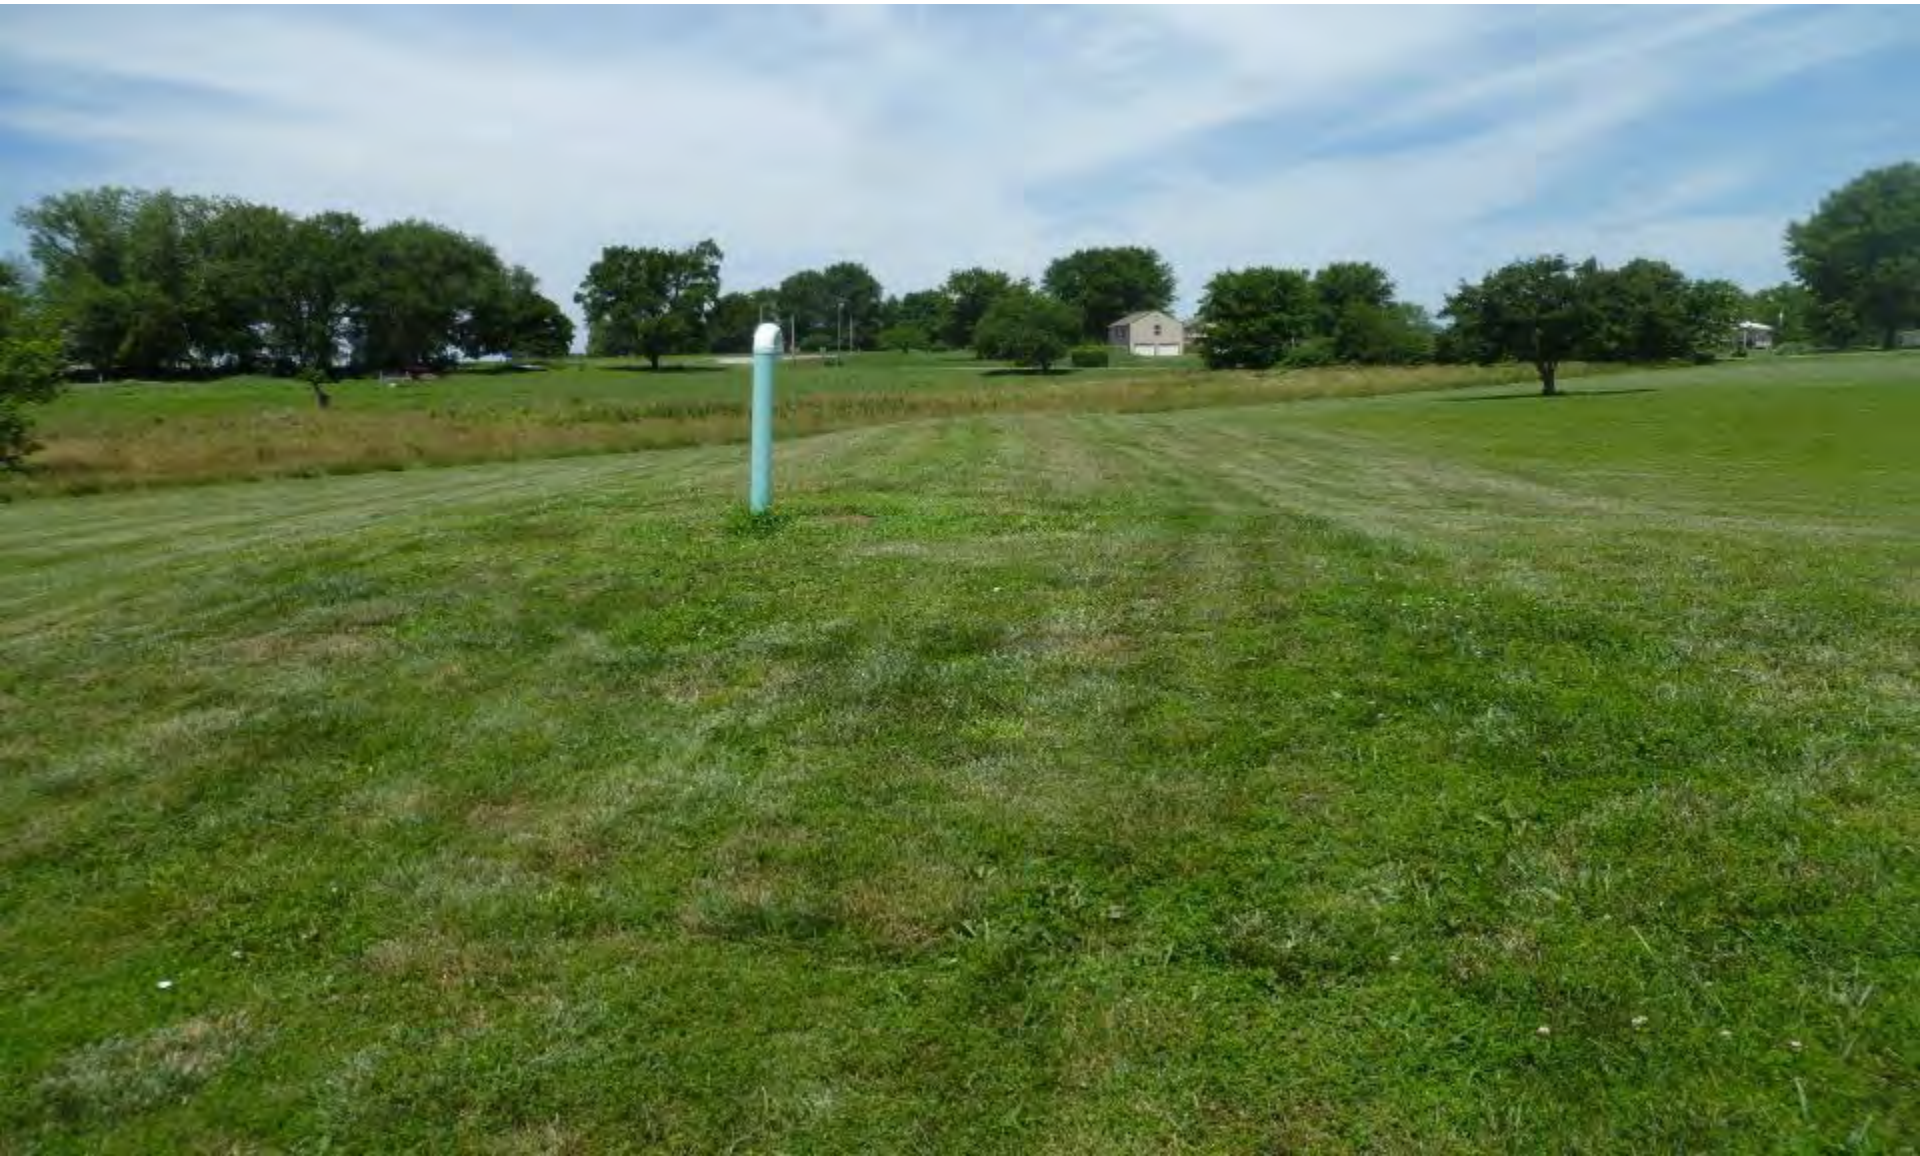
# Photo M5-1. AES Technology Excelsior Springs, MO

Site M5 located at 24205 NE 136<sup>th</sup> Terrace, Excelsior Springs, MO had a design soil loading rate of 0.40 gpd/sqft and 150 linear feet of AES (2 lines of 75 ft of product) (Table 1). Photos of this site and system are provided in photos M5-1 and M5-2 (Appendix B). This system was installed in May 2016. The summary of the field evaluation observed no current surfacing effluent over any part of the system, nor evidence of past surfacing. There was no surfacing of sewage with pressure of footwear. No straight pipe discharges were found and no visible signs of malfunction were observed (Table 1 and Appendix A, Table M5). Additionally, uniform, even green vegetation was prevalent, with no green striping and no effluent odor noted within 10 feet of the system. The homeowners were available to interview. They were very positive about the system performance (Appendix A, Table M5).

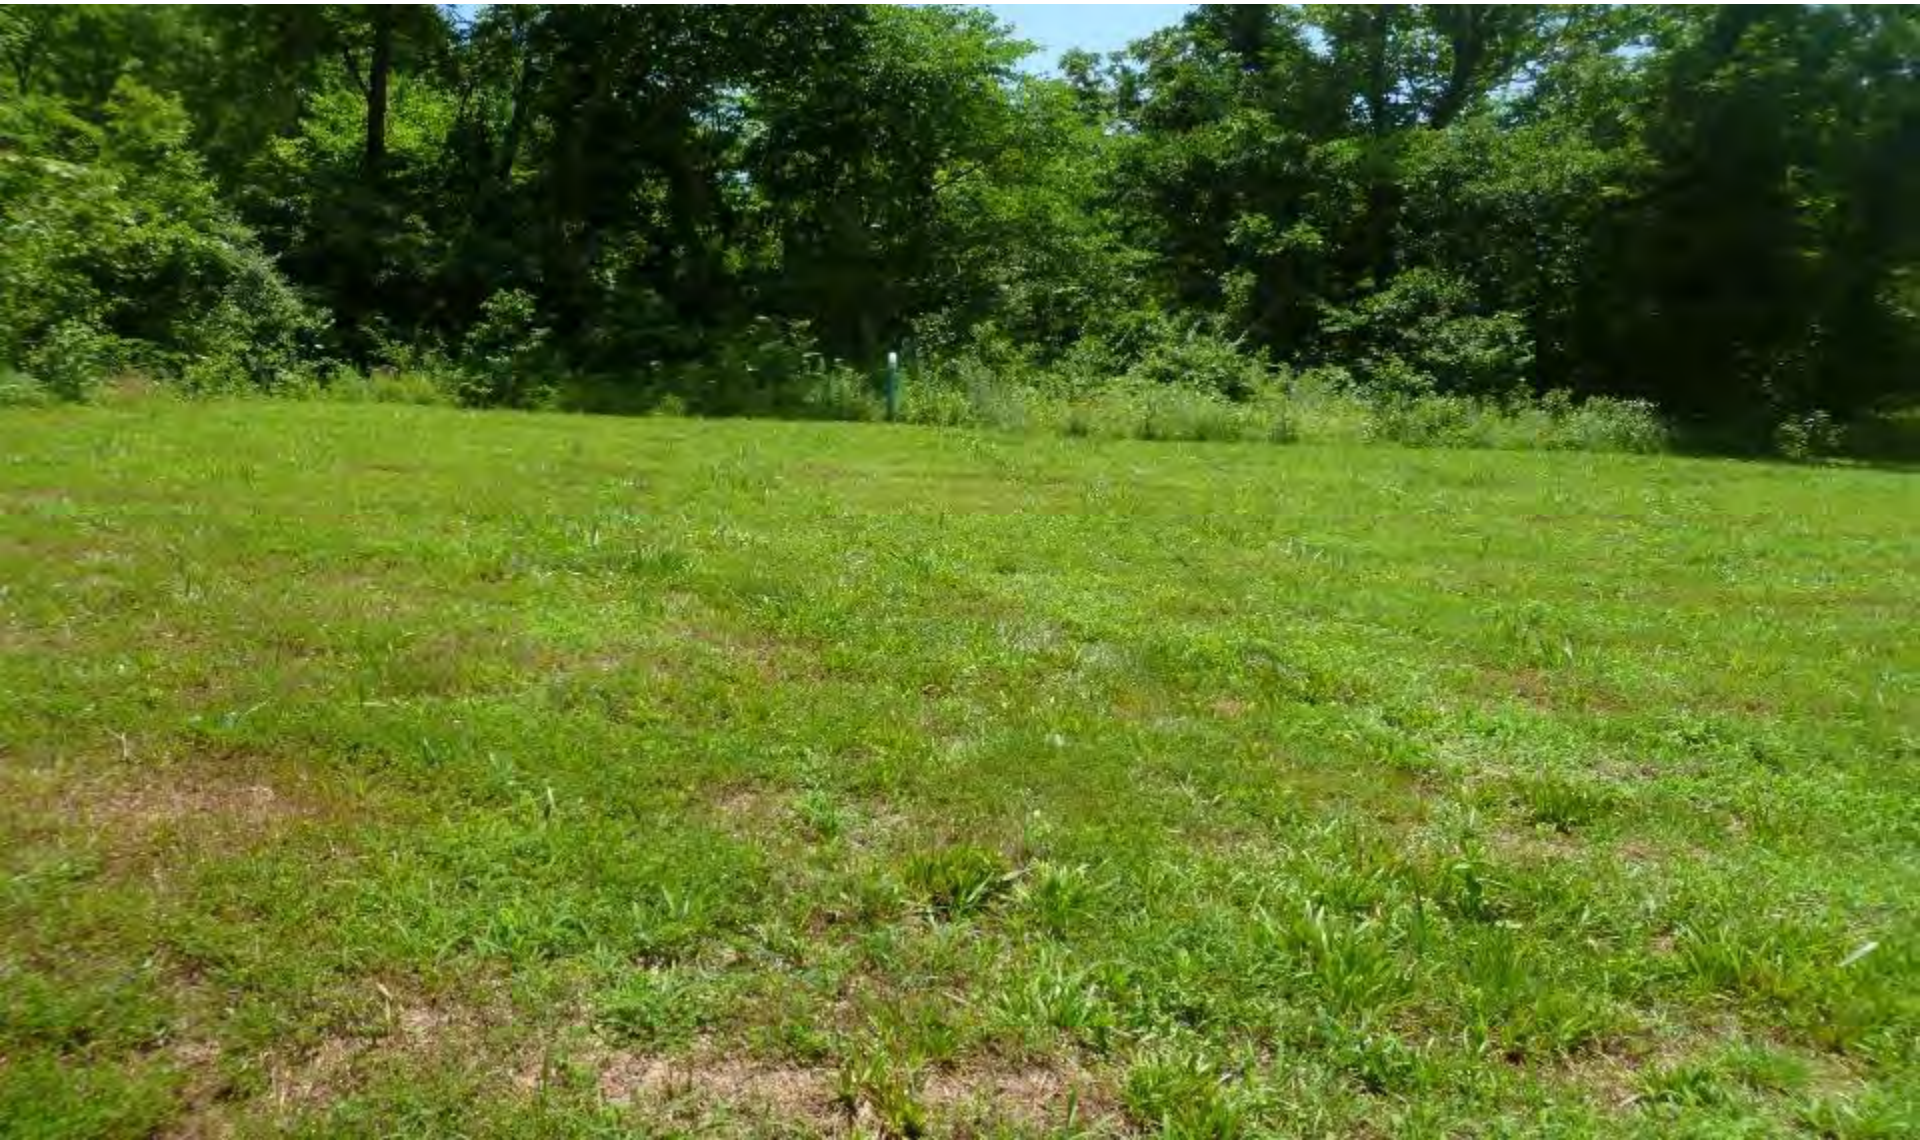
# Photo M6-1. AES Technology Liberty, MO

Site M6 located at 6851 Nebo Hills Road, Liberty, MO had a design soil loading rate of 0.30 gpd/sqft and 225 linear feet of AES (3 lines of 75 ft of product) (Table 1). Photos of this site and system are provided in photos M6-1 through M6-3 (Appendix B). This system was installed in October 2018. The summary of the field evaluation observed no current surfacing effluent over any part of the system, nor evidence of past surfacing. There was no surfacing of sewage with pressure of footwear. No straight pipe discharges were found and no visible signs of malfunction were observed (Table 1 and Appendix A, Table M6). Additionally, field observations indicated that runoff water could be intruding on the system, as there was some rill and sheet erosion (Photo M6-2). The need for consistent vegetative cover upslope to divert water off of the system was strongly suggested. The homeowners were available to interview. They expressed no problems with the system (Appendix A, Table M6).

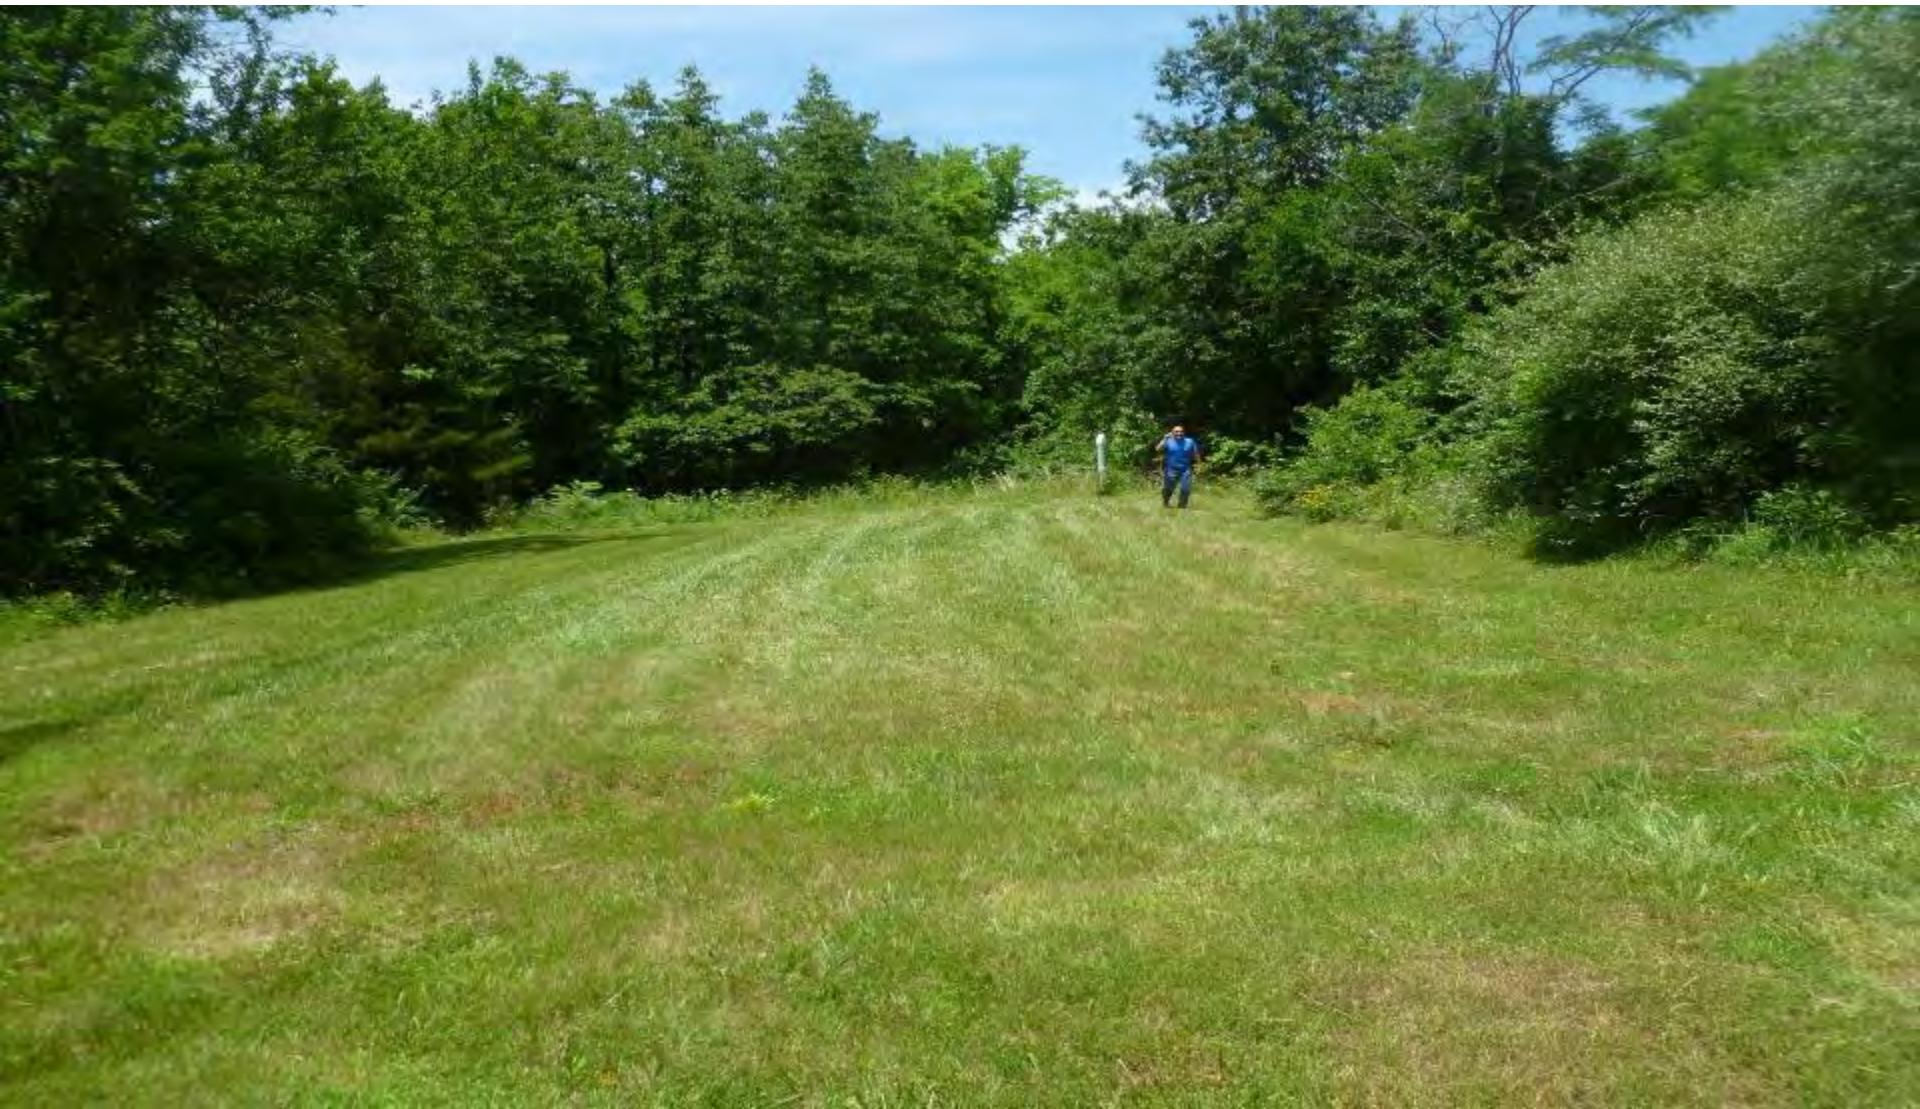
# Photo M7-1. AES Technology Excelsior Springs, MO

Site M7 located at 6901 Nebo Hills Road, Liberty, MO had a design soil loading rate of 0.30 gpd/sqft and 225 linear feet of AES (3 lines of 75 ft of product) (Table 1). Photos of this site and system are provided in photos M7-1 and M7-2 (Appendix B). This system was installed in April 2019. The summary of the field evaluation observed no current surfacing effluent over any part of the system, nor evidence of past surfacing. There was no surfacing of sewage with pressure of footwear. No straight pipe discharges were found and no visible signs of malfunction were observed (Table 1 and Appendix A, Table M7). There was no striping of vegetation, no effluent odor within 10 feet of the system or breakouts. A surface diversion could be added to prevent intrusion of water on the system from upslope, possibly consisting of through flow of surface water on the site during heavy rainfall events. The homeowners were available to interview. They expressed satisfaction with the system performance (Appendix A, Table M7).

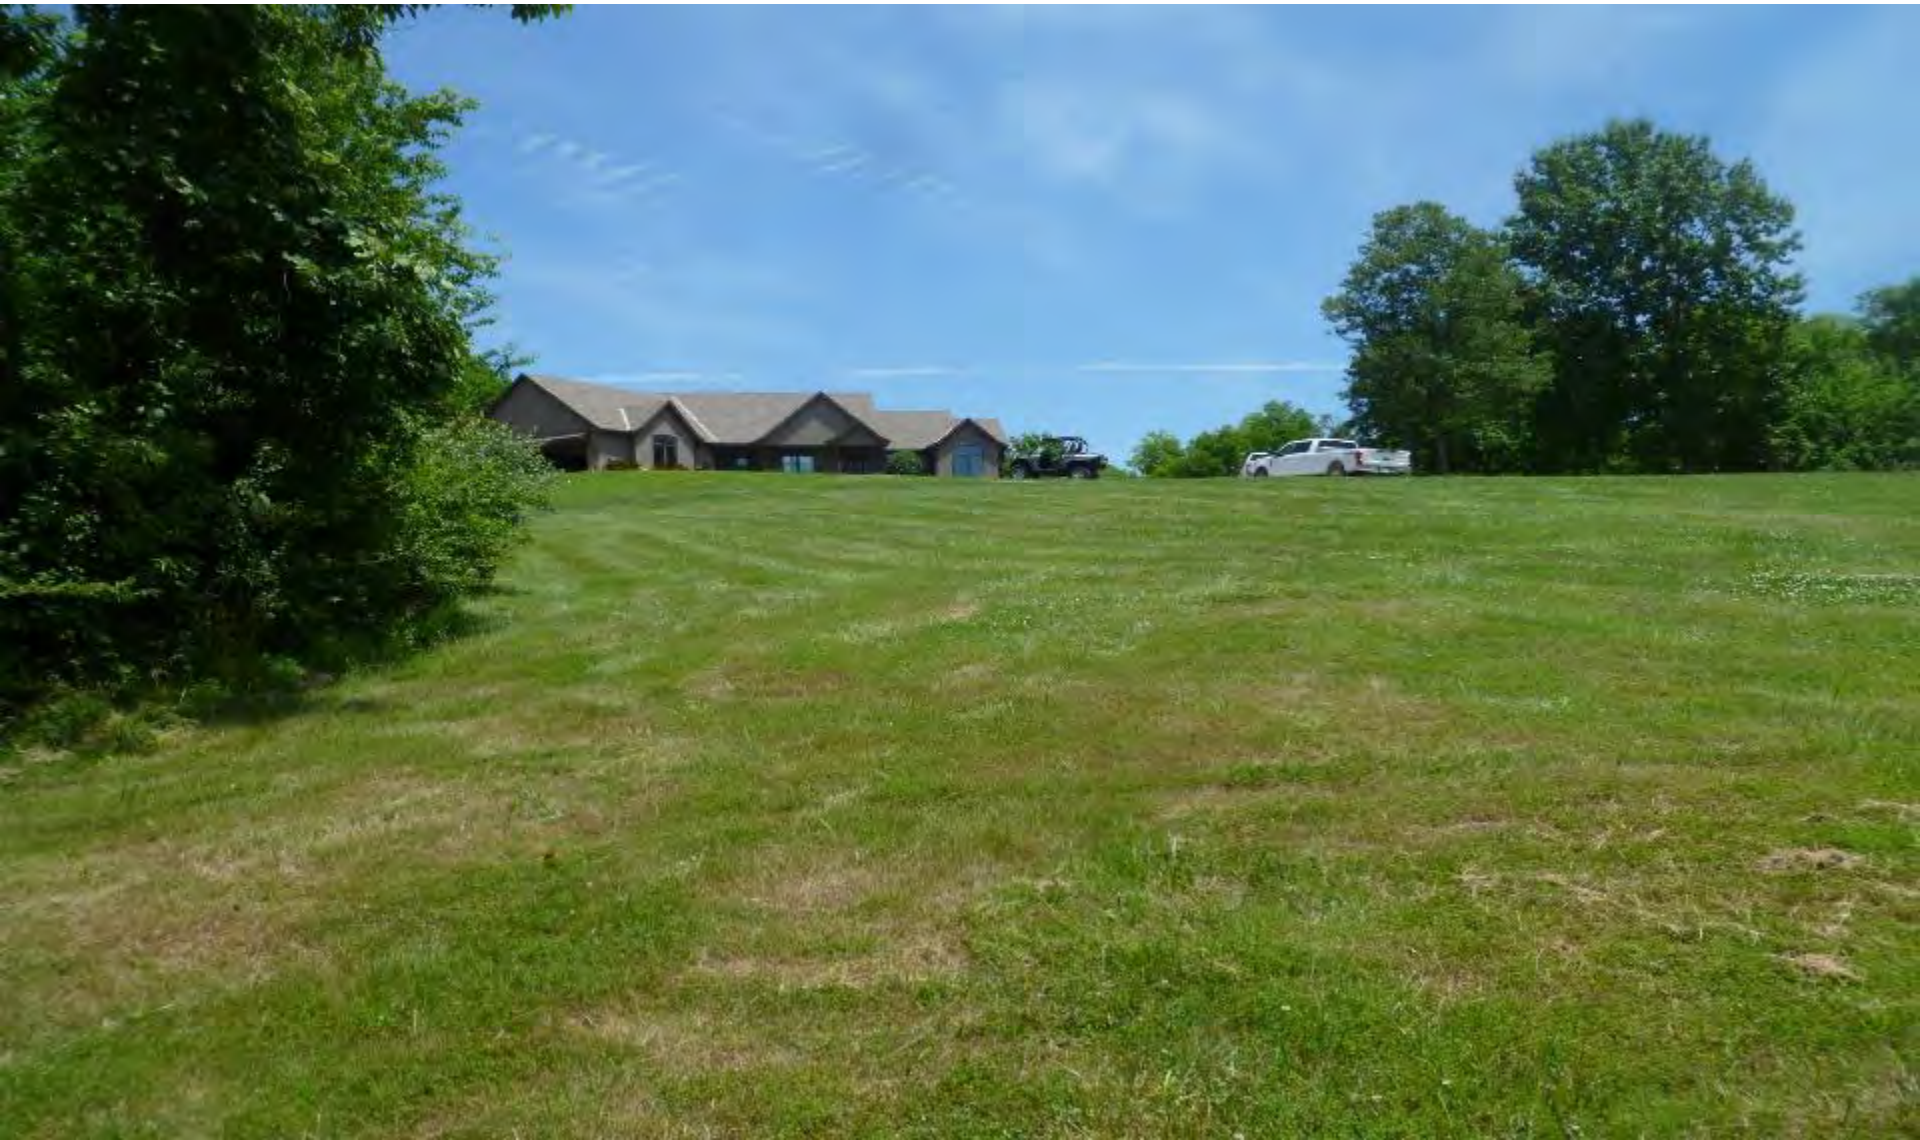
# Photo M7-2. Upslope from AES Technology Excelsior Springs, MO
