## **Final Report**

### **Field Performance Assessment of the Advanced Enviro-Septic Wastewater Treatment and Dispersal System in Missouri, 2022**

**Dr. Randall J. Miles, Soil Scientist, Emeritus Associate Professor**

**February 7, 2023**

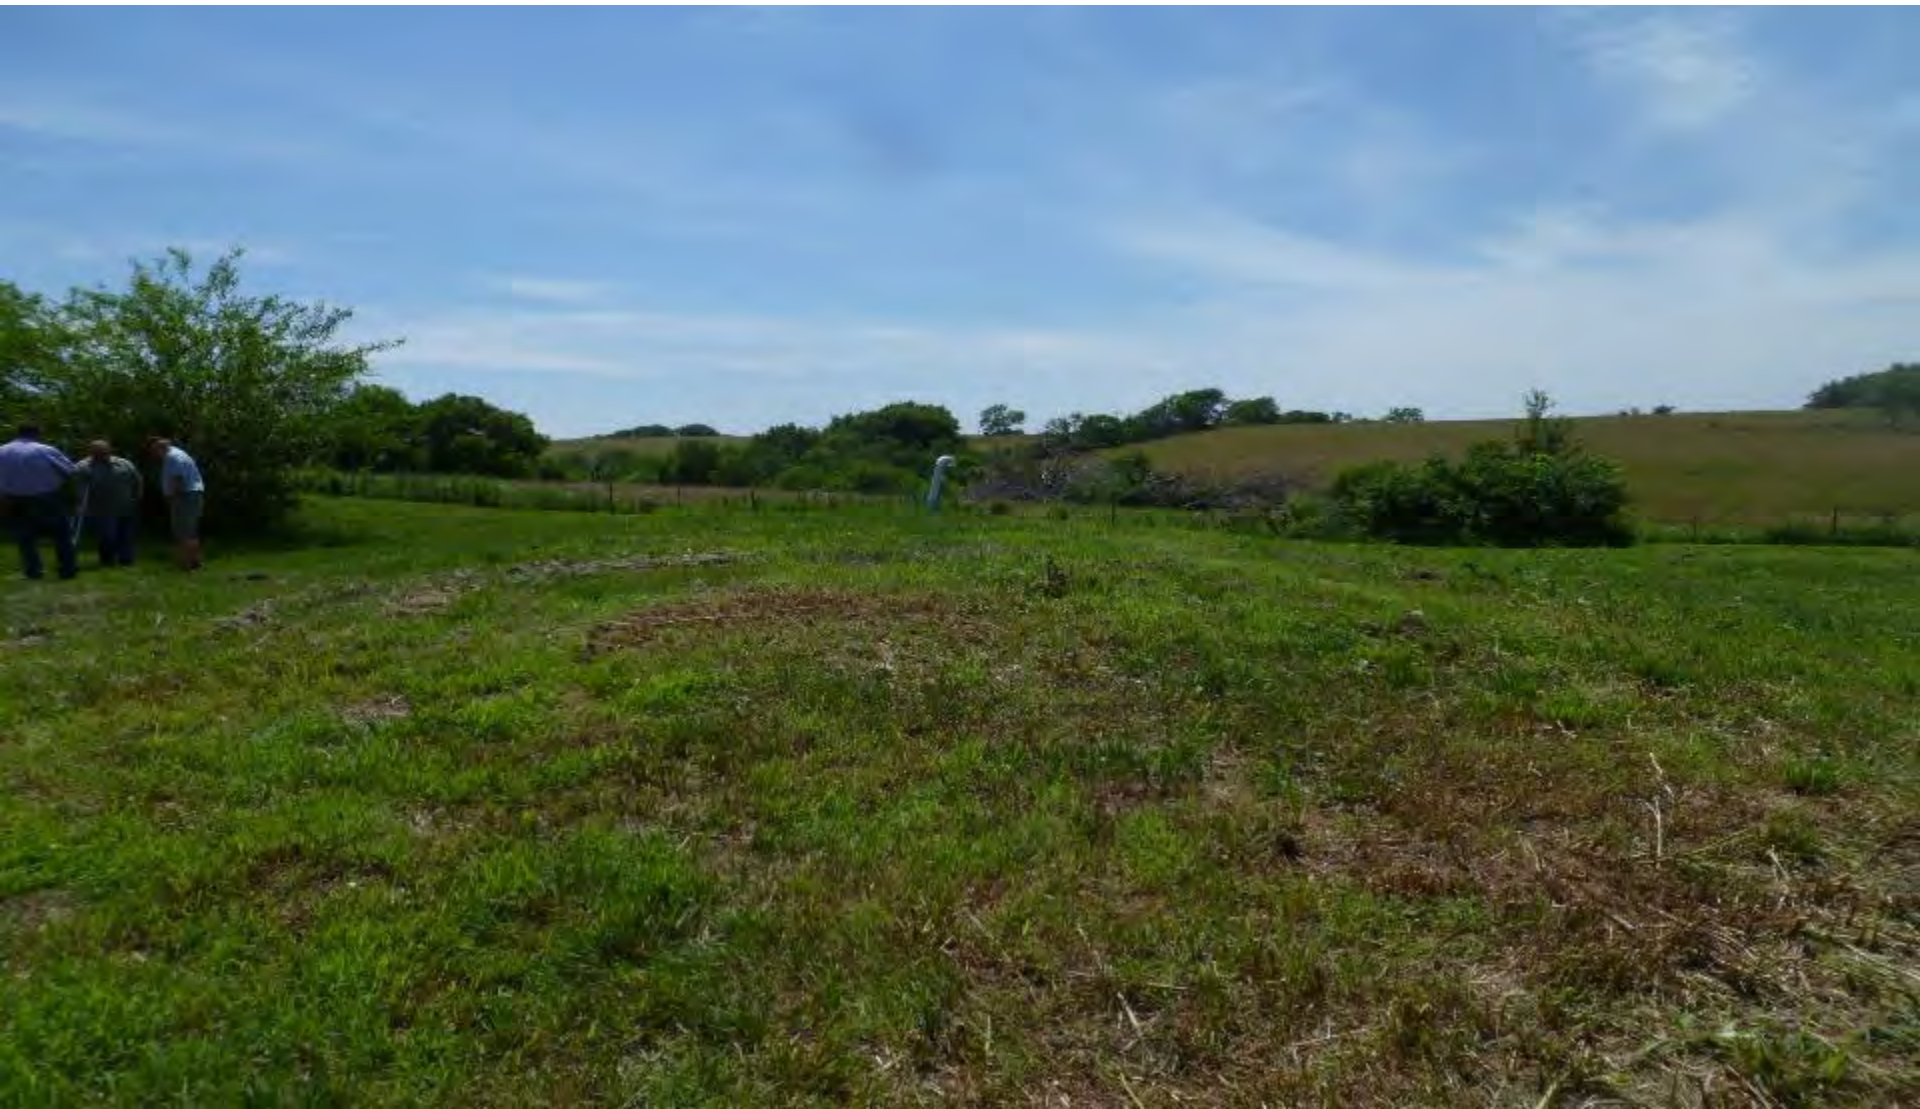
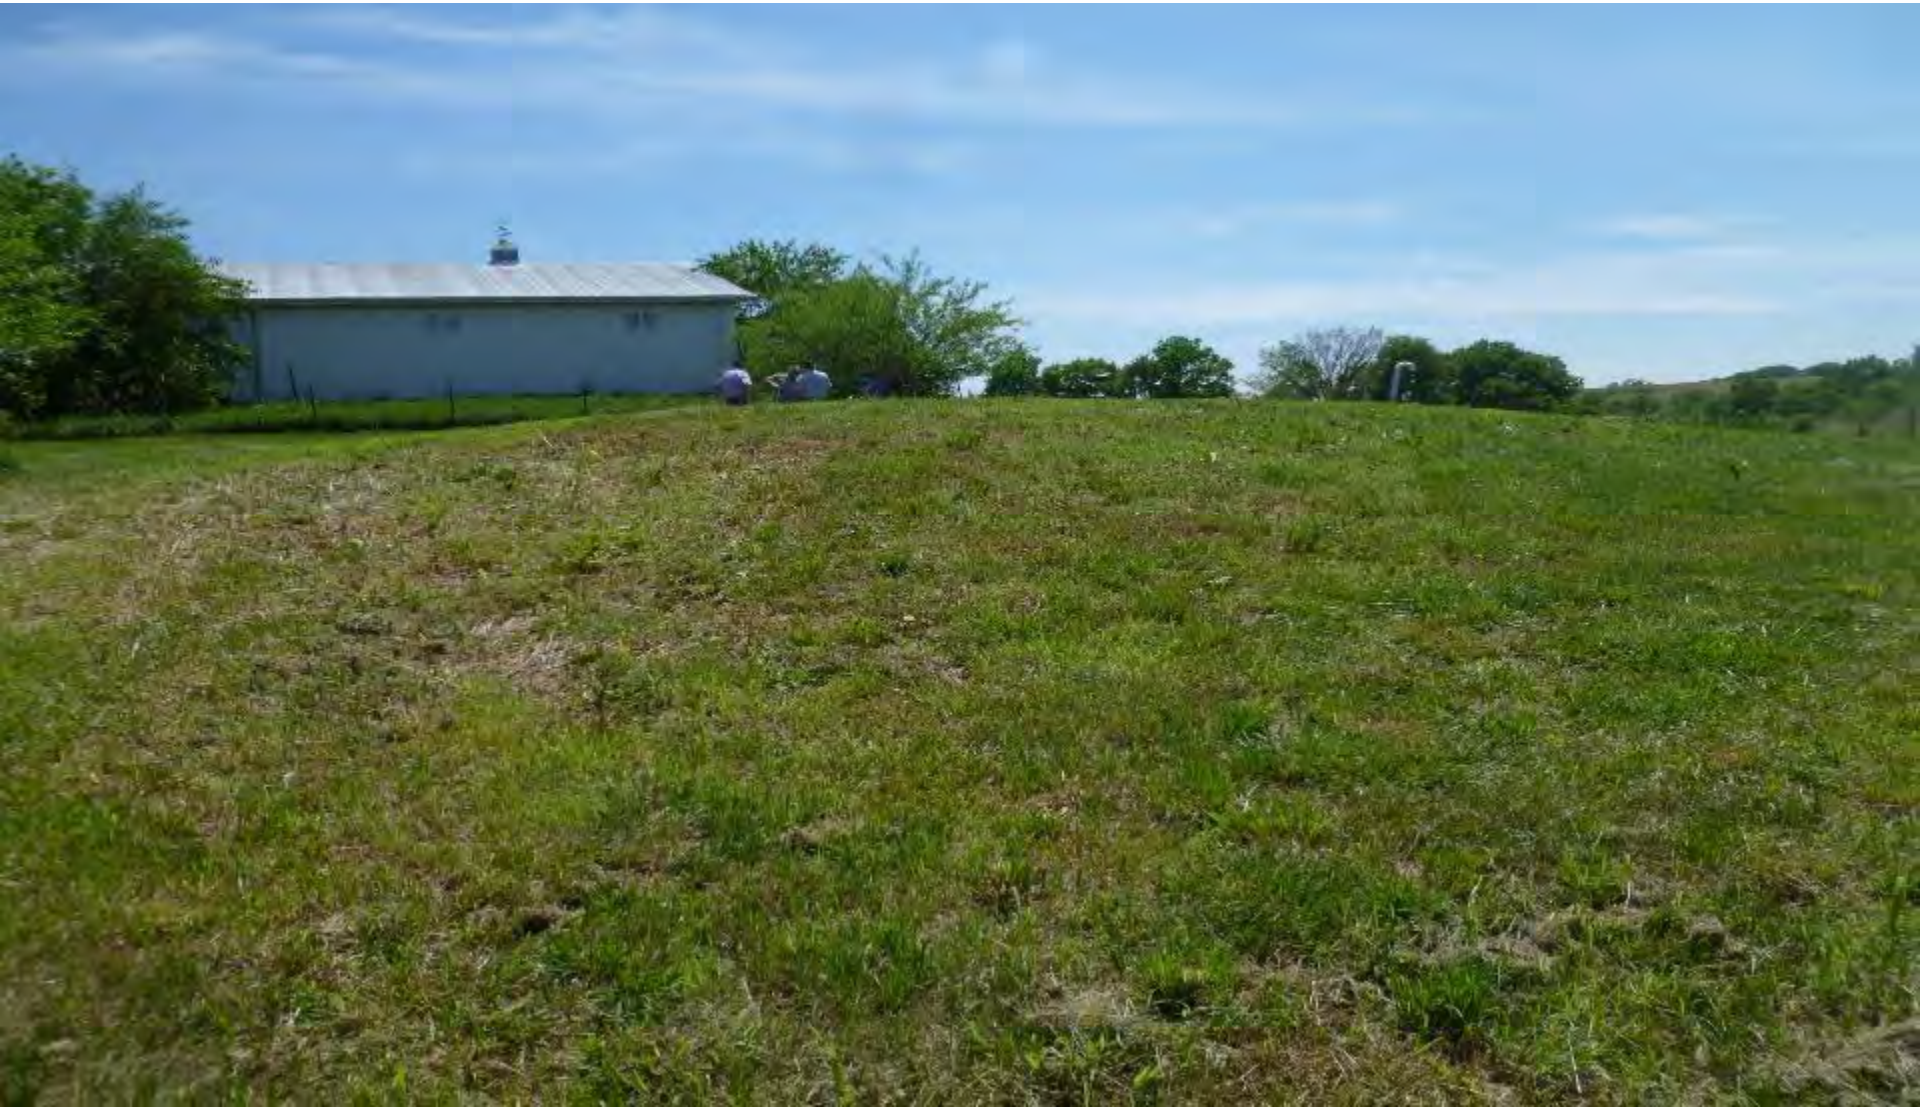
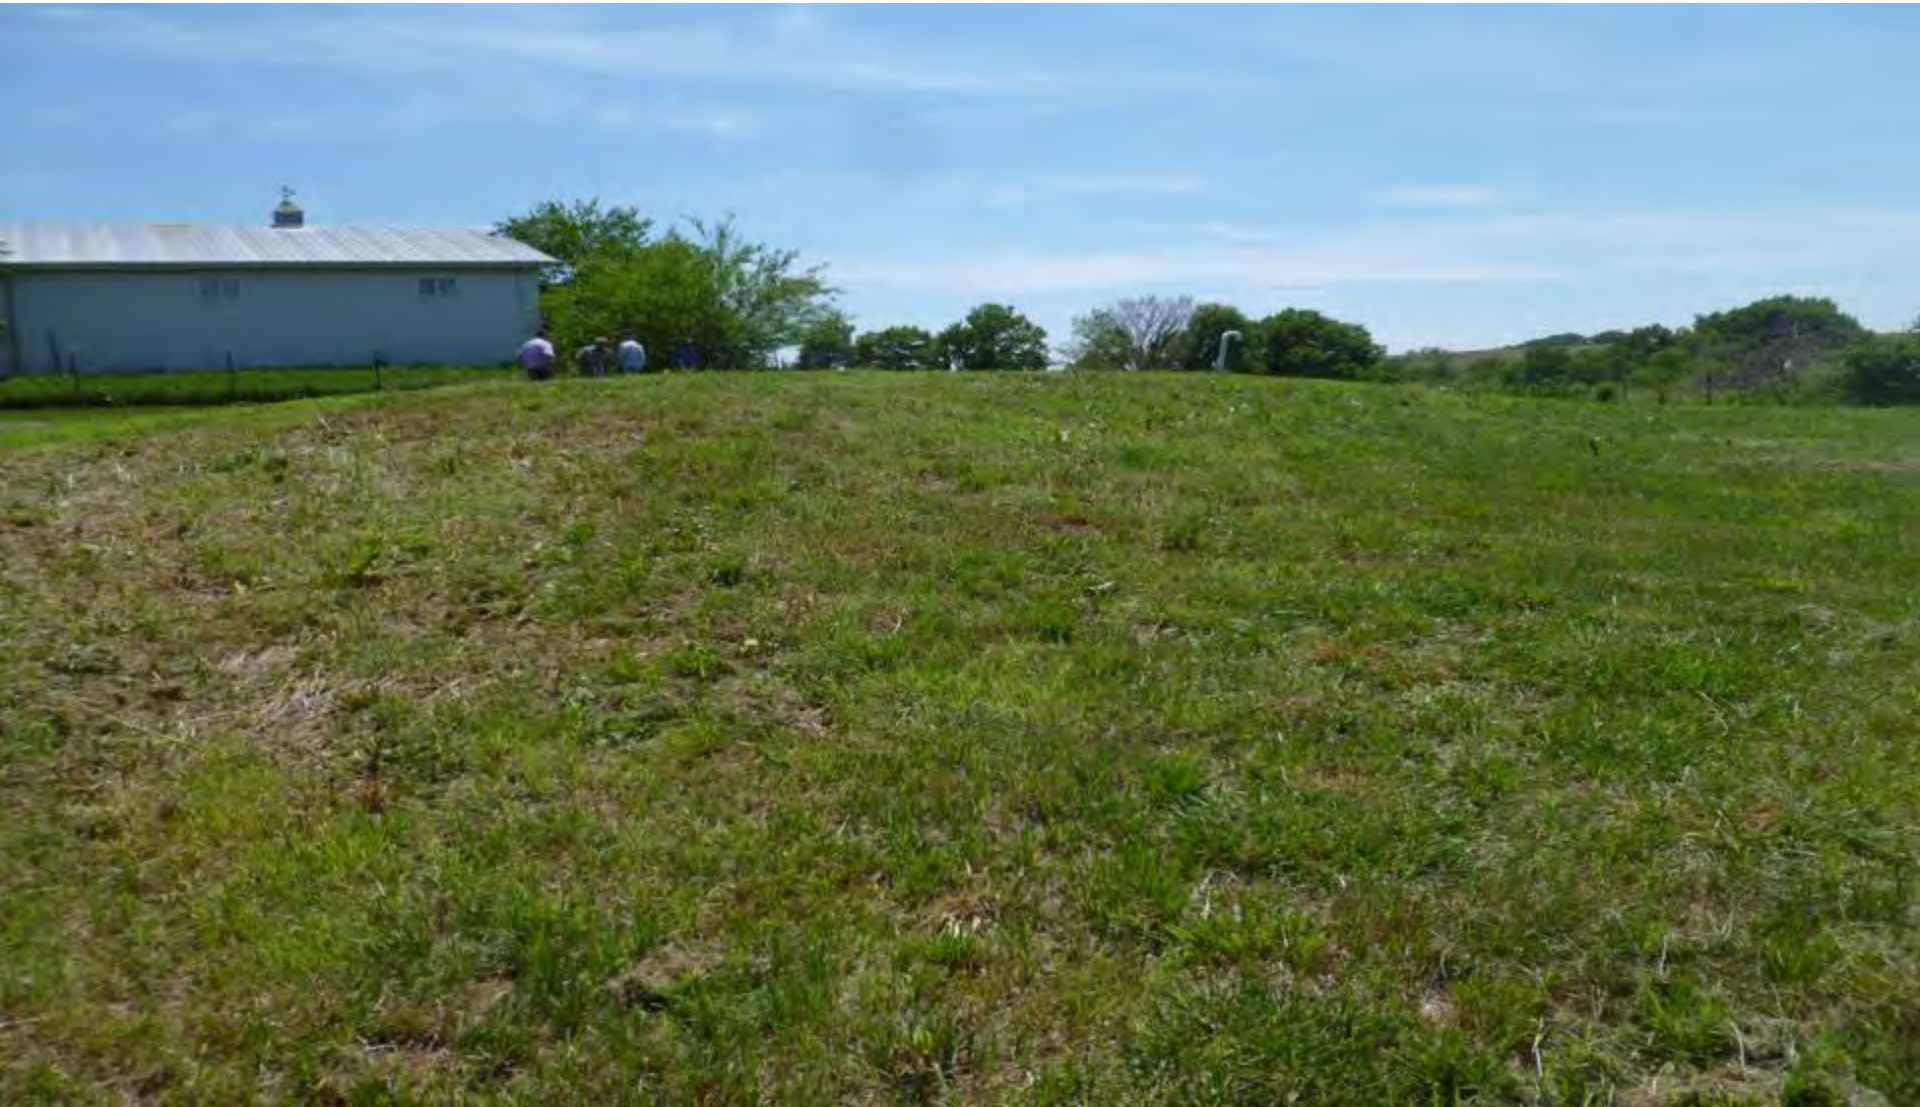
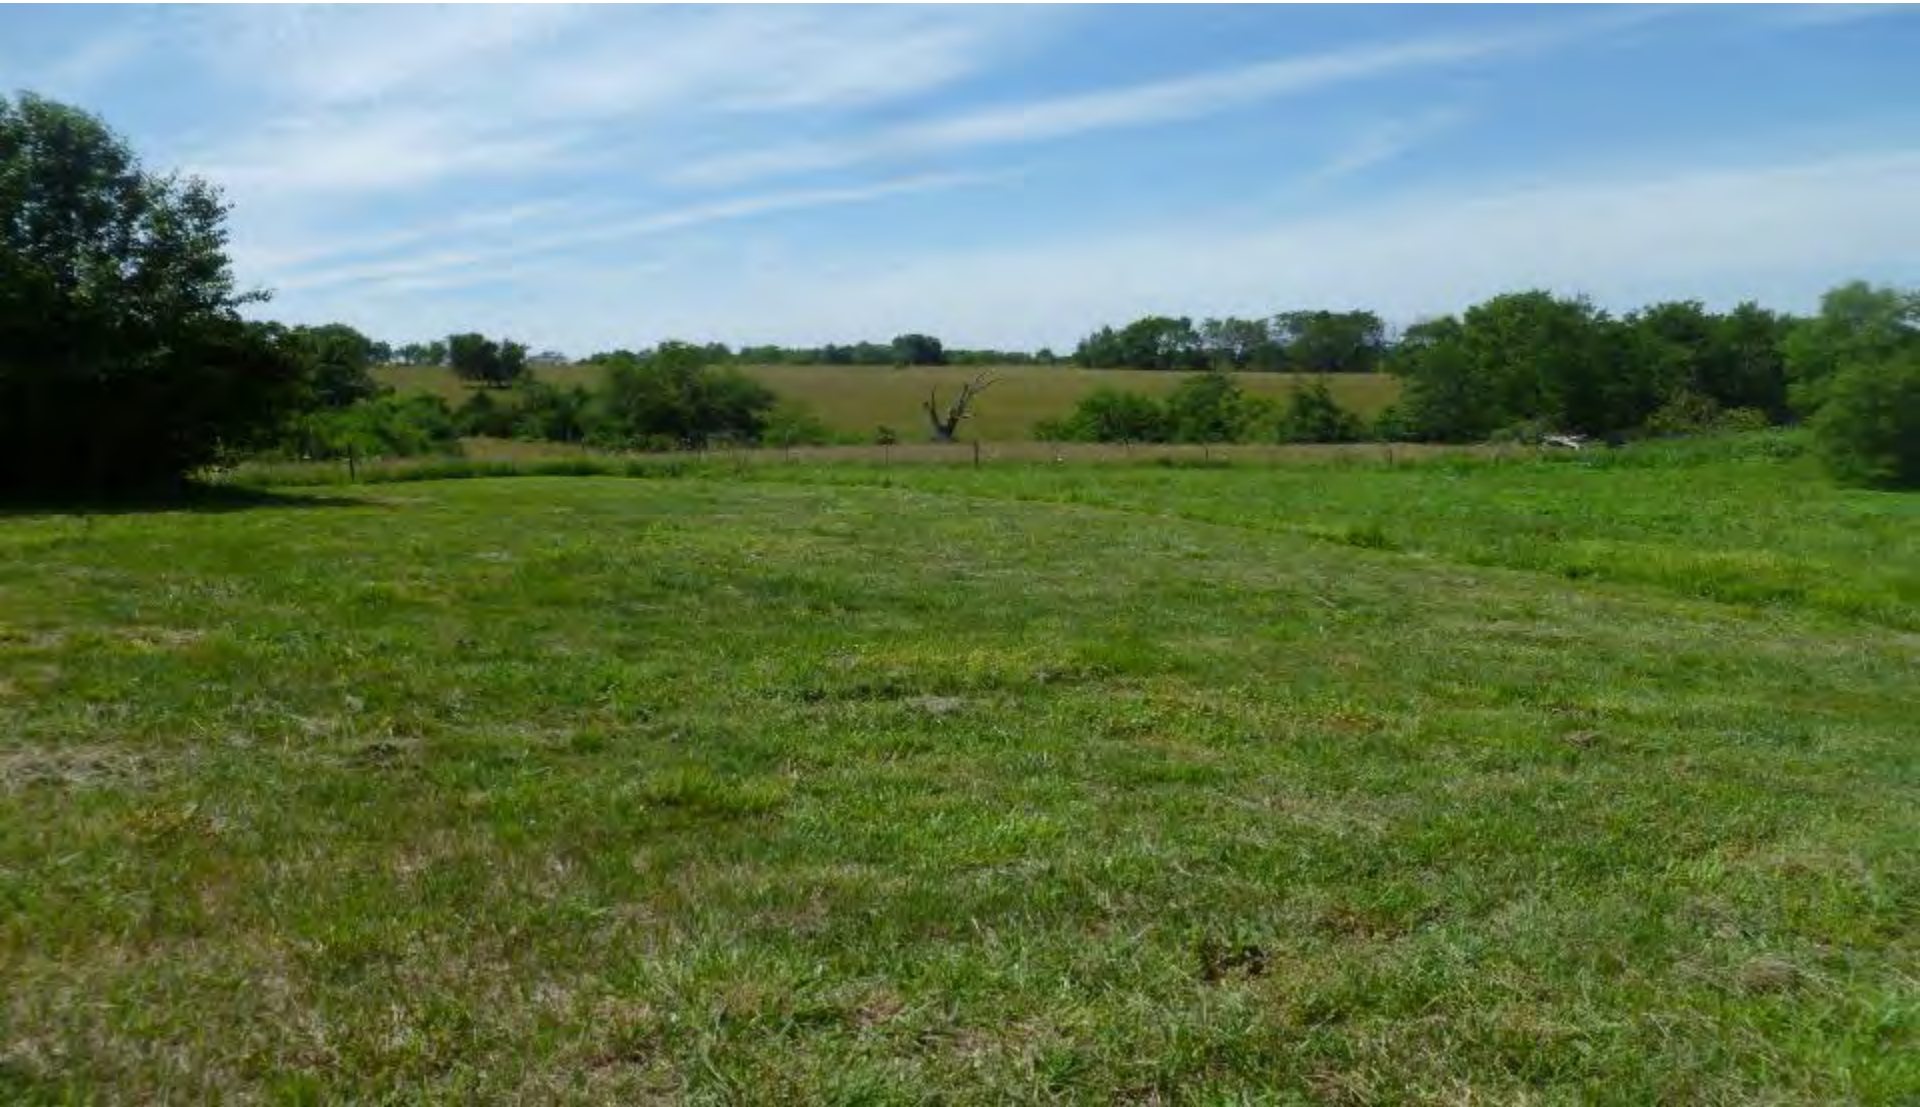
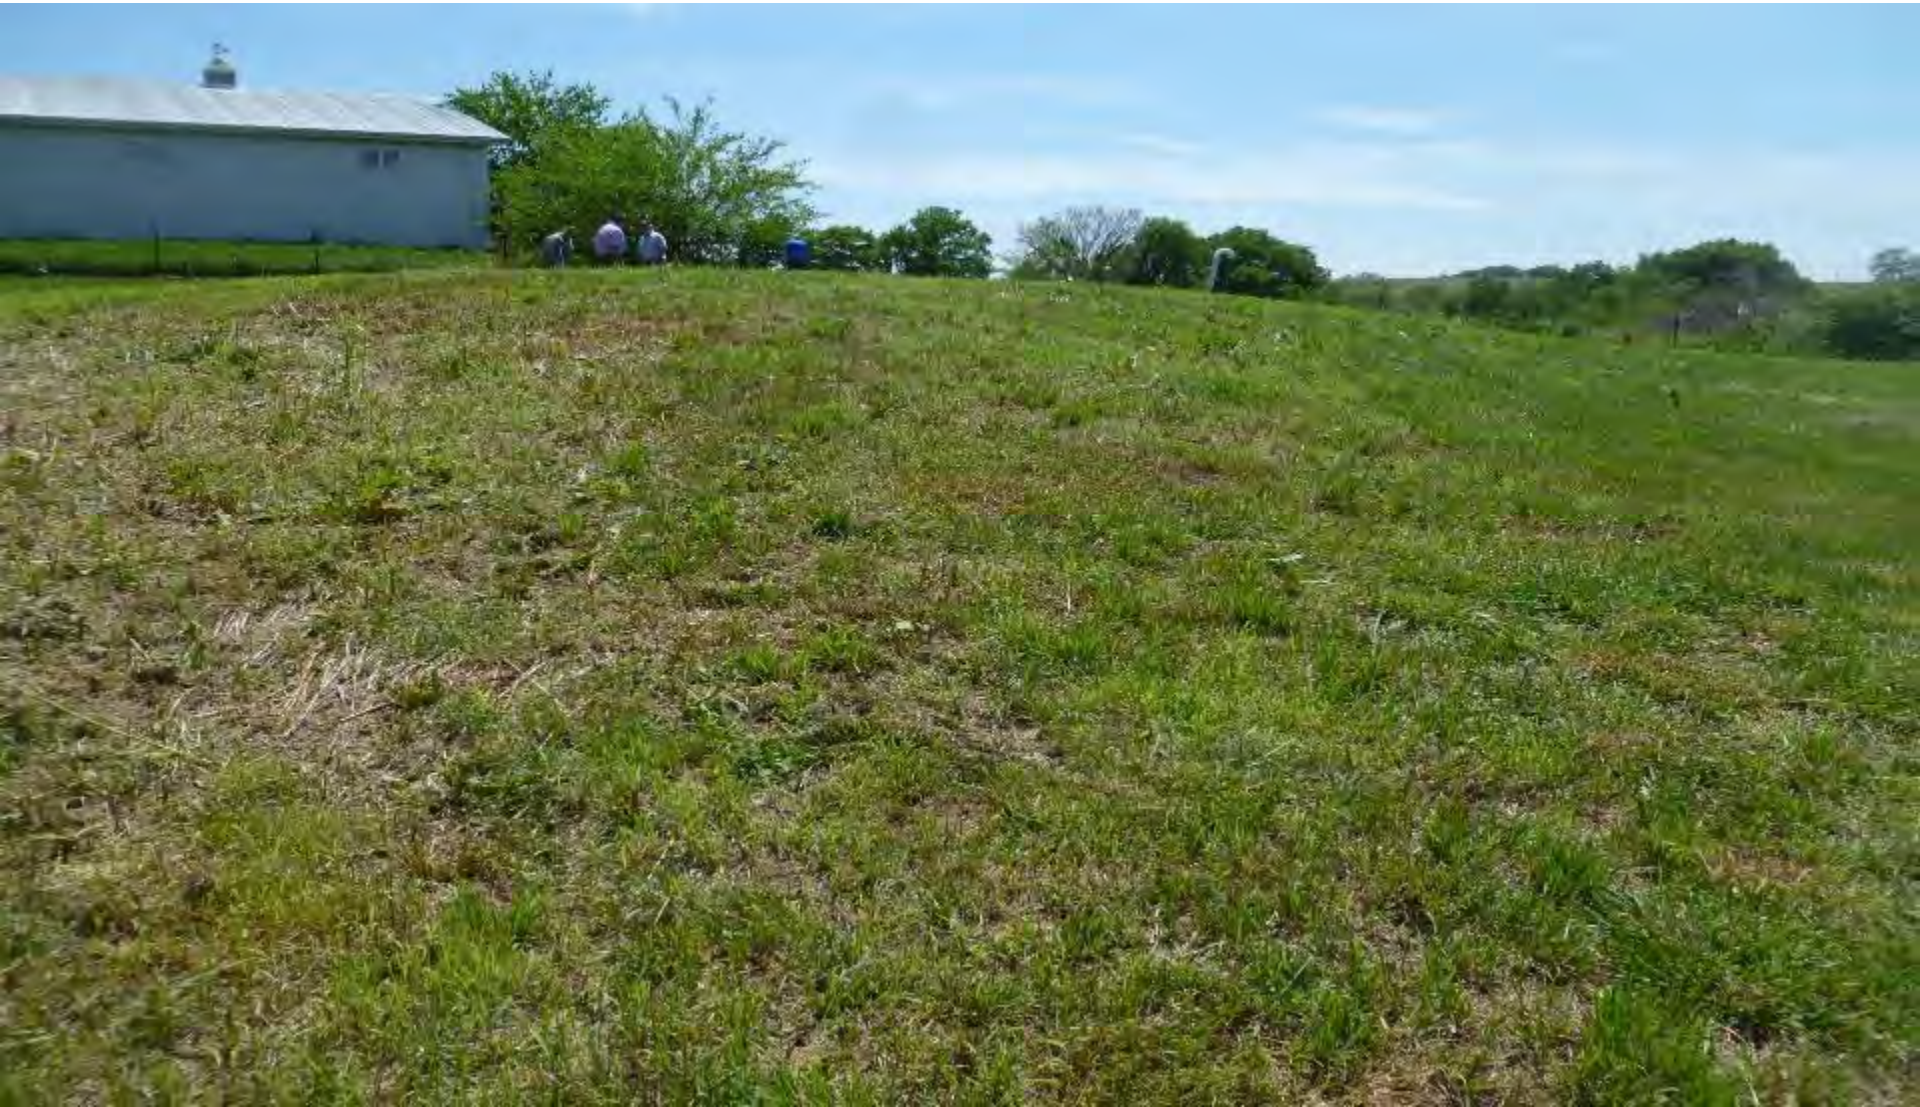
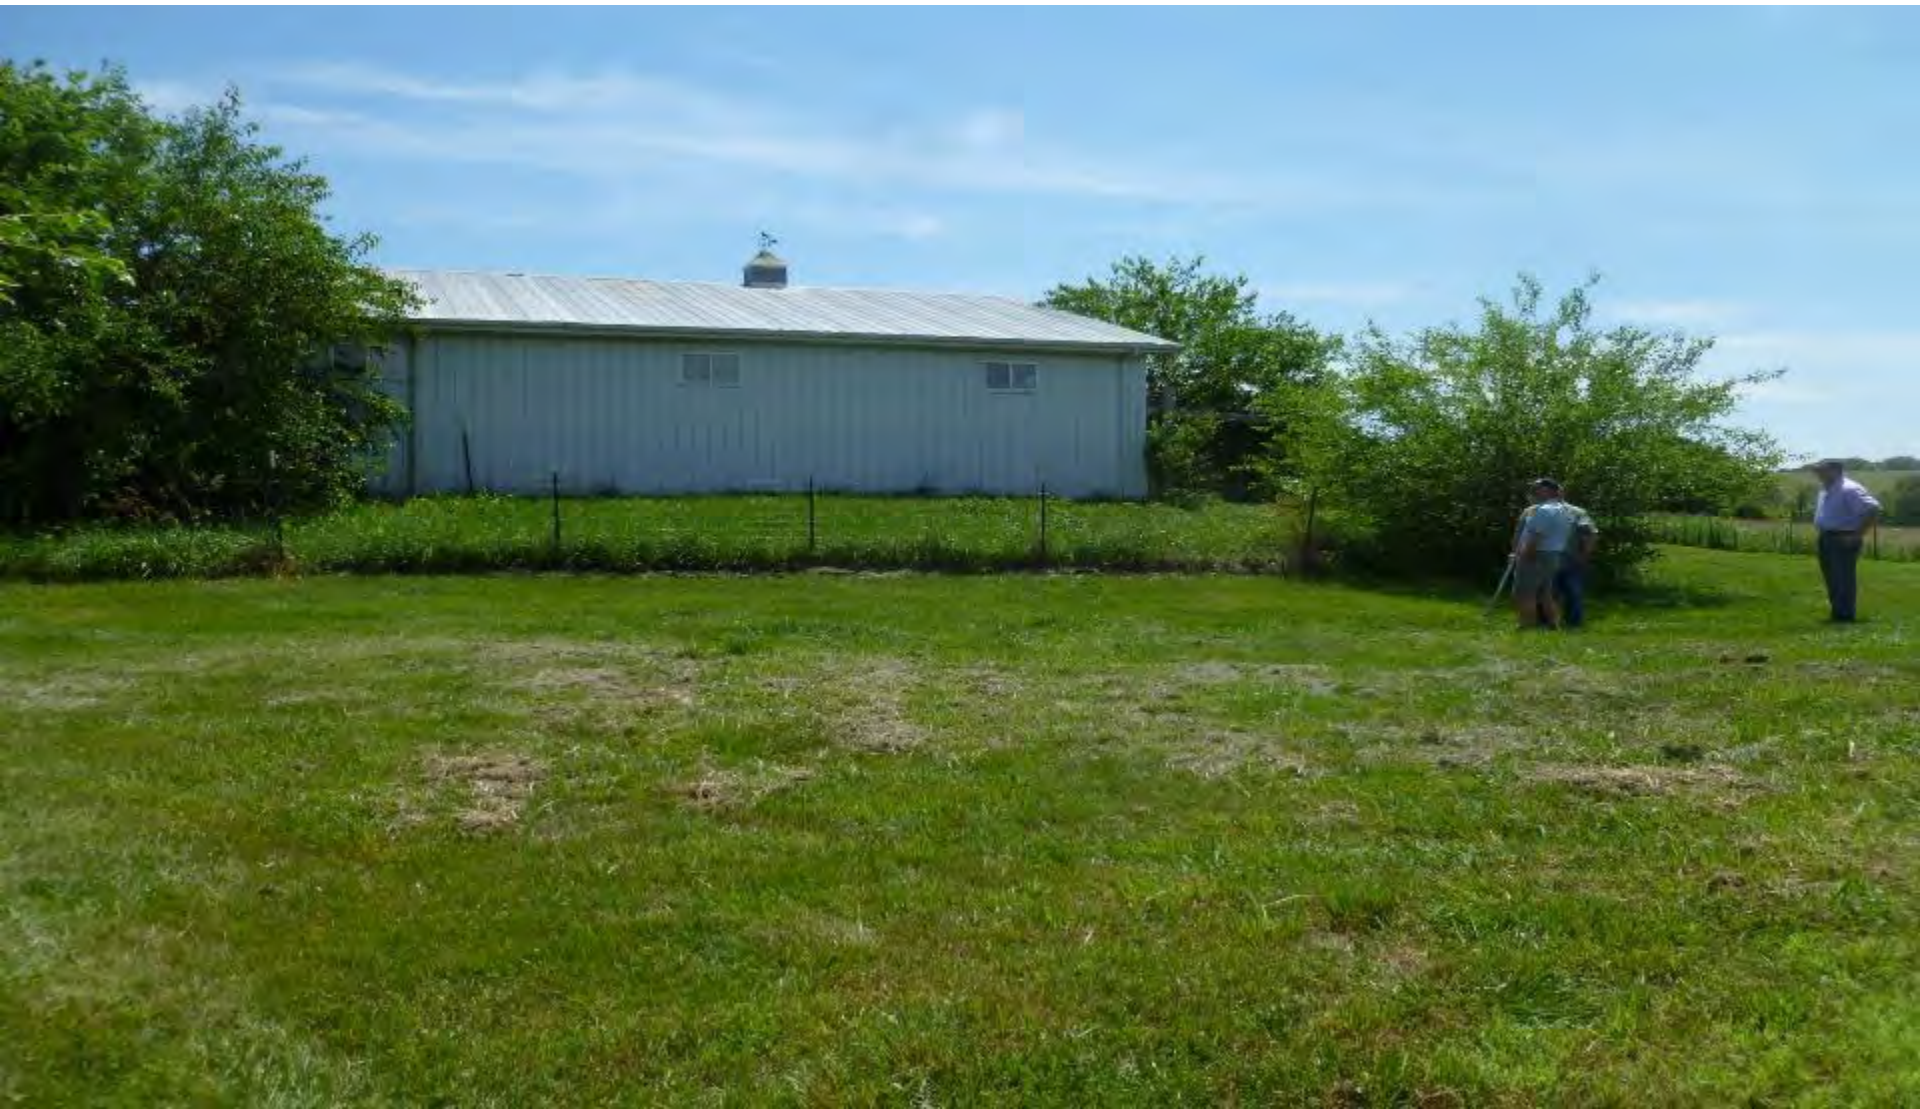
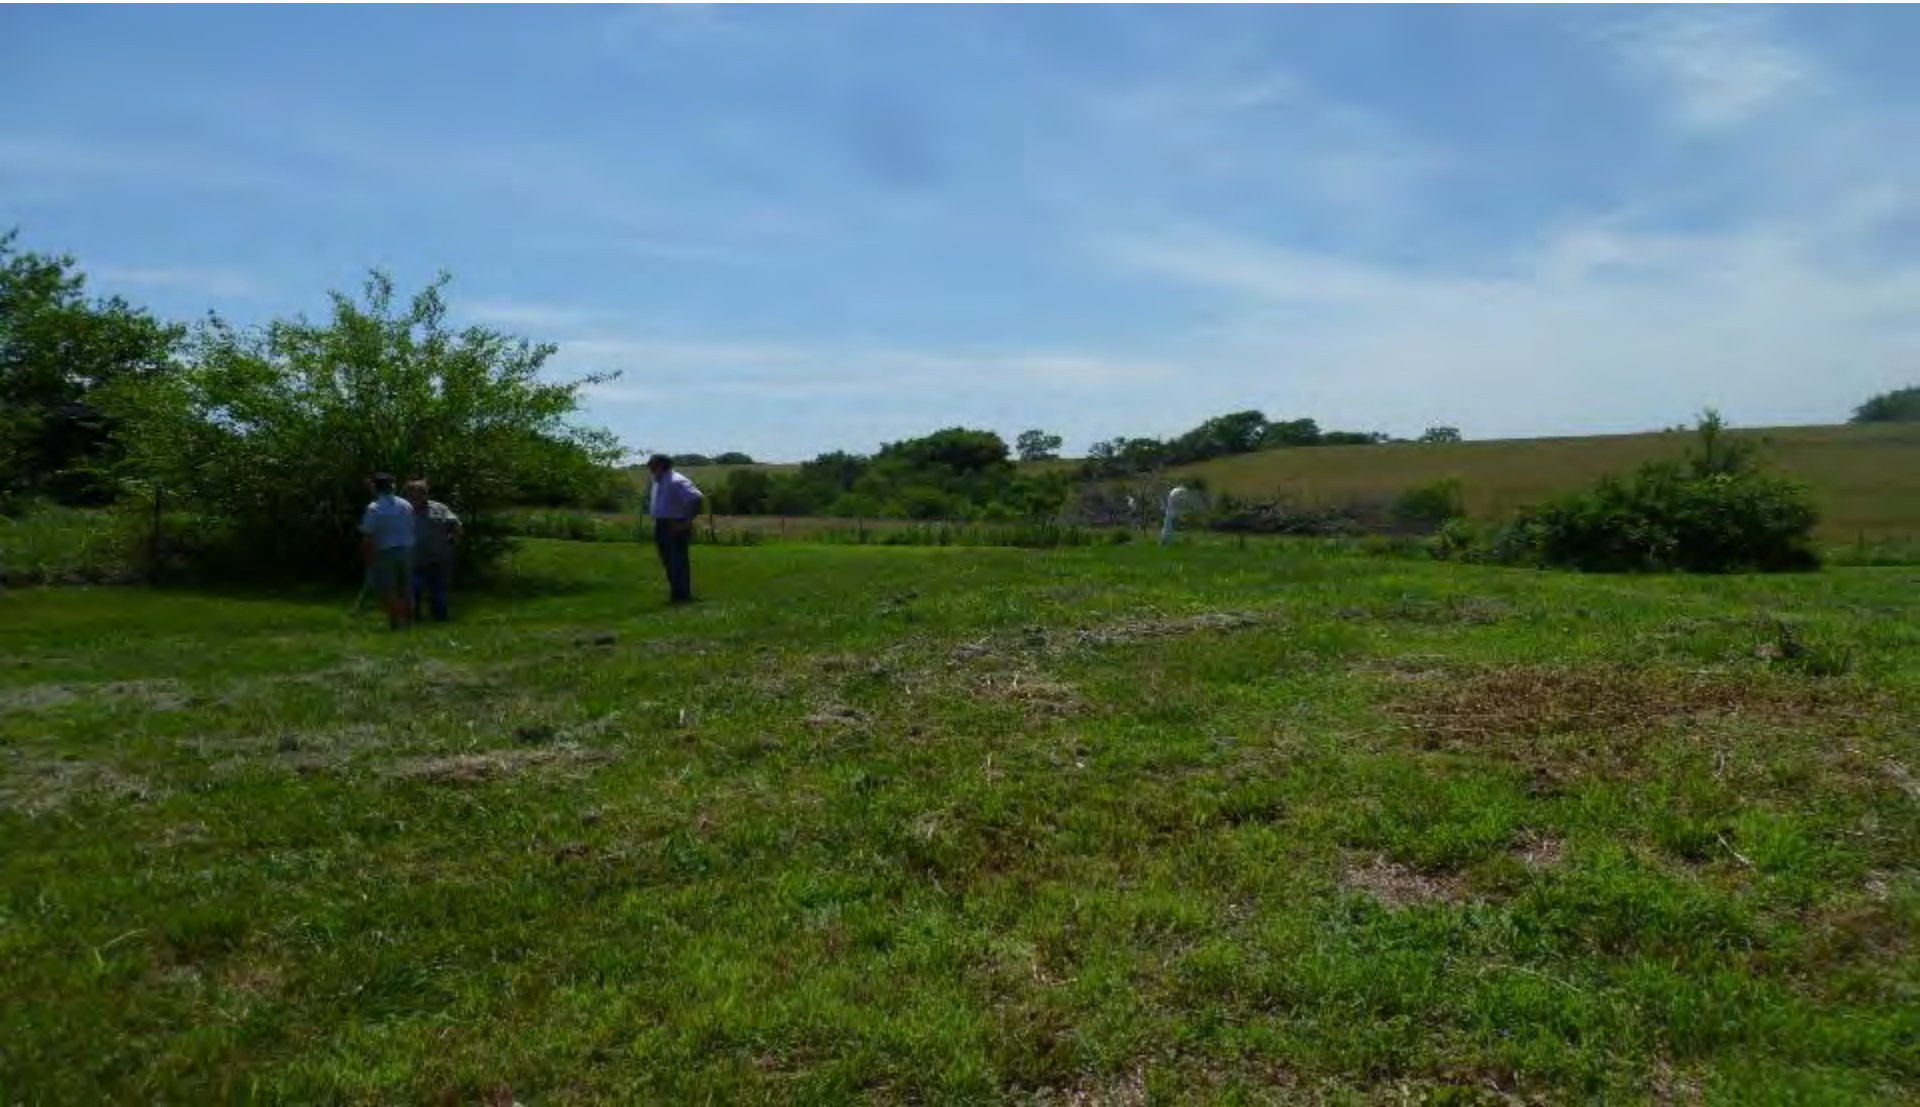
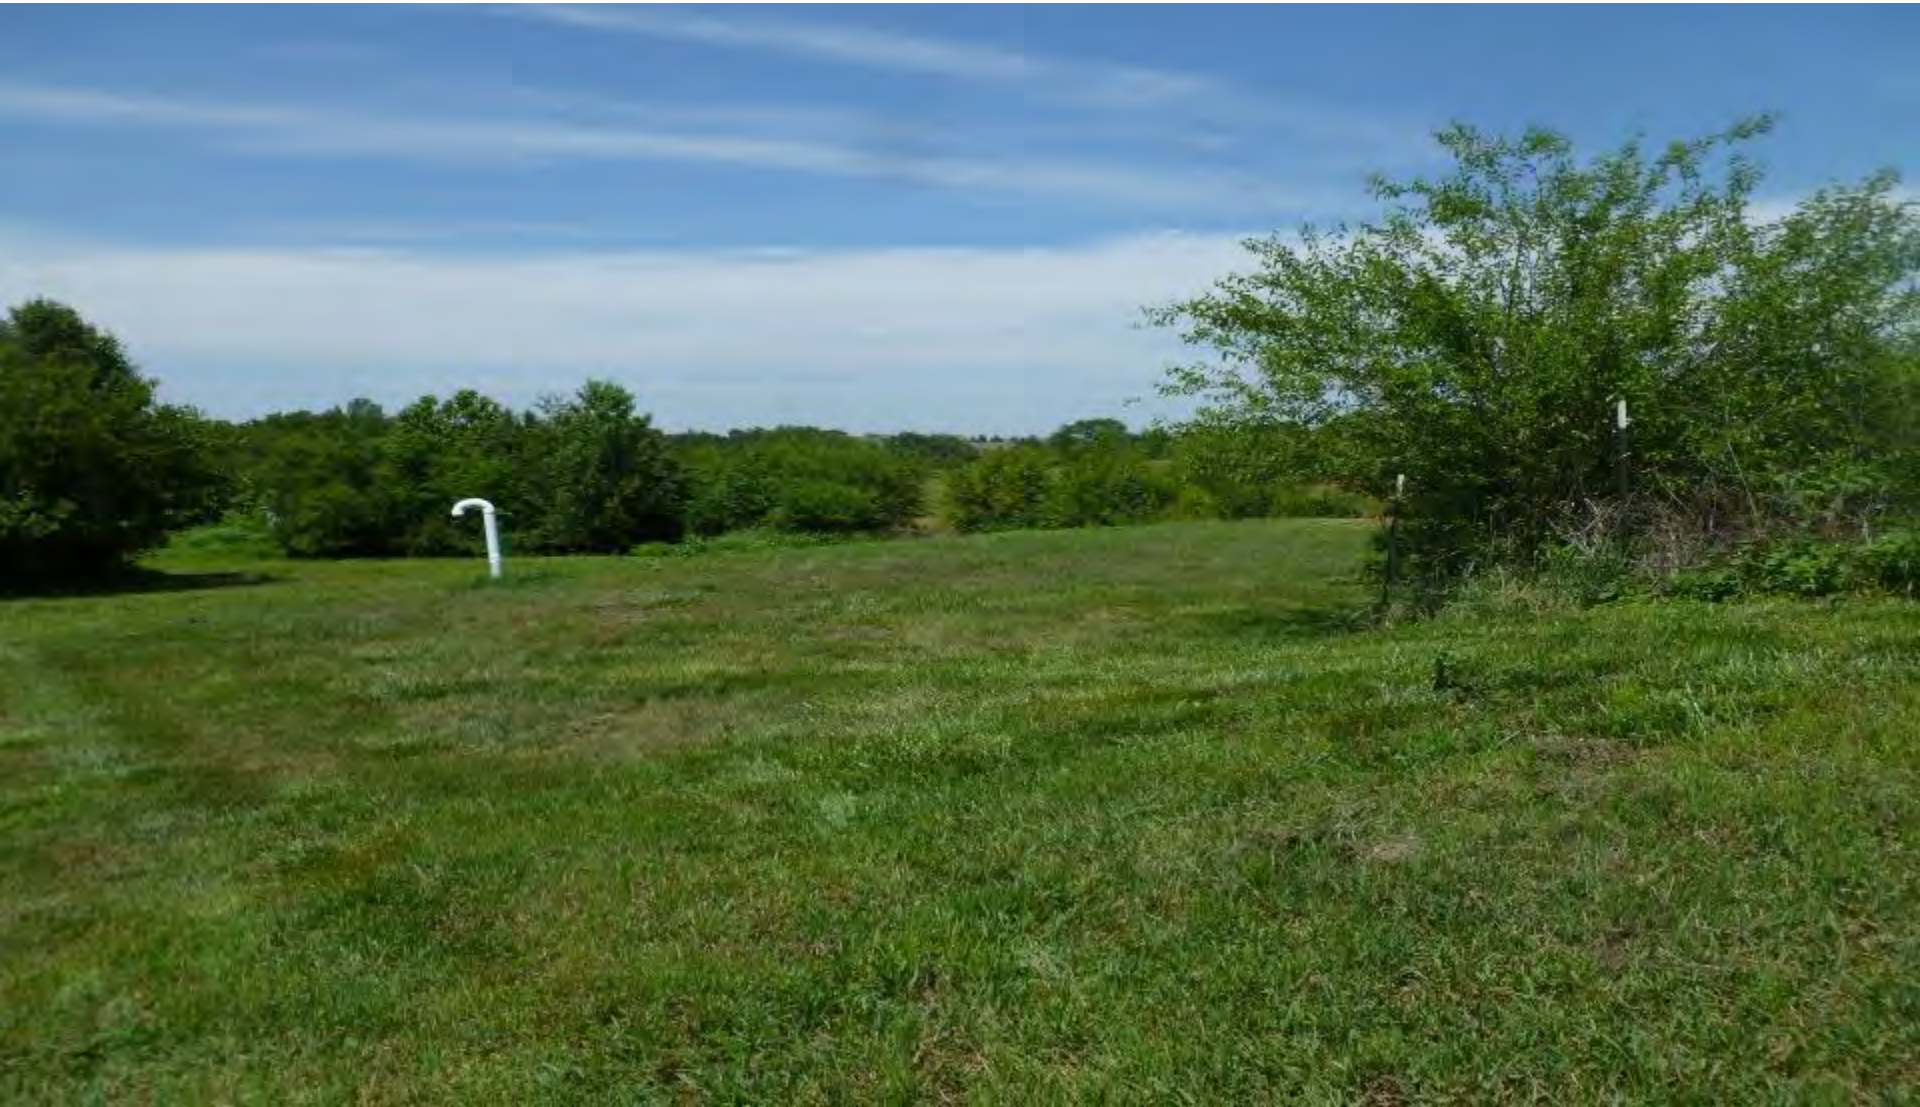
Site M8 located at 12402 NE 112<sup>th</sup>, Liberty, MO had a design soil loading rate of 0.30 gpd/sqft and 220 linear feet of AES (4 lines of 55 ft of product) (Table 1). Photos of this site and system are provided in photos M8-1 and M8-2 (Appendix B). This system was installed in April 2015. The summary of the field evaluation observed no current surfacing effluent over any part of the system, nor evidence of past surfacing. There was no surfacing of sewage with pressure of footwear. No straight pipe discharges were found and no visible signs of malfunction were observed (Table 1 and Appendix A, Table M8). The homeowners were available to interview. They expressed no problems with the system (Appendix A, Table M8).

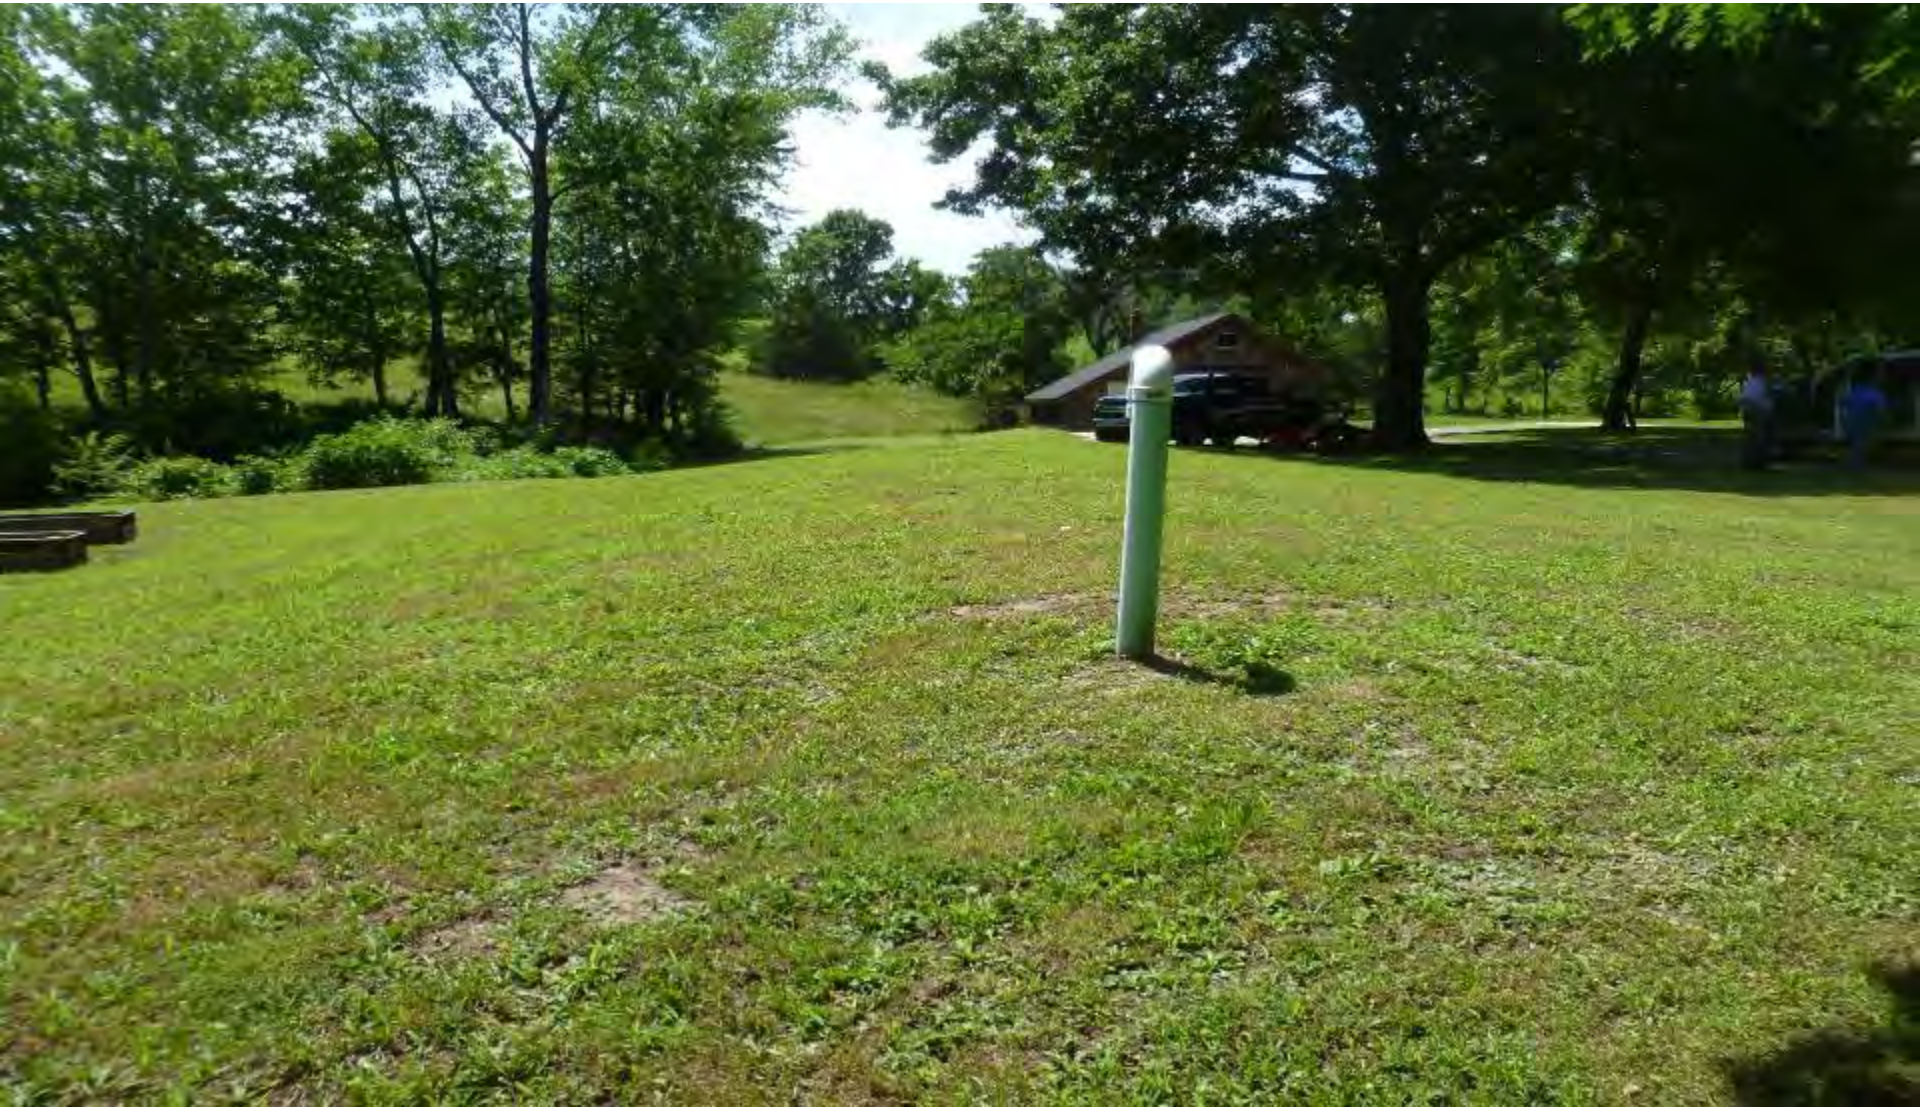
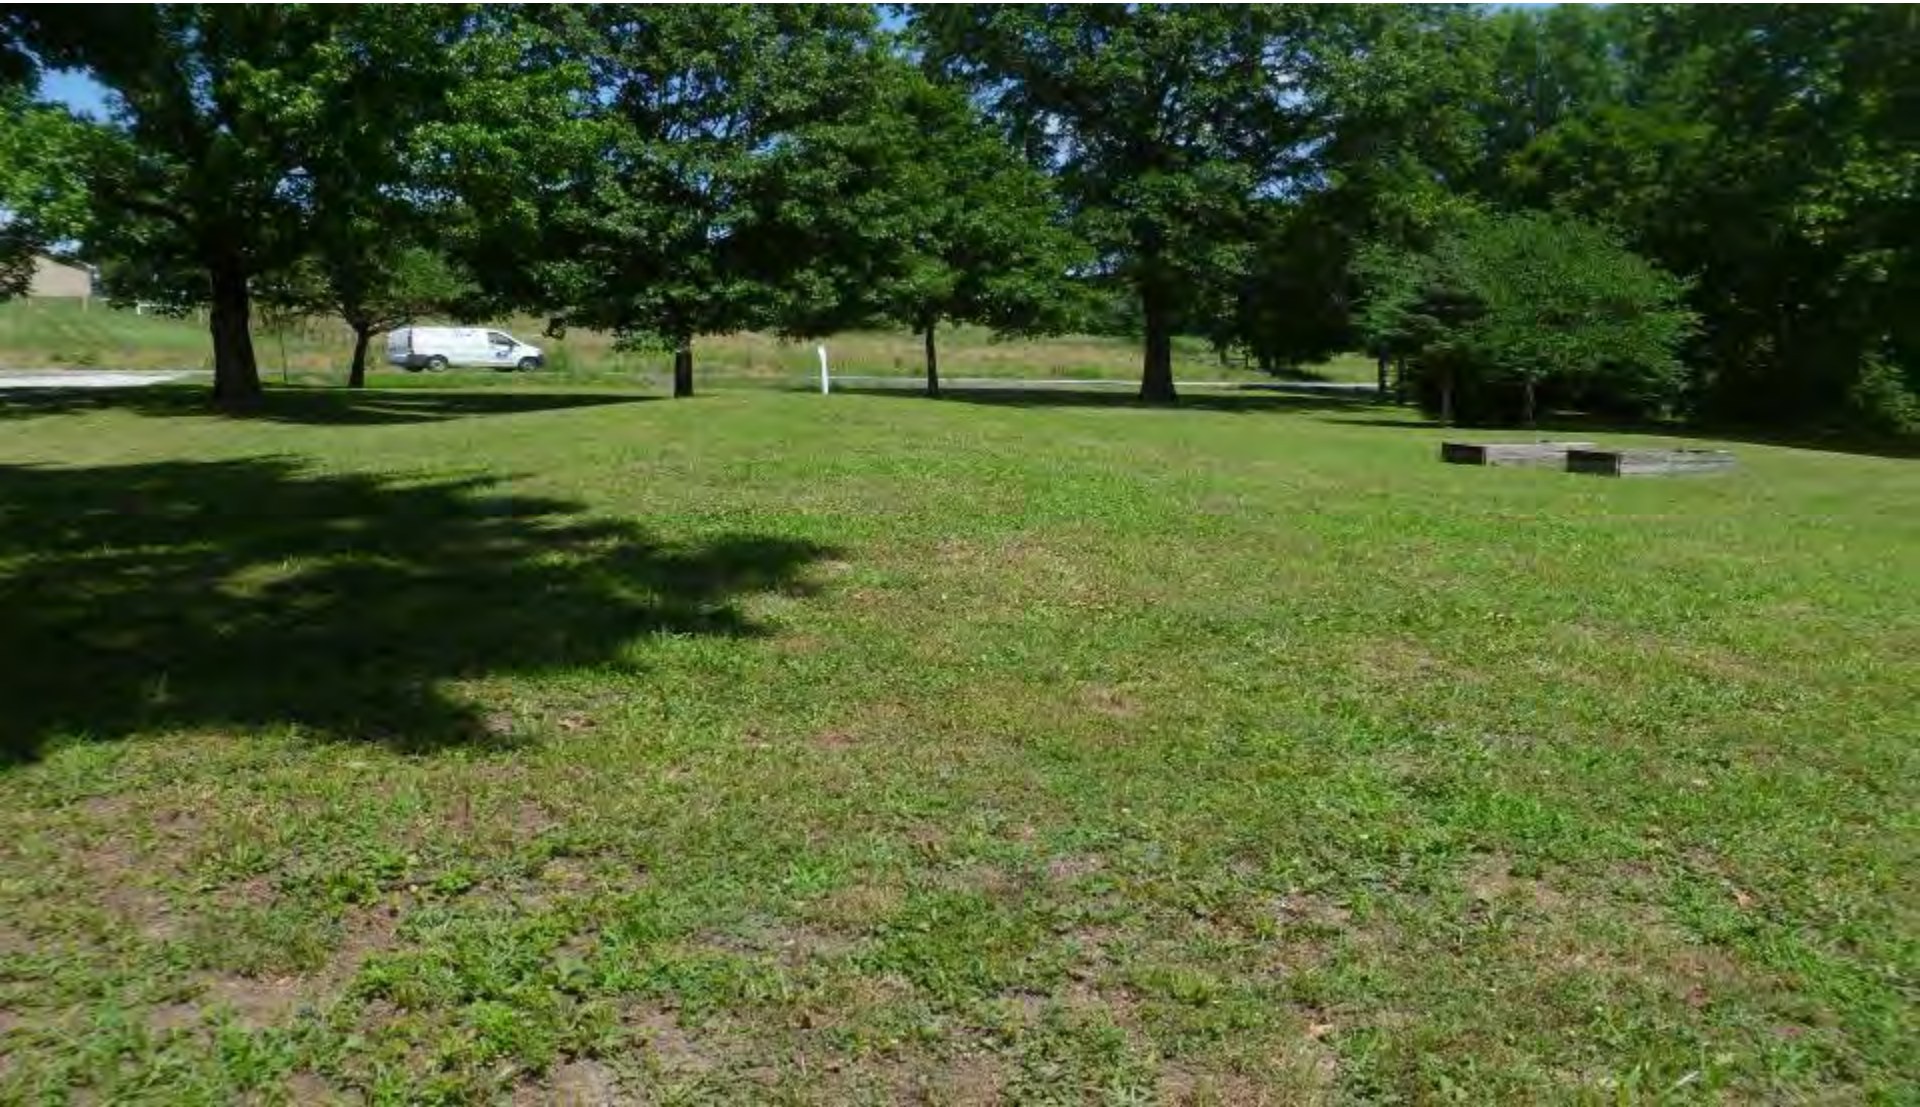
Site M9 located at 13416 Plattsburg Road, Kearney, MO had a design soil loading rate of 0.50 gpd/sqft and 210 linear feet of AES (3 lines of 70 ft of product) (Table 1). Photos of this site and system are provided in photos M9-1 and M9-2 (Appendix B). This system was installed in May 2017. The summary of the field evaluation observed no current surfacing effluent over any part of the system, nor evidence of past surfacing. There was no surfacing of sewage with pressure of footwear. No straight pipe discharges were found and no visible signs of malfunction were observed (Table 1 and Appendix A, Table M9). Additionally, no breakouts or effluent odor was observed with 10 feet of the system. A functional upslope surface water diversion was in place,
