## **Final Report**

### **Field Performance Assessment of the Advanced Enviro-Septic Wastewater Treatment and Dispersal System in Missouri, 2022**

**Dr. Randall J. Miles, Soil Scientist, Emeritus Associate Professor**

**February 7, 2023**

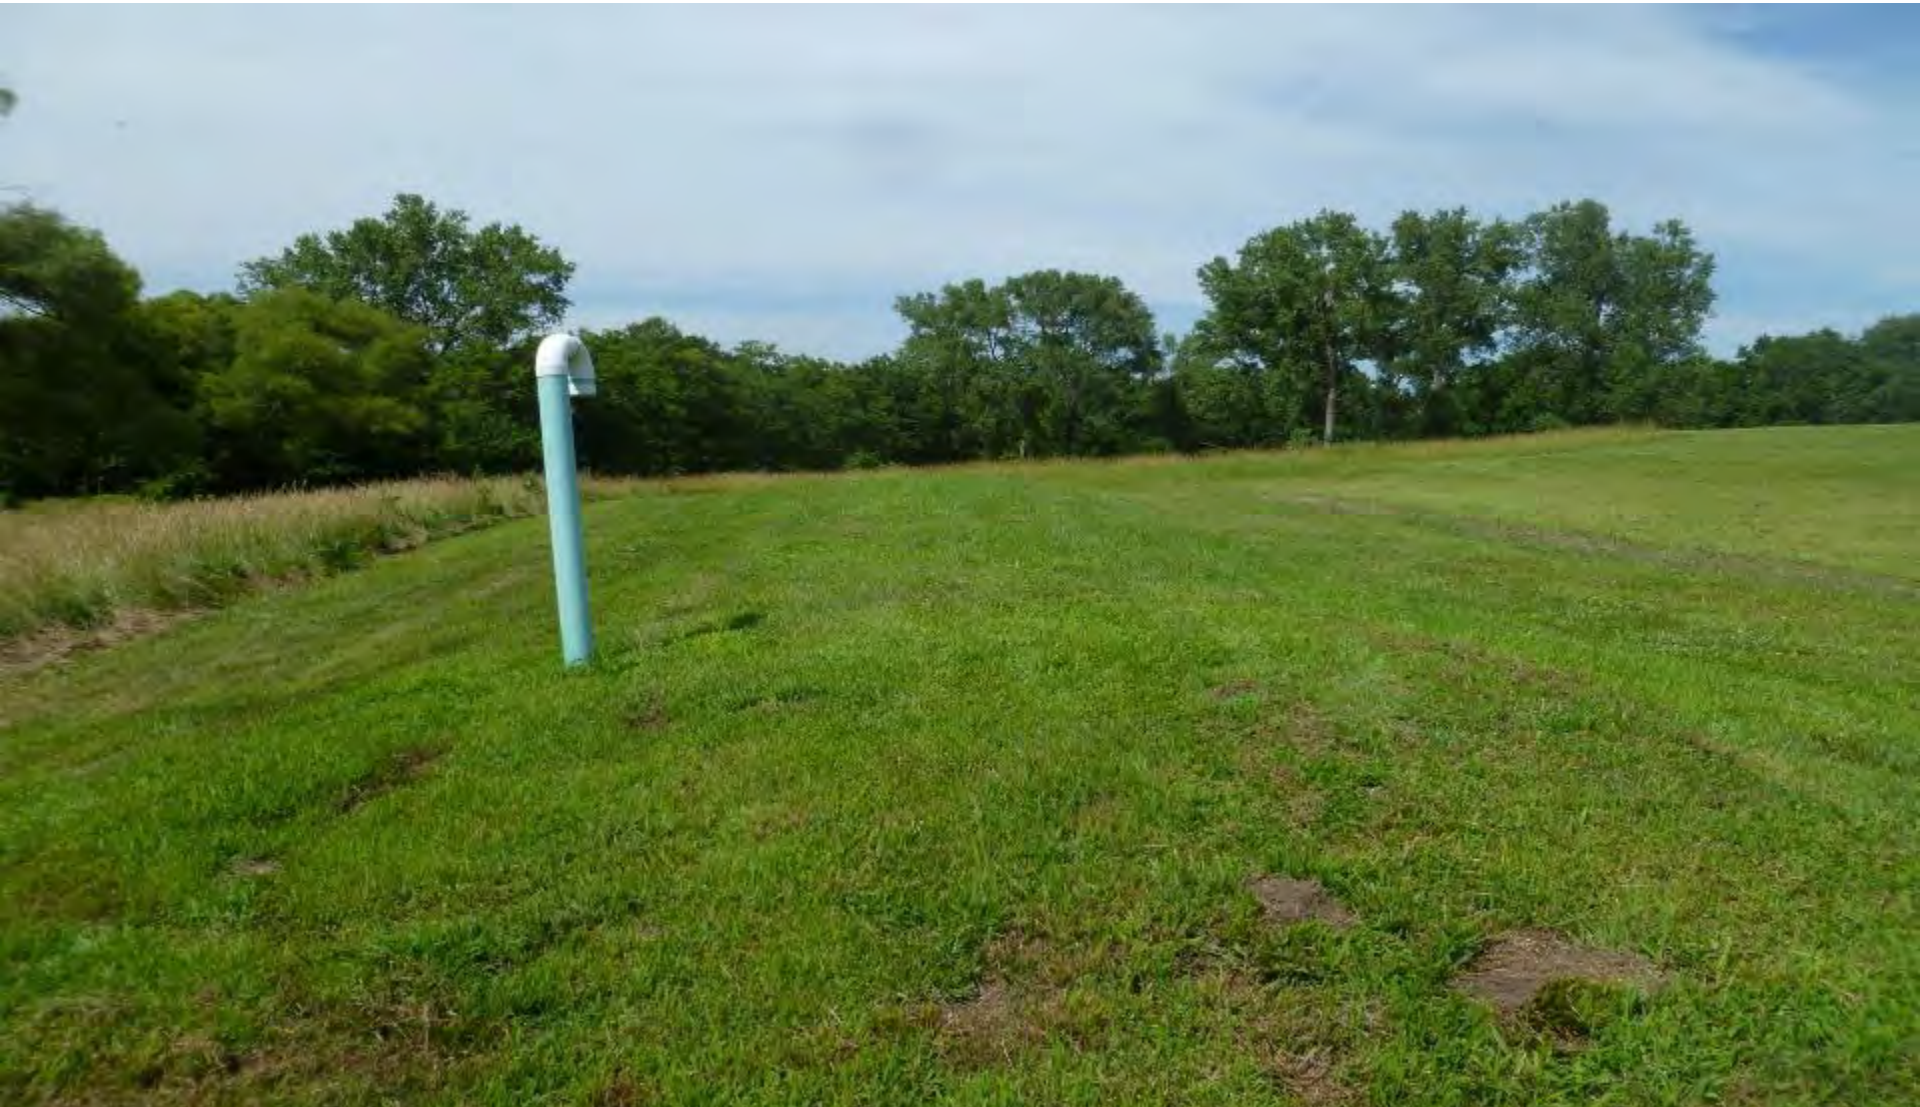
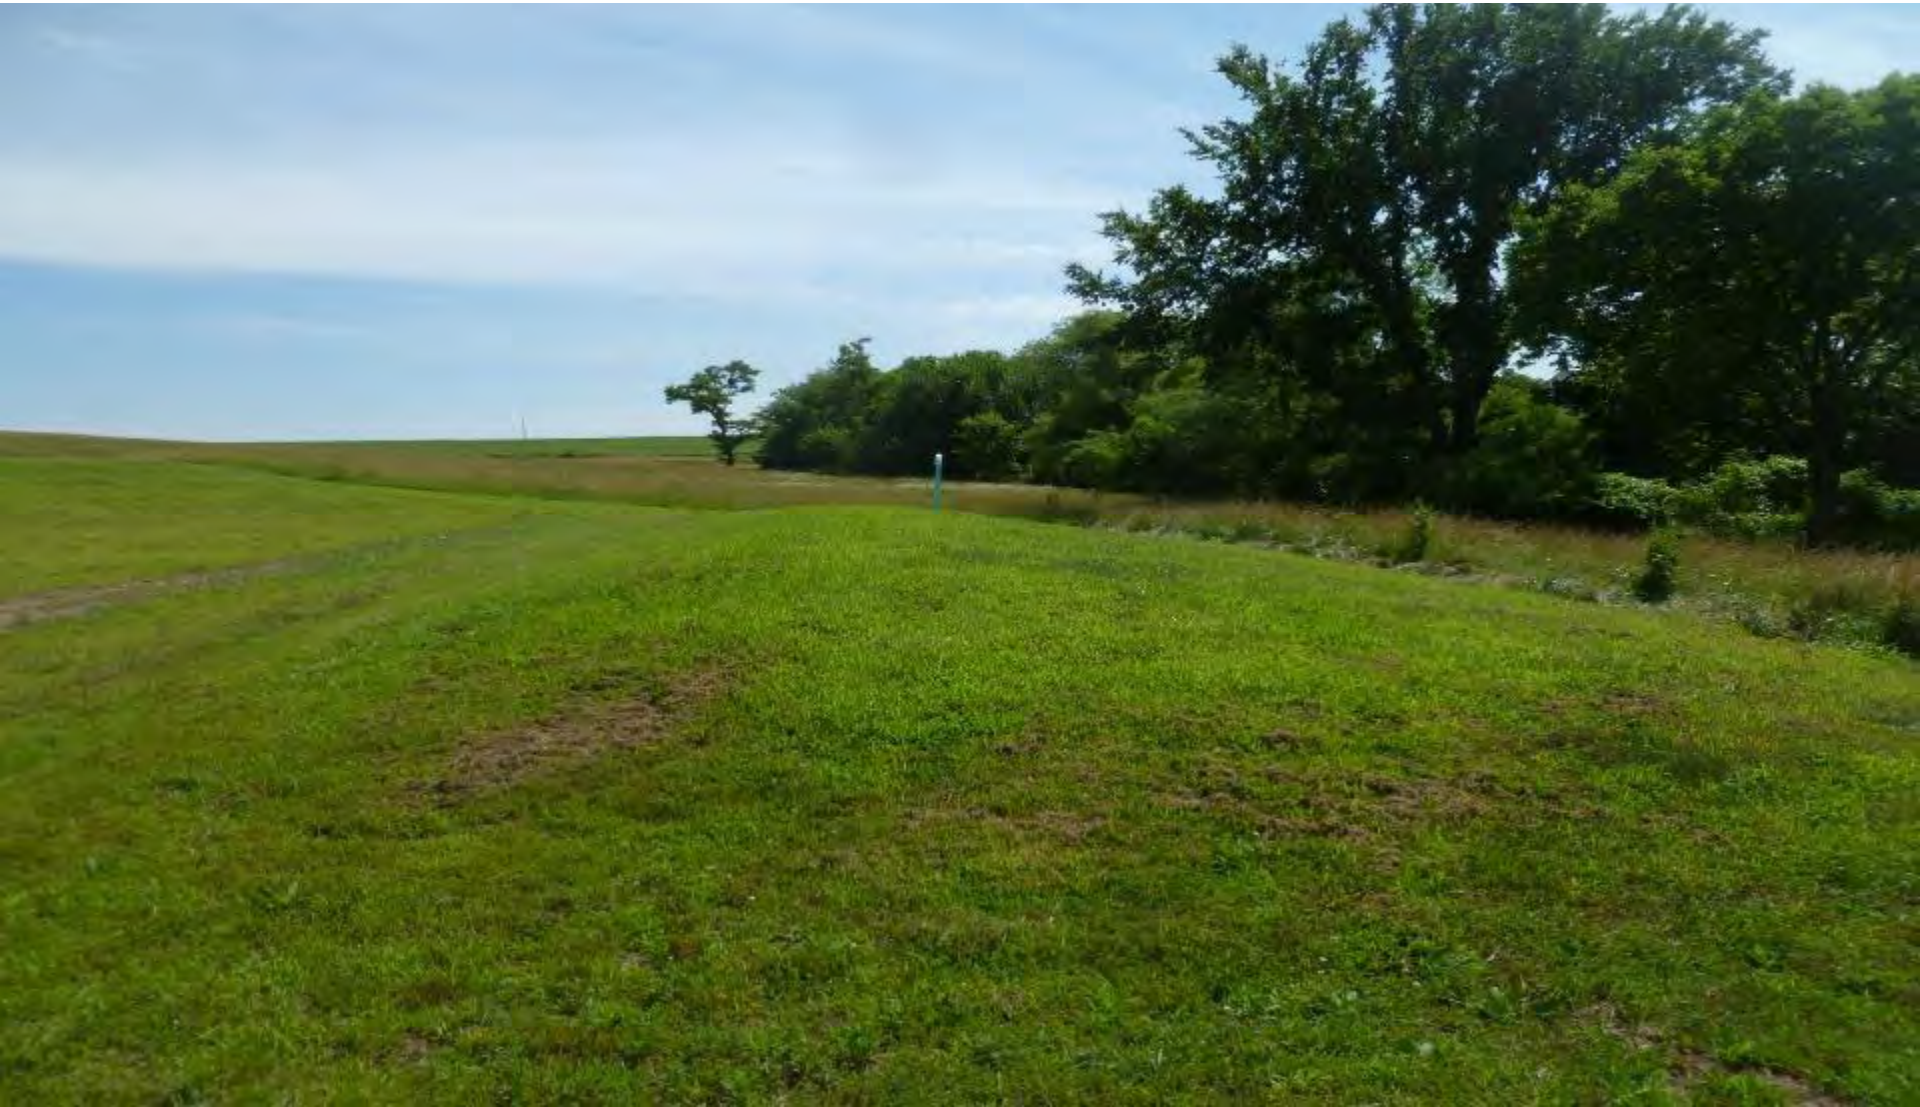
Site M10 located at 9578 SW 247<sup>th</sup>, Gower, MO had a design soil loading rate of 0.30 gpd/sqft and 150 linear feet of AES (2 lines of 75 ft of product (Table 1). Photos of this site and system are provided in photos M10-1 through M10-3) (Appendix B). This system was installed in October 2016. The summary of the field evaluation observed no current surfacing effluent over any part of the system, nor evidence of past surfacing. There was no surfacing of sewage with pressure of footwear. No straight pipe discharges were found and no visible signs of malfunction were observed (Table 1 and Appendix A, Table M10). Additionally, no stripes in the vegetation or effluent odor within 10 feet of the system was noted. An agricultural terrace above the system and a tilled strip in the surface diversion were observed, neither of which were impeding the performance of the system. The homeowners were available to interview. They expressed no problems with the system (Appendix A, Table M10).

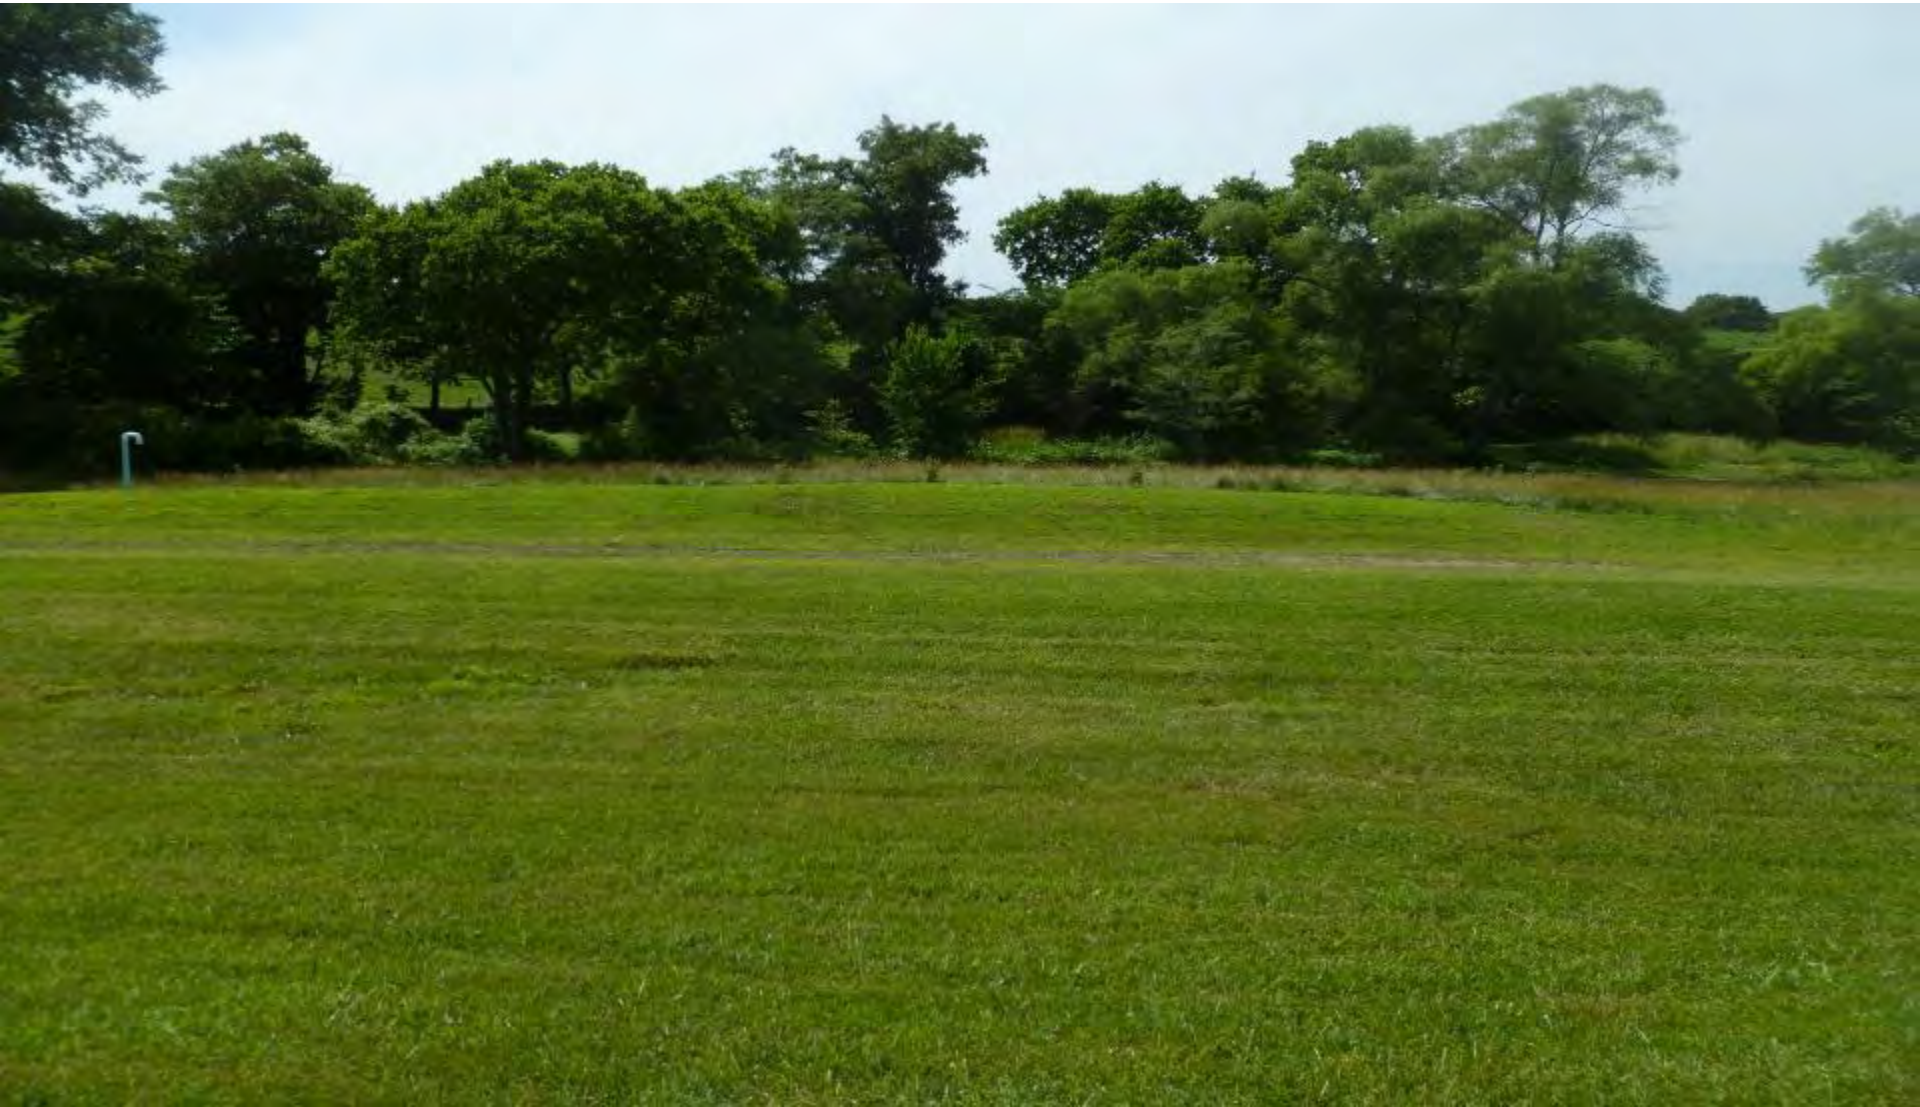
# Photo M10-4. AES Technology, Below and Agriculture Terrace Above, Gower, MO

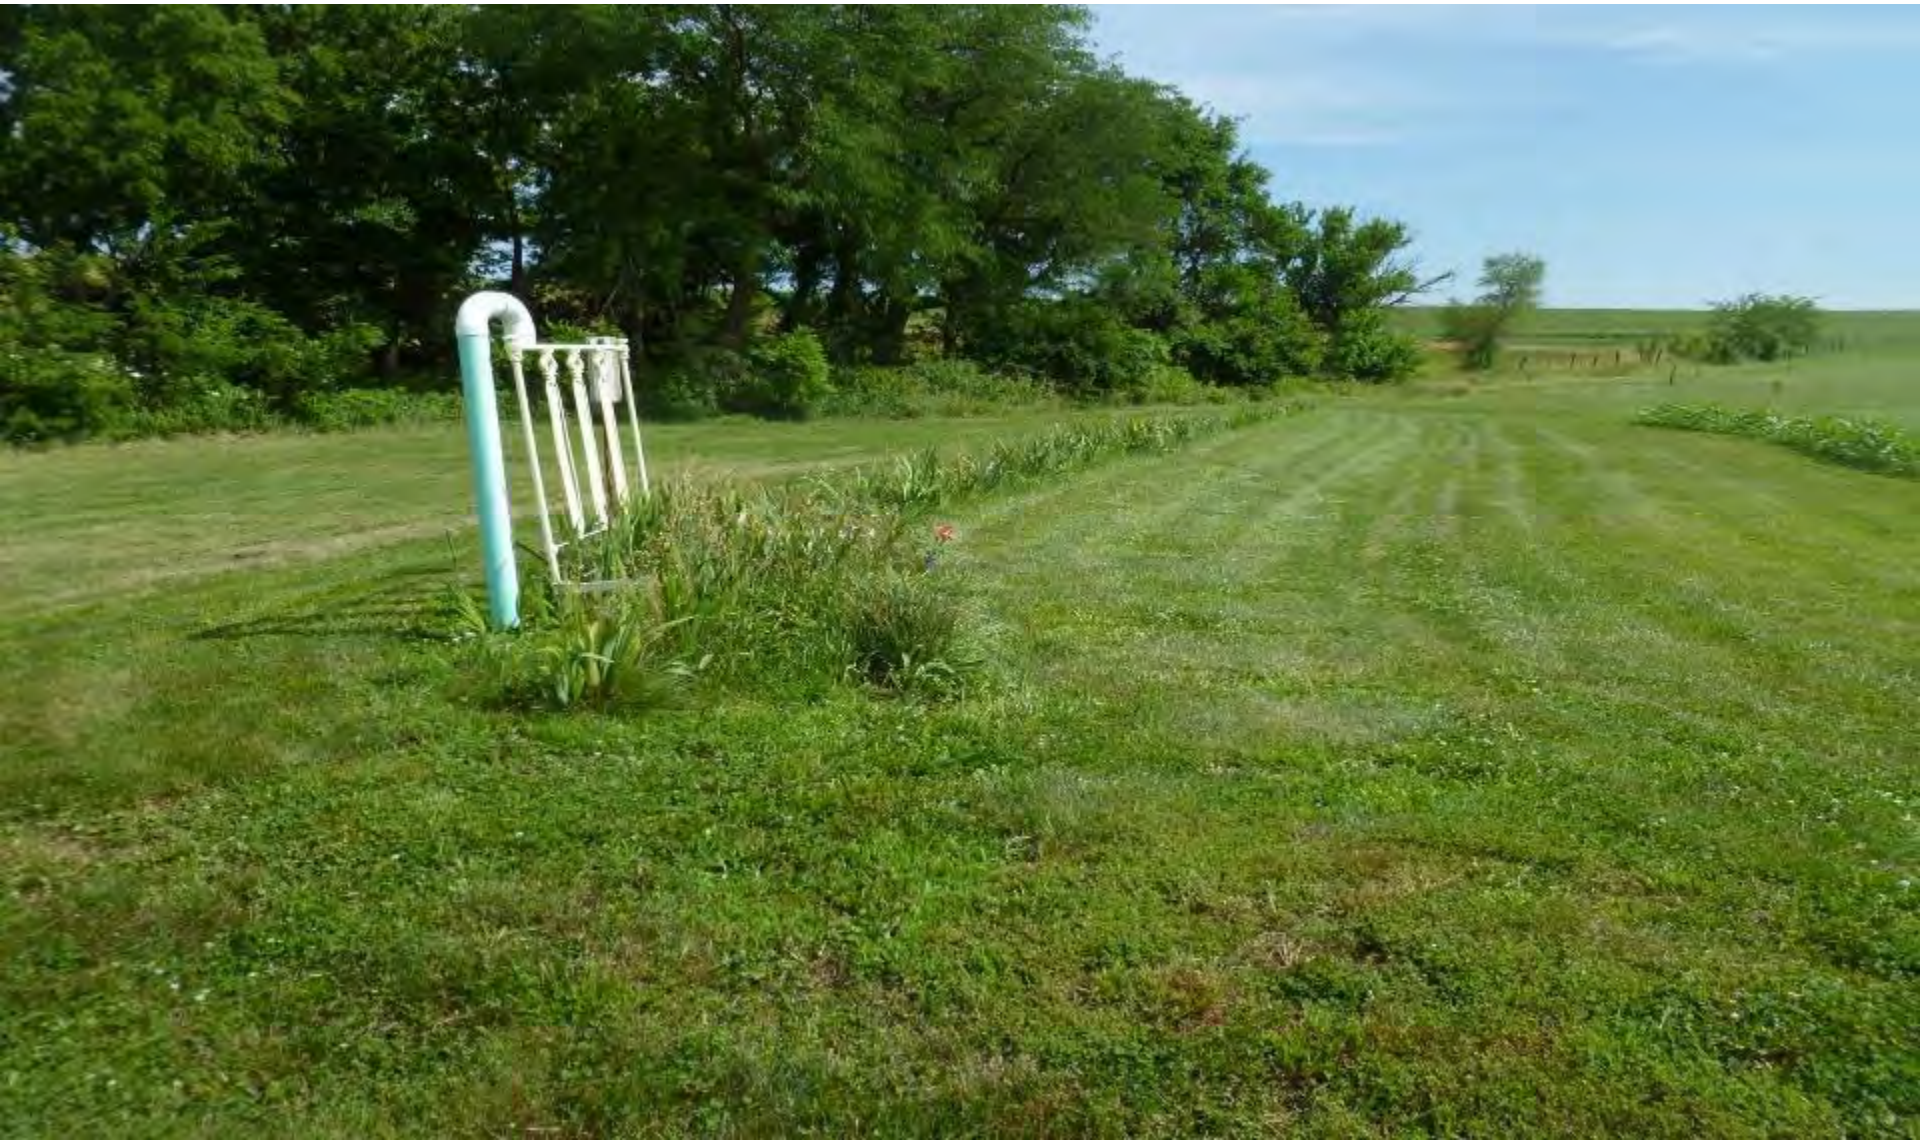
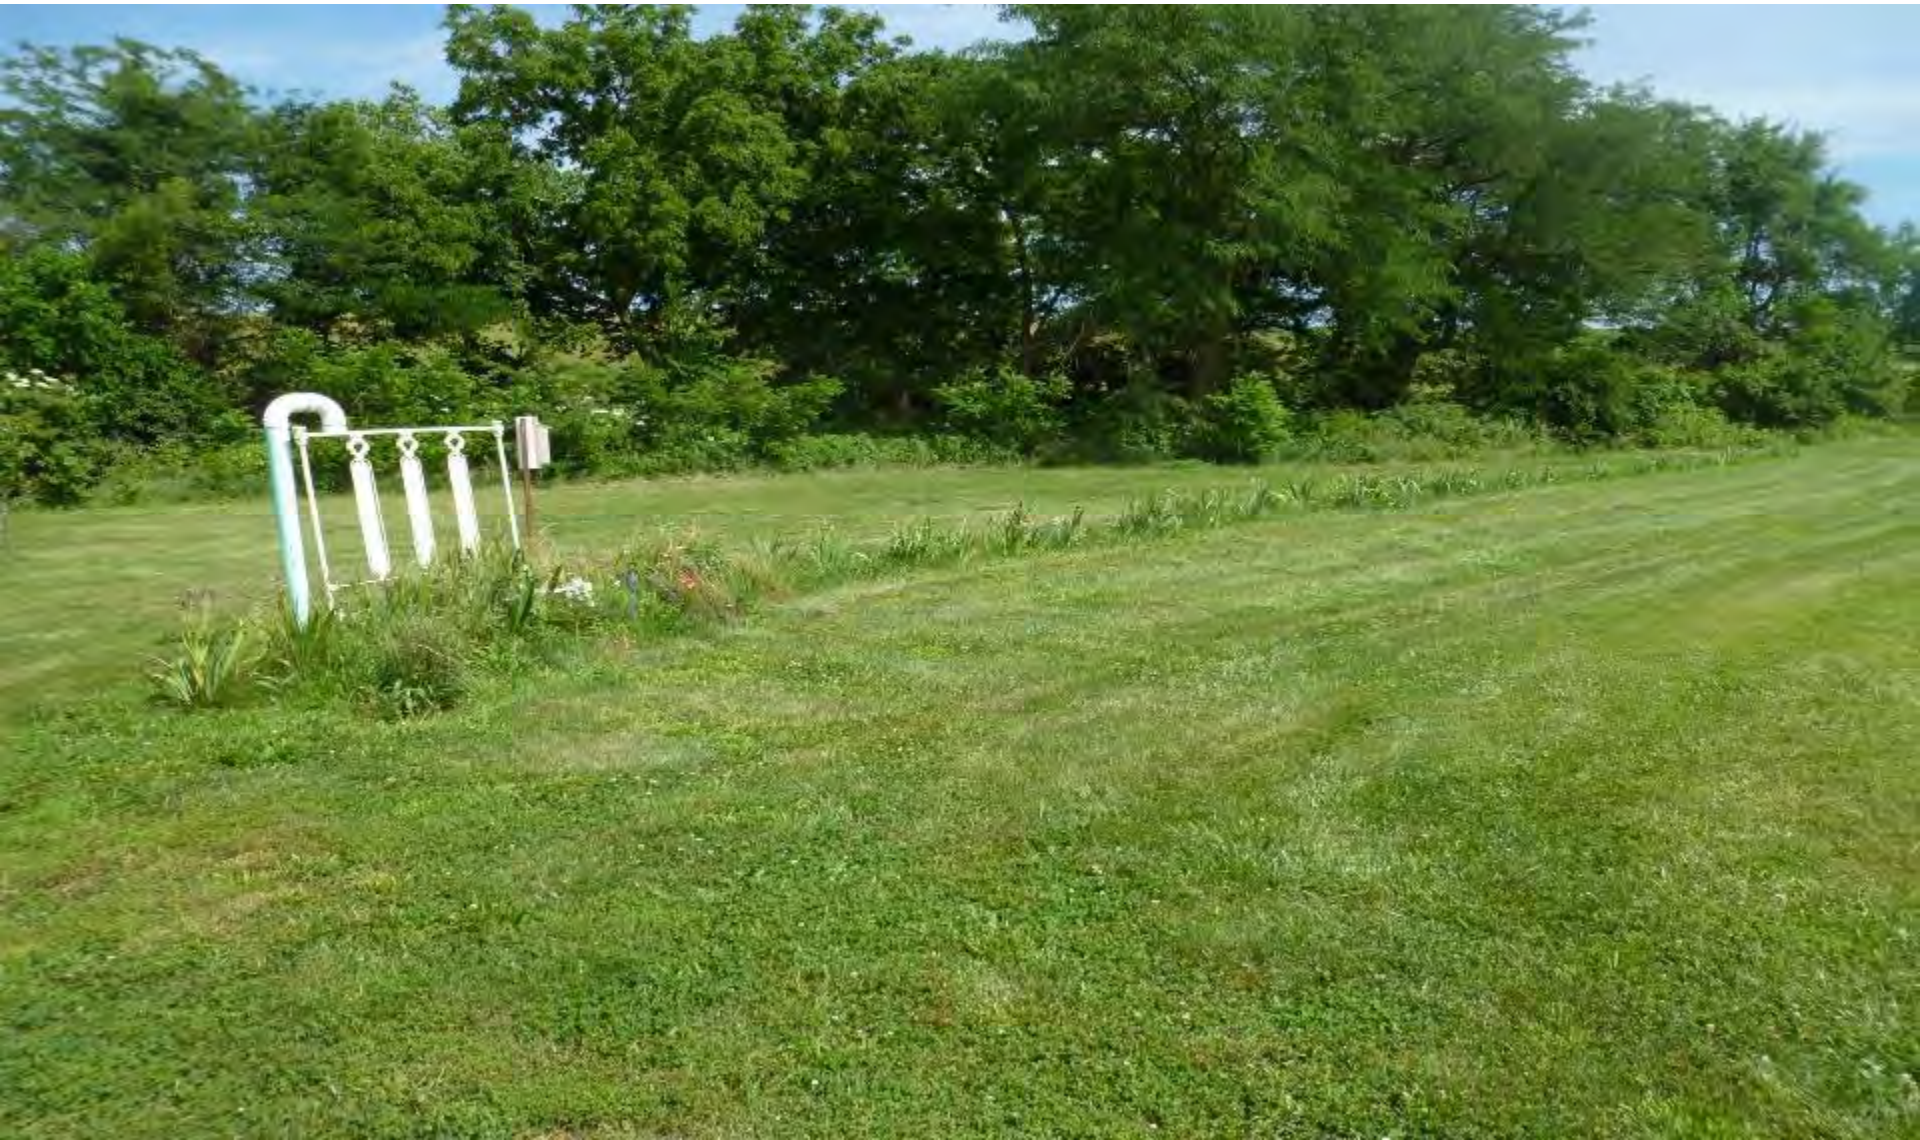
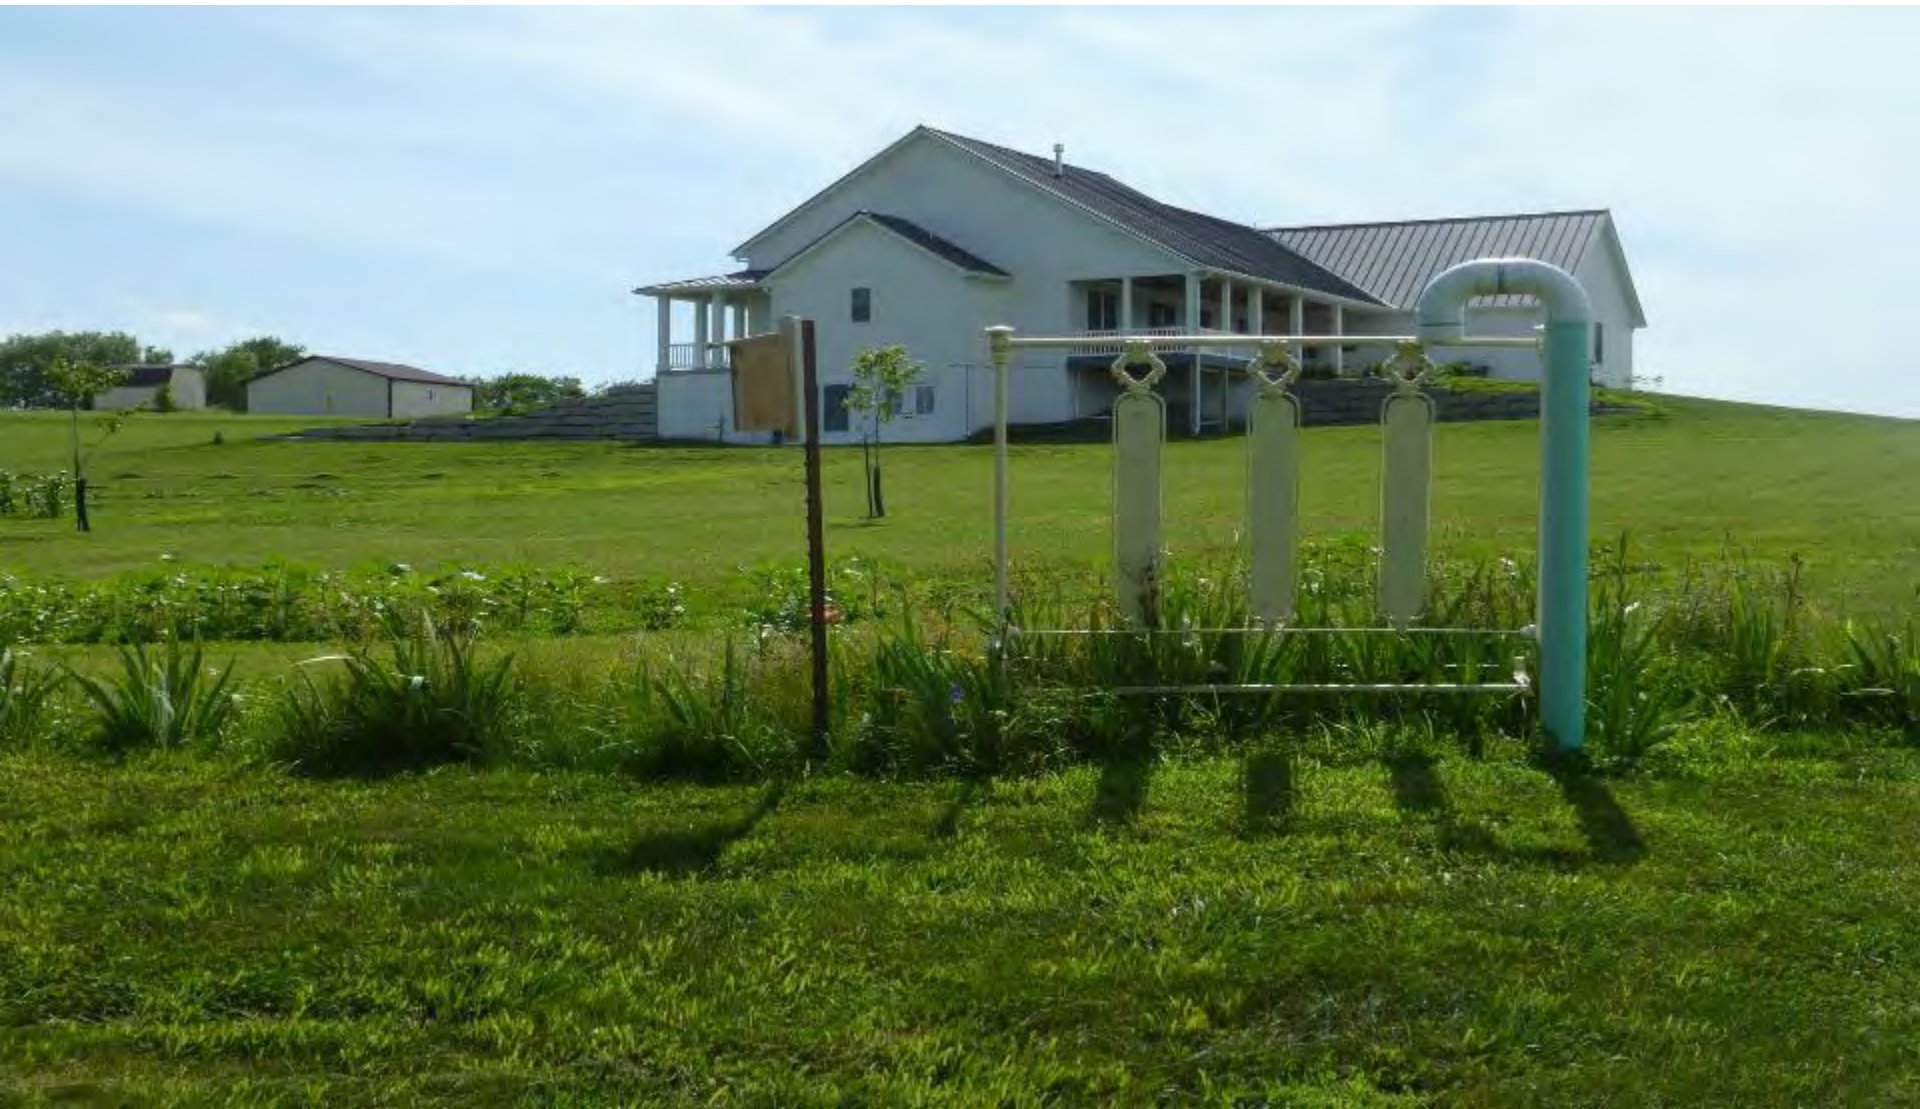
Site M11 located at 9740 SW 247<sup>th</sup>, Gower, MO had a design soil loading rate of 0.30 gpd/sqft and 200 linear feet of AES (Table 1). The configuration of the AES rows was not shown on the permit. Photos of this site and system are provided in photos M11-1 through M11-3) (Appendix B). This system was installed in June 2017. The summary of the field evaluation observed no current surfacing effluent over any part of the system, nor evidence of past surfacing. There was no surfacing of sewage with pressure of footwear. No straight pipe discharges were found and no visible signs of malfunction were observed (Table 1 and Appendix A, Table M11). Additionally, consistent vegetative cover was observed, with no stripes. No effluent odor was detected within 10 feet of the system. Adequate diversion of surface water above the system was in place (Photo M11-1). The homeowners were available to interview. They expressed no problems with the system (Appendix A, Table M11).

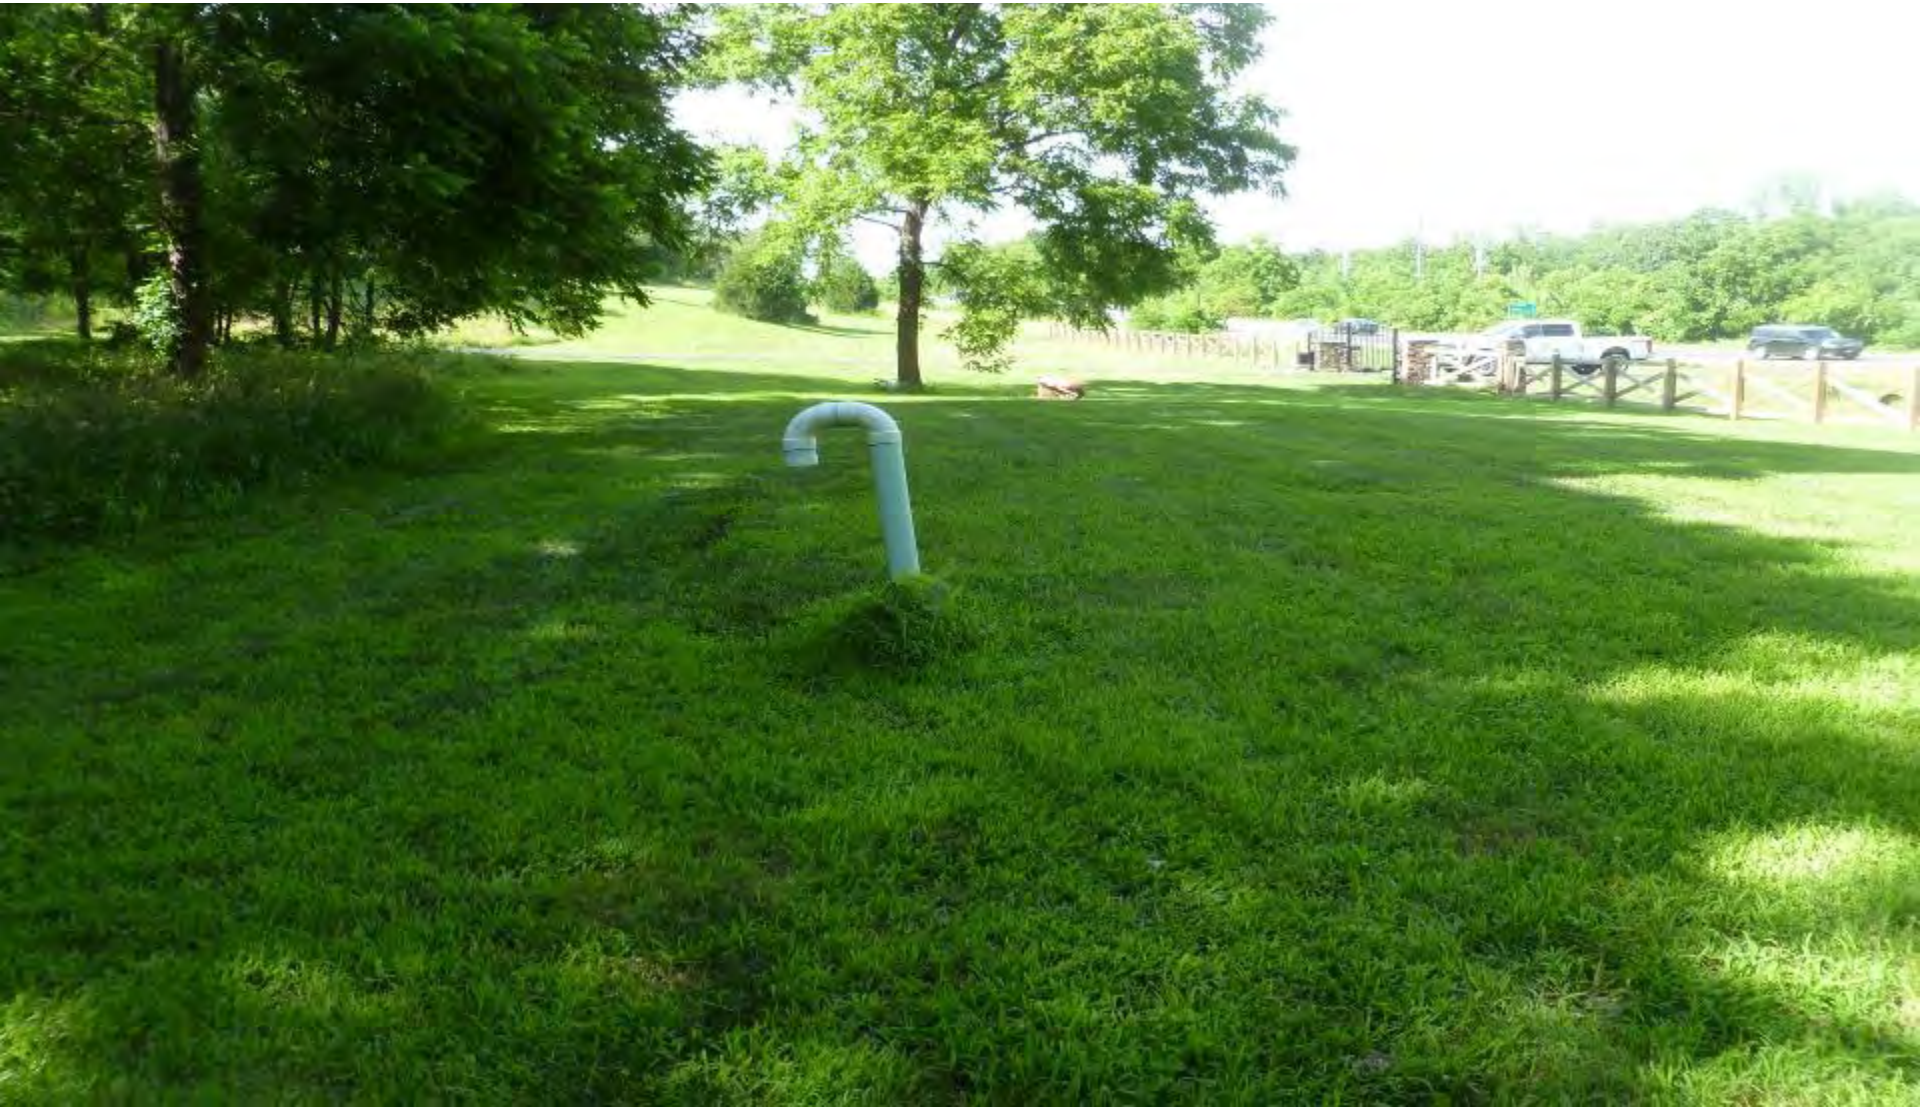
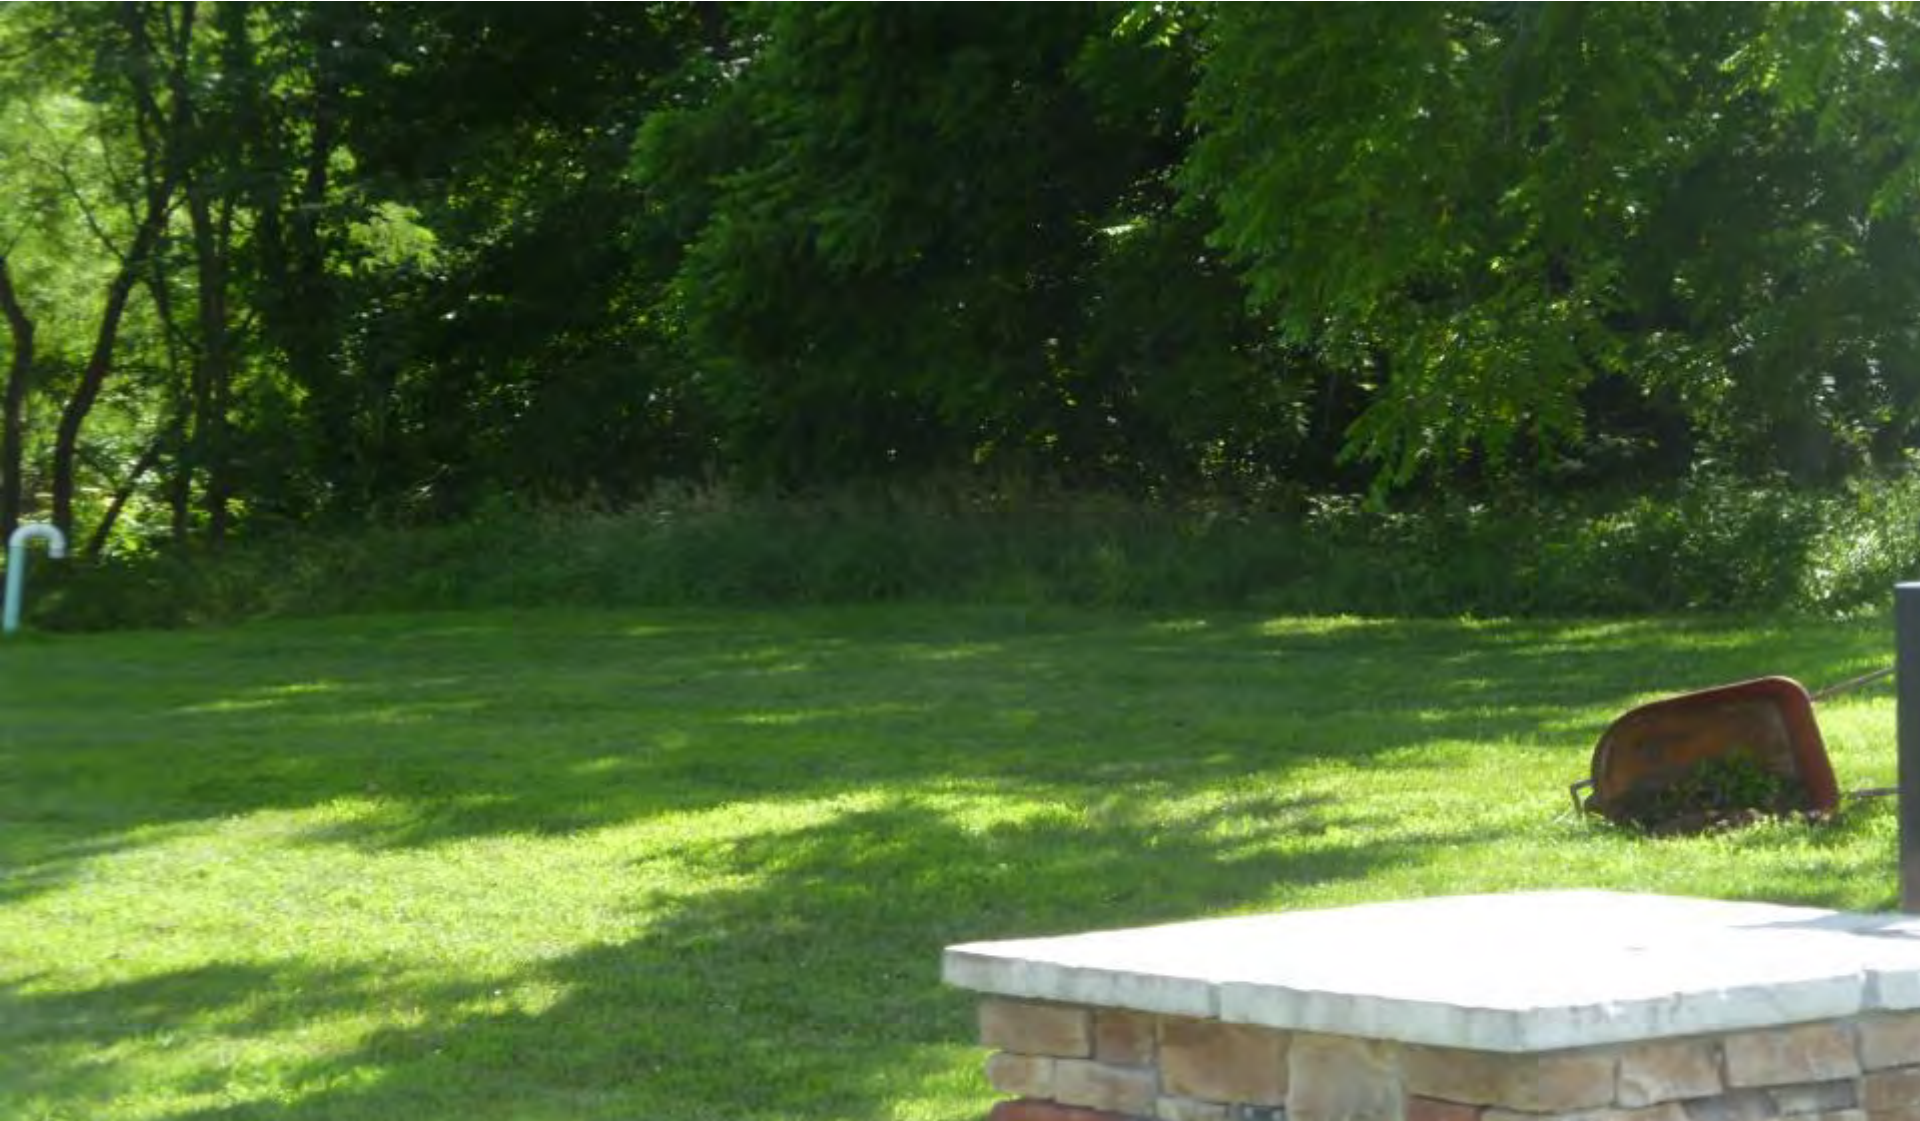
Site M12 located at 17270 N. US Highway 169, Smithville, MO had a design soil loading rate of 0.40 gpd/sqft and 210 linear feet of AES (3 lines of 70 ft of product) (Table 1). Photos of this site and system are provided in photos M12-1 through M12-2 (Appendix B). This system was installed in October 2016. The summary of the field evaluation observed no current surfacing effluent over any part of the system, nor evidence of past surfacing. There was no surfacing of sewage with pressure of footwear. No straight pipe discharges were found and no visible signs of malfunction were observed (Table 1 and Appendix A, Table M12). There was no effluent odor within 10 feet of the system, and consistent vegetative cover with no green stripes was noted. A surface diversion could be placed above the site to divert surface runoff away from the site. The occupants of this home were not available for an interview (Appendix A, Table M12).
