## **Final Report**

### **Field Performance Assessment of the Advanced Enviro-Septic Wastewater Treatment and Dispersal System in Missouri, 2022**

**Dr. Randall J. Miles, Soil Scientist, Emeritus Associate Professor**

**February 7, 2023**

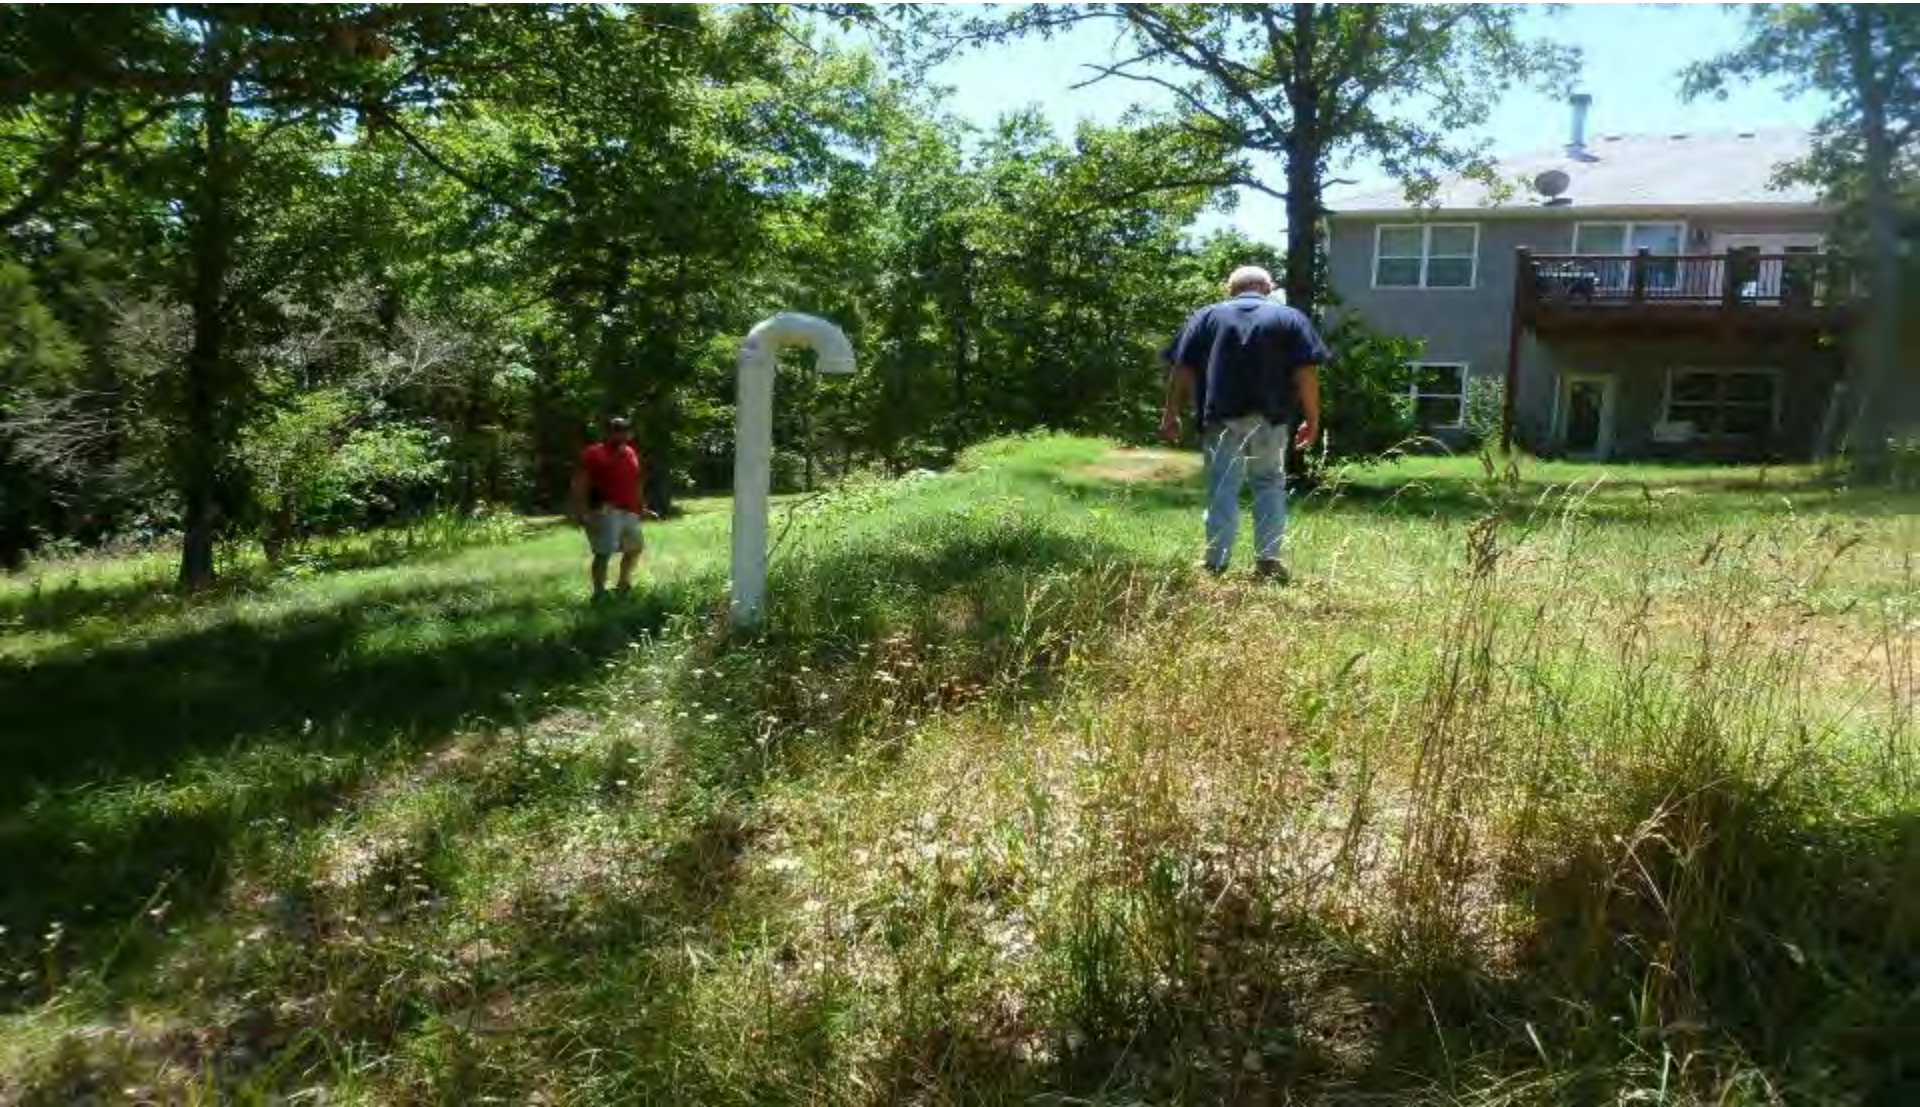
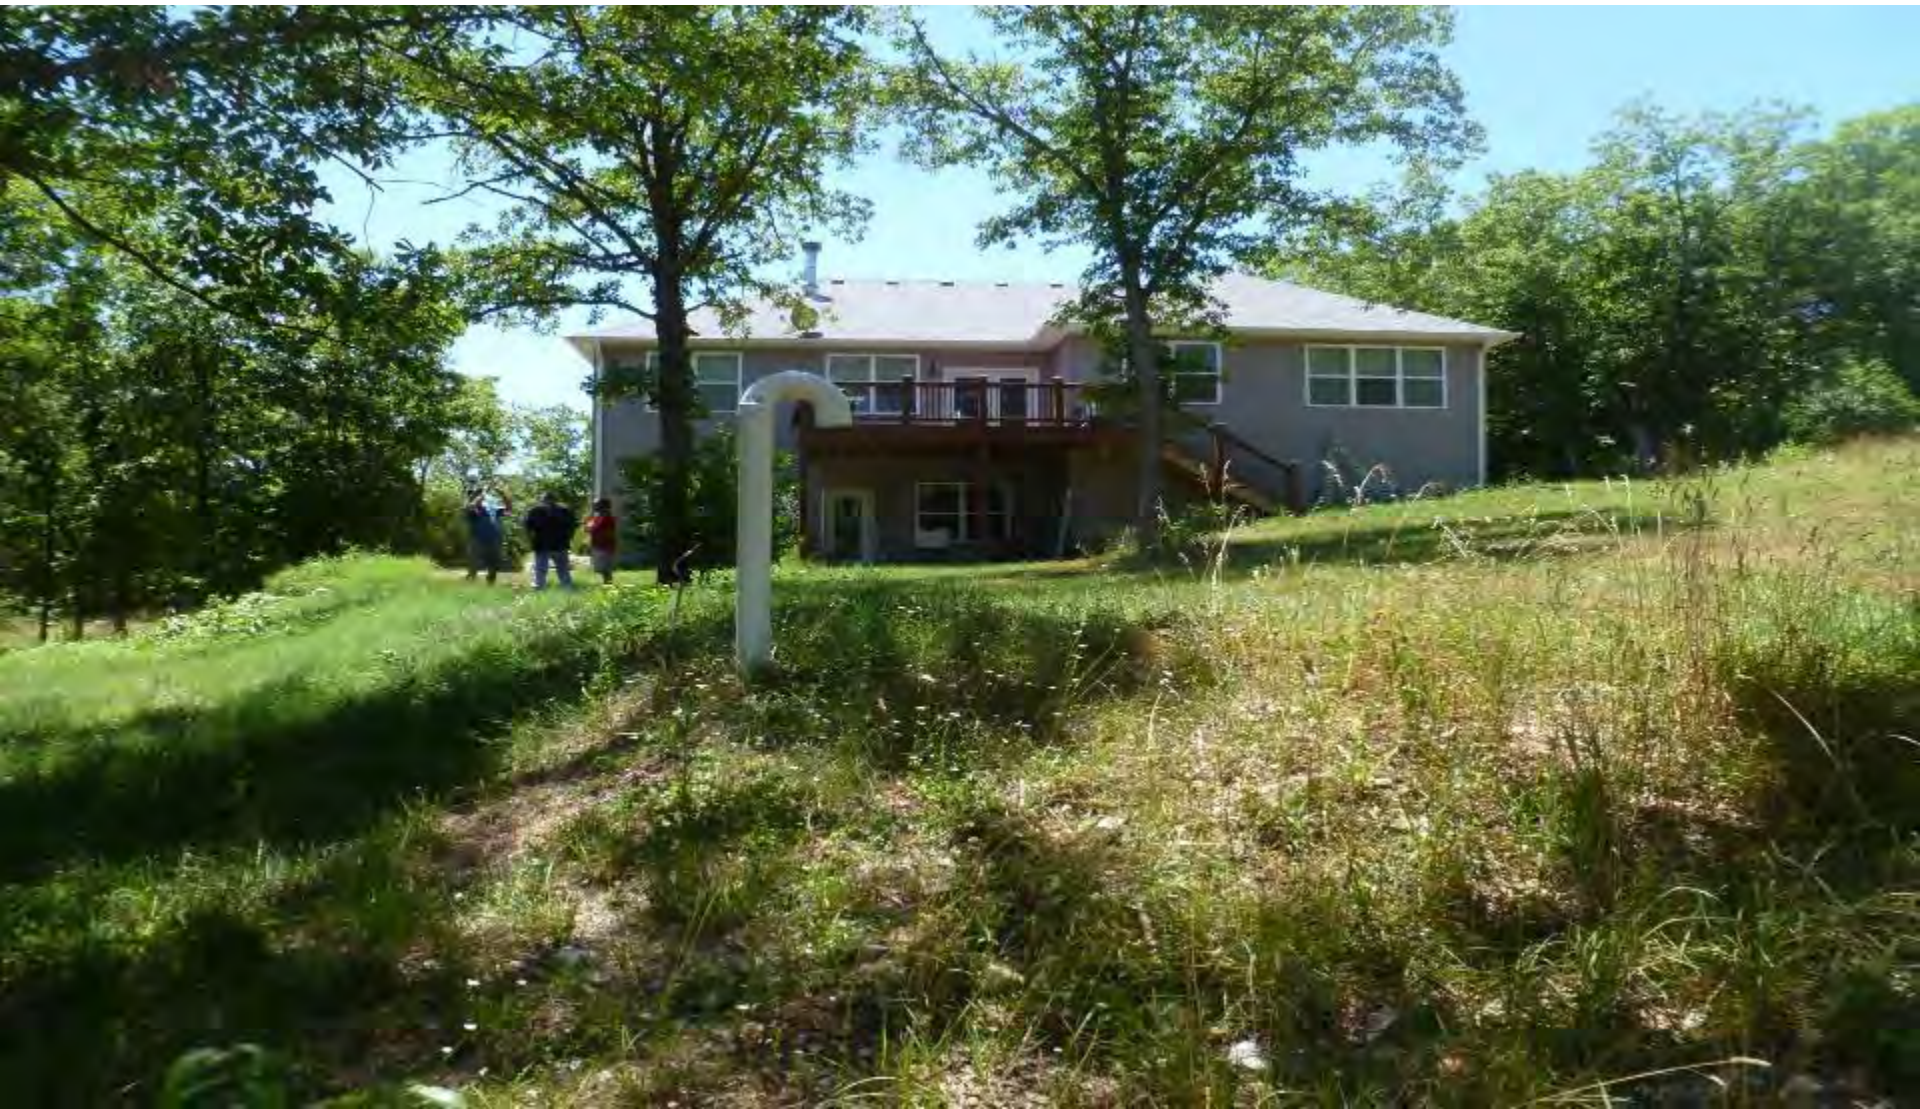
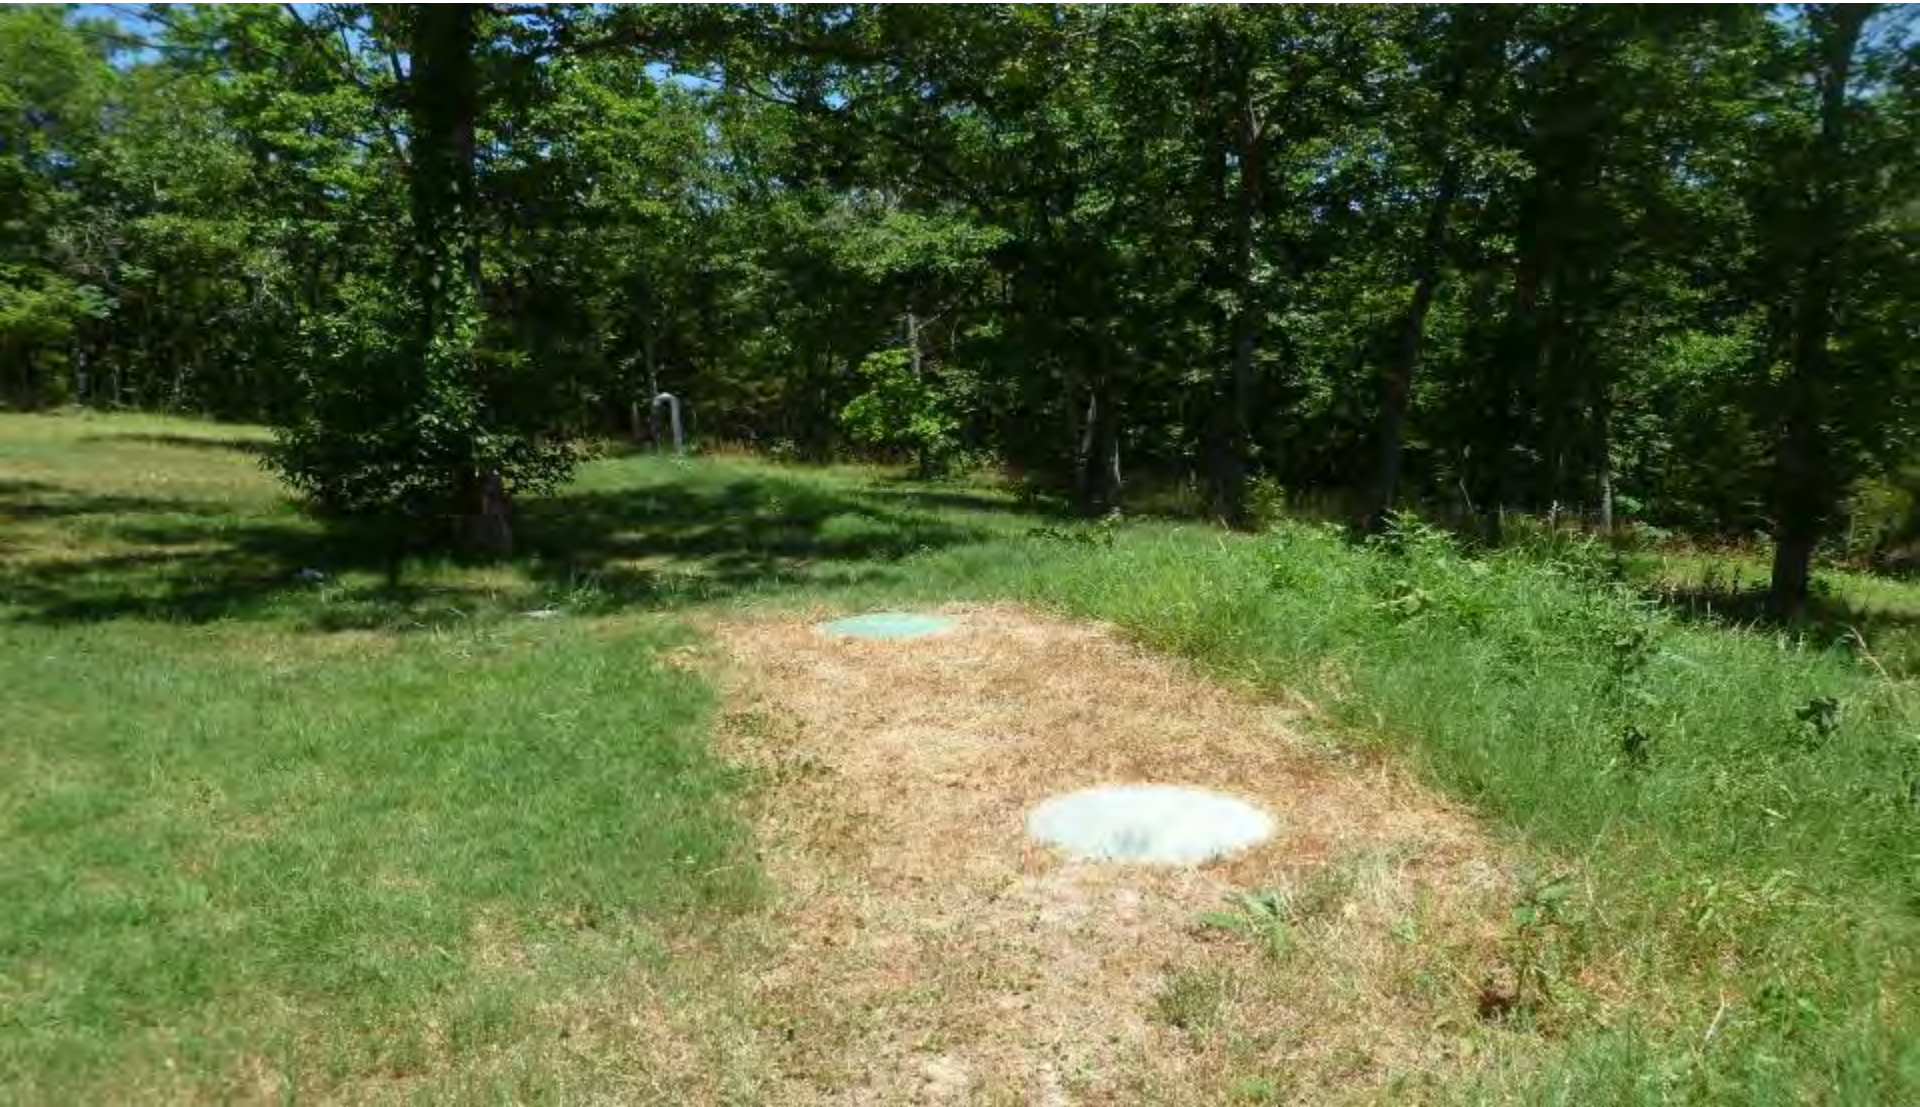
Site T14 located at 298 Bear Creek Estates, Walnut Shade, MO had a design soil loading rate of 0.30 gpd/sqft and 195 linear feet of AES (3 lines of 65 ft of product) (Table 1). Photos of this site and system are provided in photos T14-1 through T14-3 (Appendix B). This system was installed in June 2018. The summary of the field evaluation observed no current surfacing effluent over any part of the system, nor evidence of past surfacing. There was no surfacing of sewage with pressure of footwear. No straight pipe discharges were found and no visible signs of malfunction were observed (Table 1 and Appendix A, Table T14). There was no effluent odor within 10 feet of the system and no vegetative striping. Vegetation on the system was green, compared to that above or below the system, as the system had adequate vegetative cover. A surface diversion should be placed above the site to divert surface runoff away from the site. The occupants of this home were not available for an interview (Appendix A, Table T14).

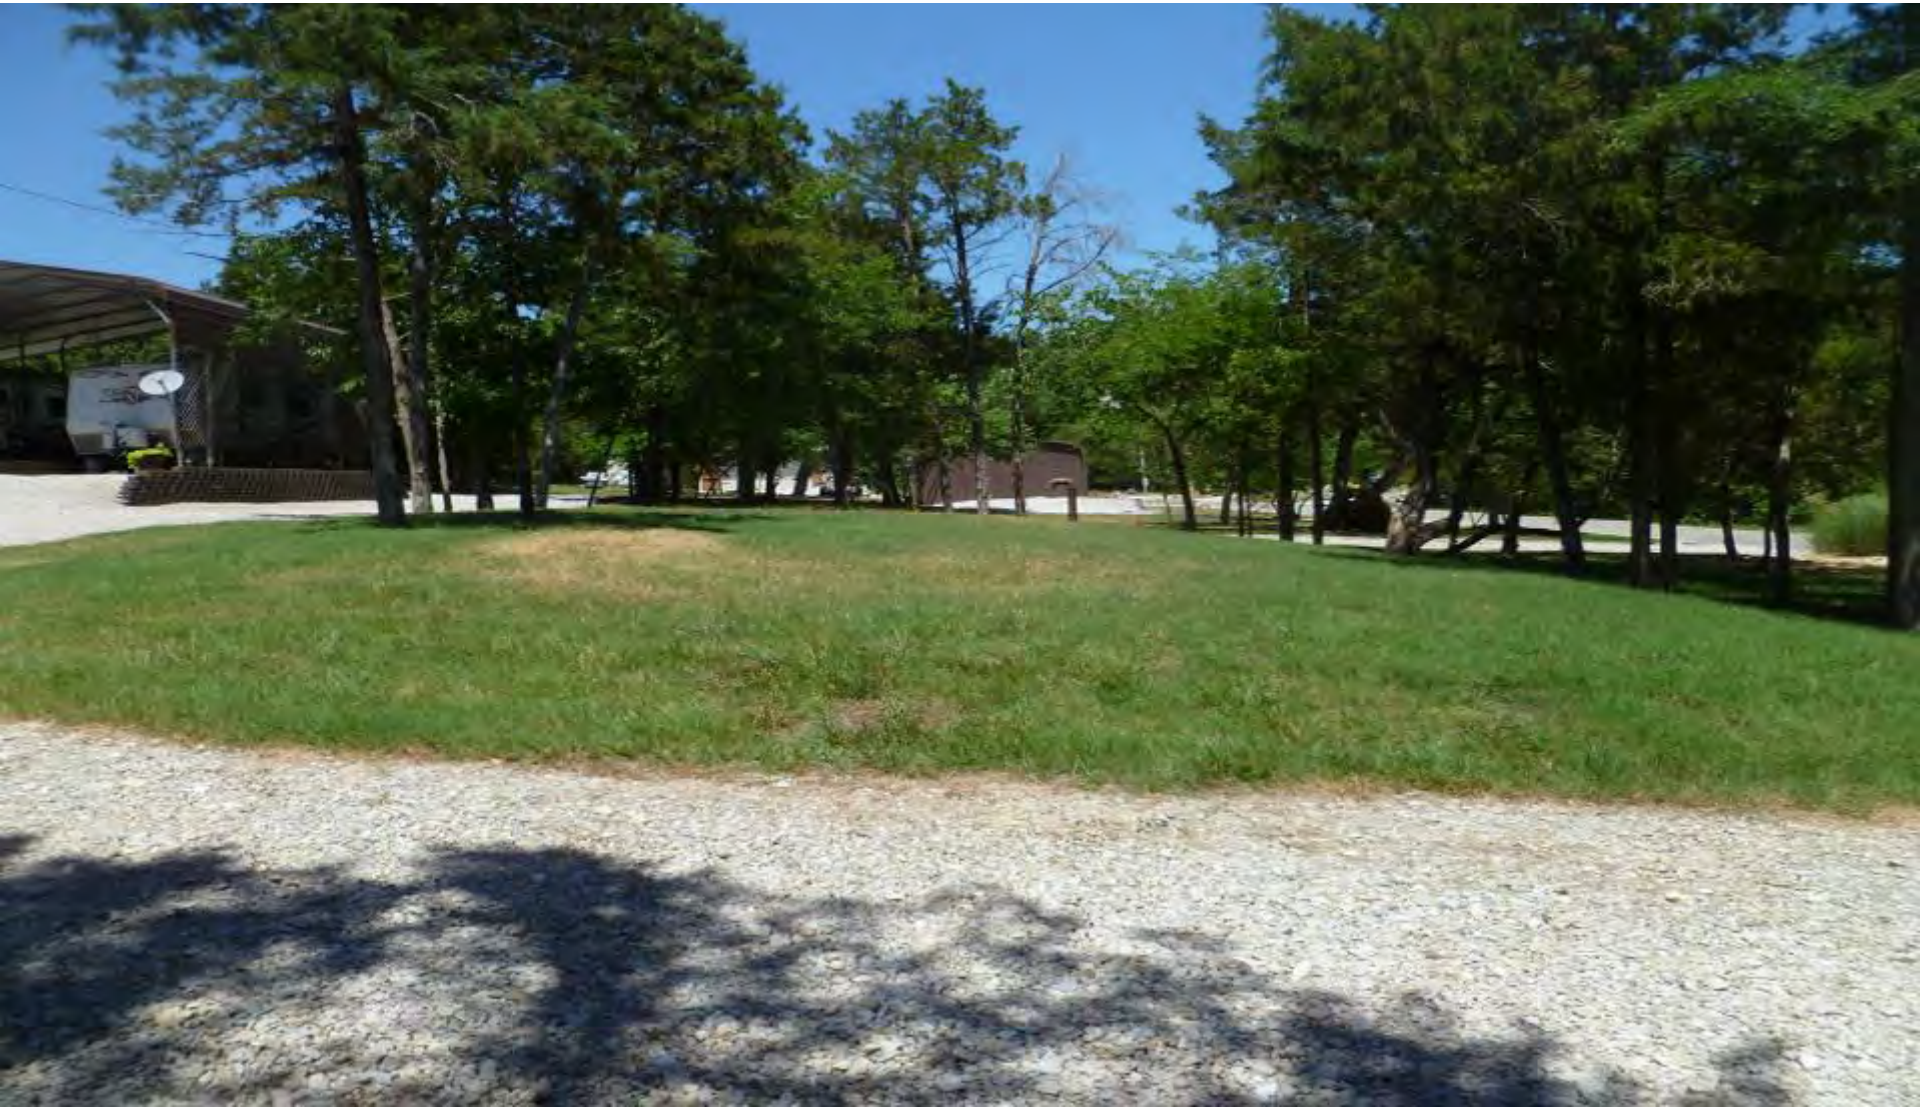
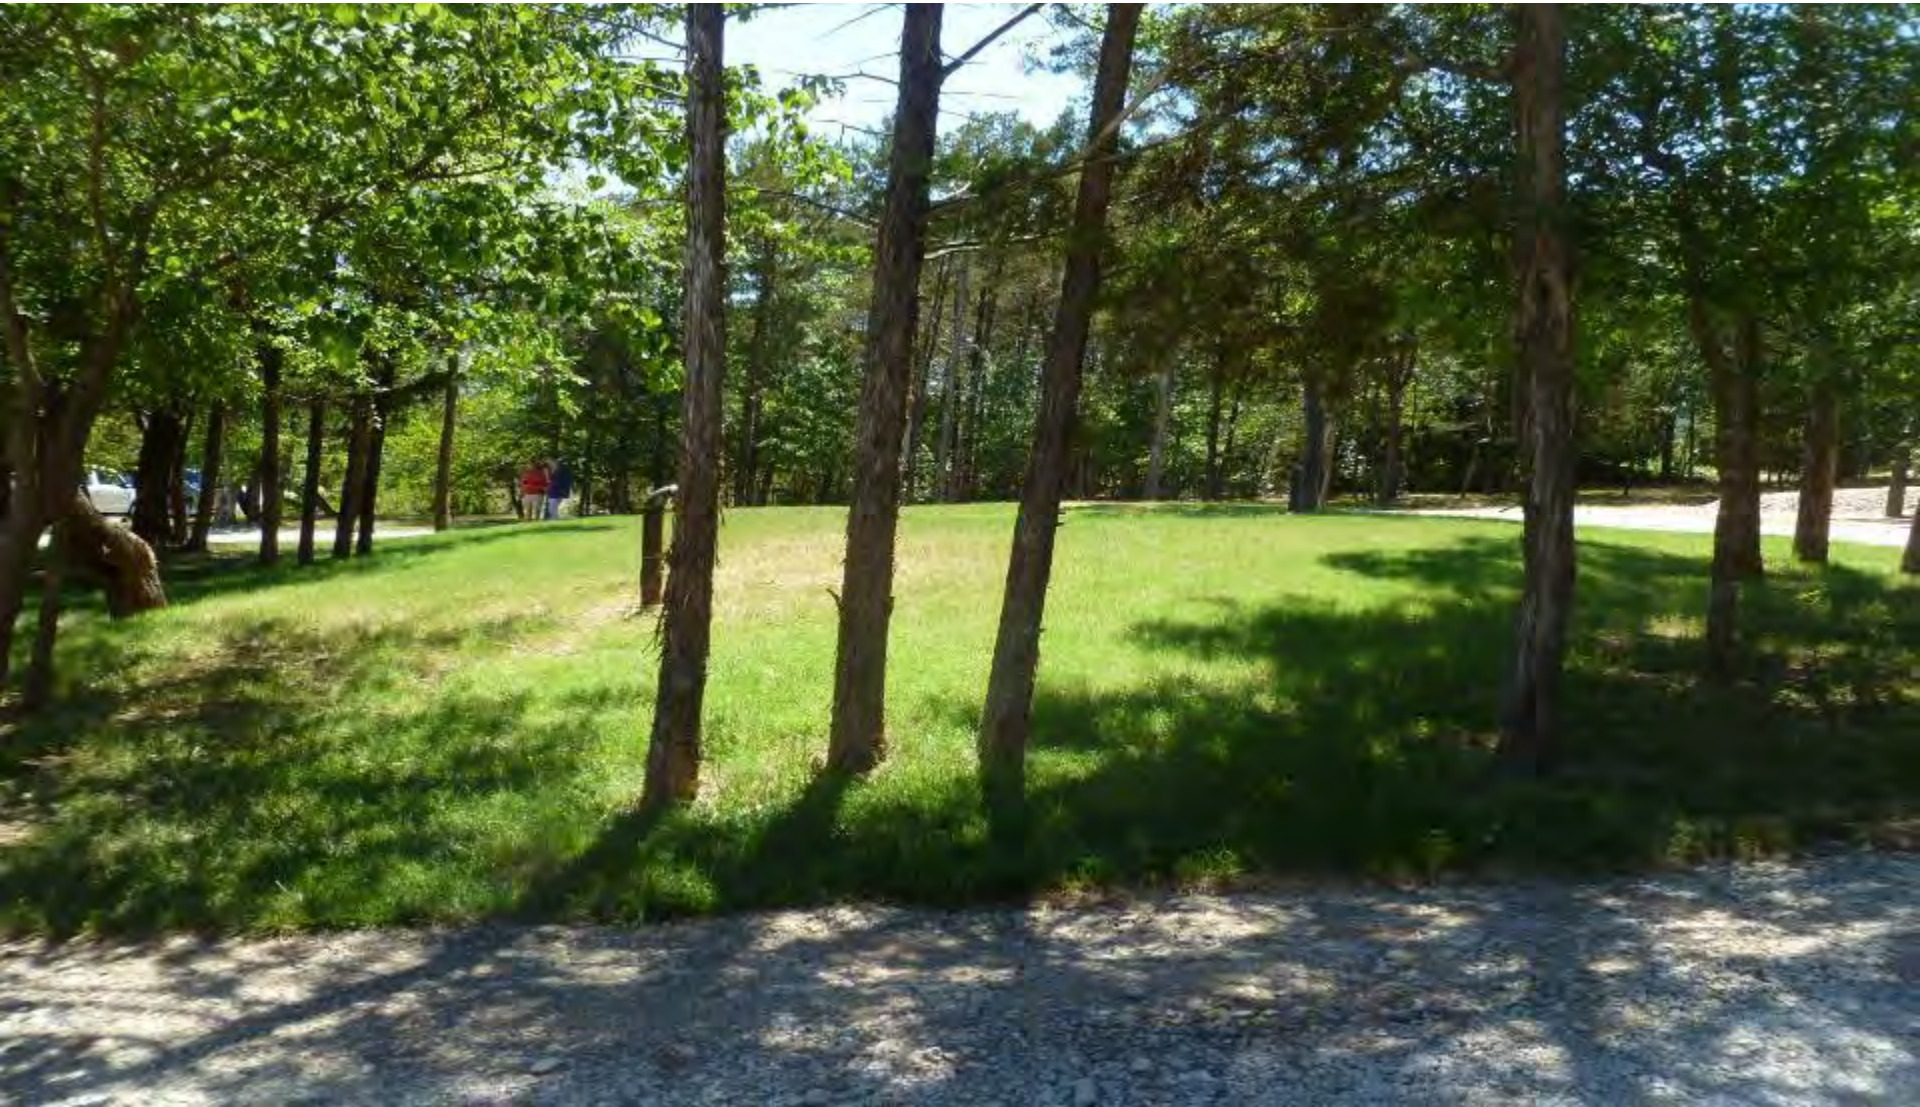
Site T15 located at 1200 Clevenger, Hollister, MO had a design soil loading rate of 0.40 gpd/sqft and 140 linear feet of AES (4 lines of 35 ft of product) (Table 1). Photos of this site and system are provided in photos T15-1 through T15-3 (Appendix B). This system was installed in December 2015. The summary of the field evaluation observed no current surfacing effluent over any part of the system, nor evidence of past surfacing. There was no surfacing of sewage with pressure of footwear. No straight pipe discharges were found and no visible signs of malfunction were observed (Table 1 and Appendix A, Table T15). There was no effluent odor within 10 feet of the system and no vegetative striping. Vegetation on the system was consistent, as the system had sufficient vegetative cover. A surface diversion was horseshoed above the AES technology, thus providing what appeared to be a model for effective surface water management appropriate for the setting and the longevity of the system (Photo T15-1). The occupants of this home were not available for an interview (Appendix A, Table T15).

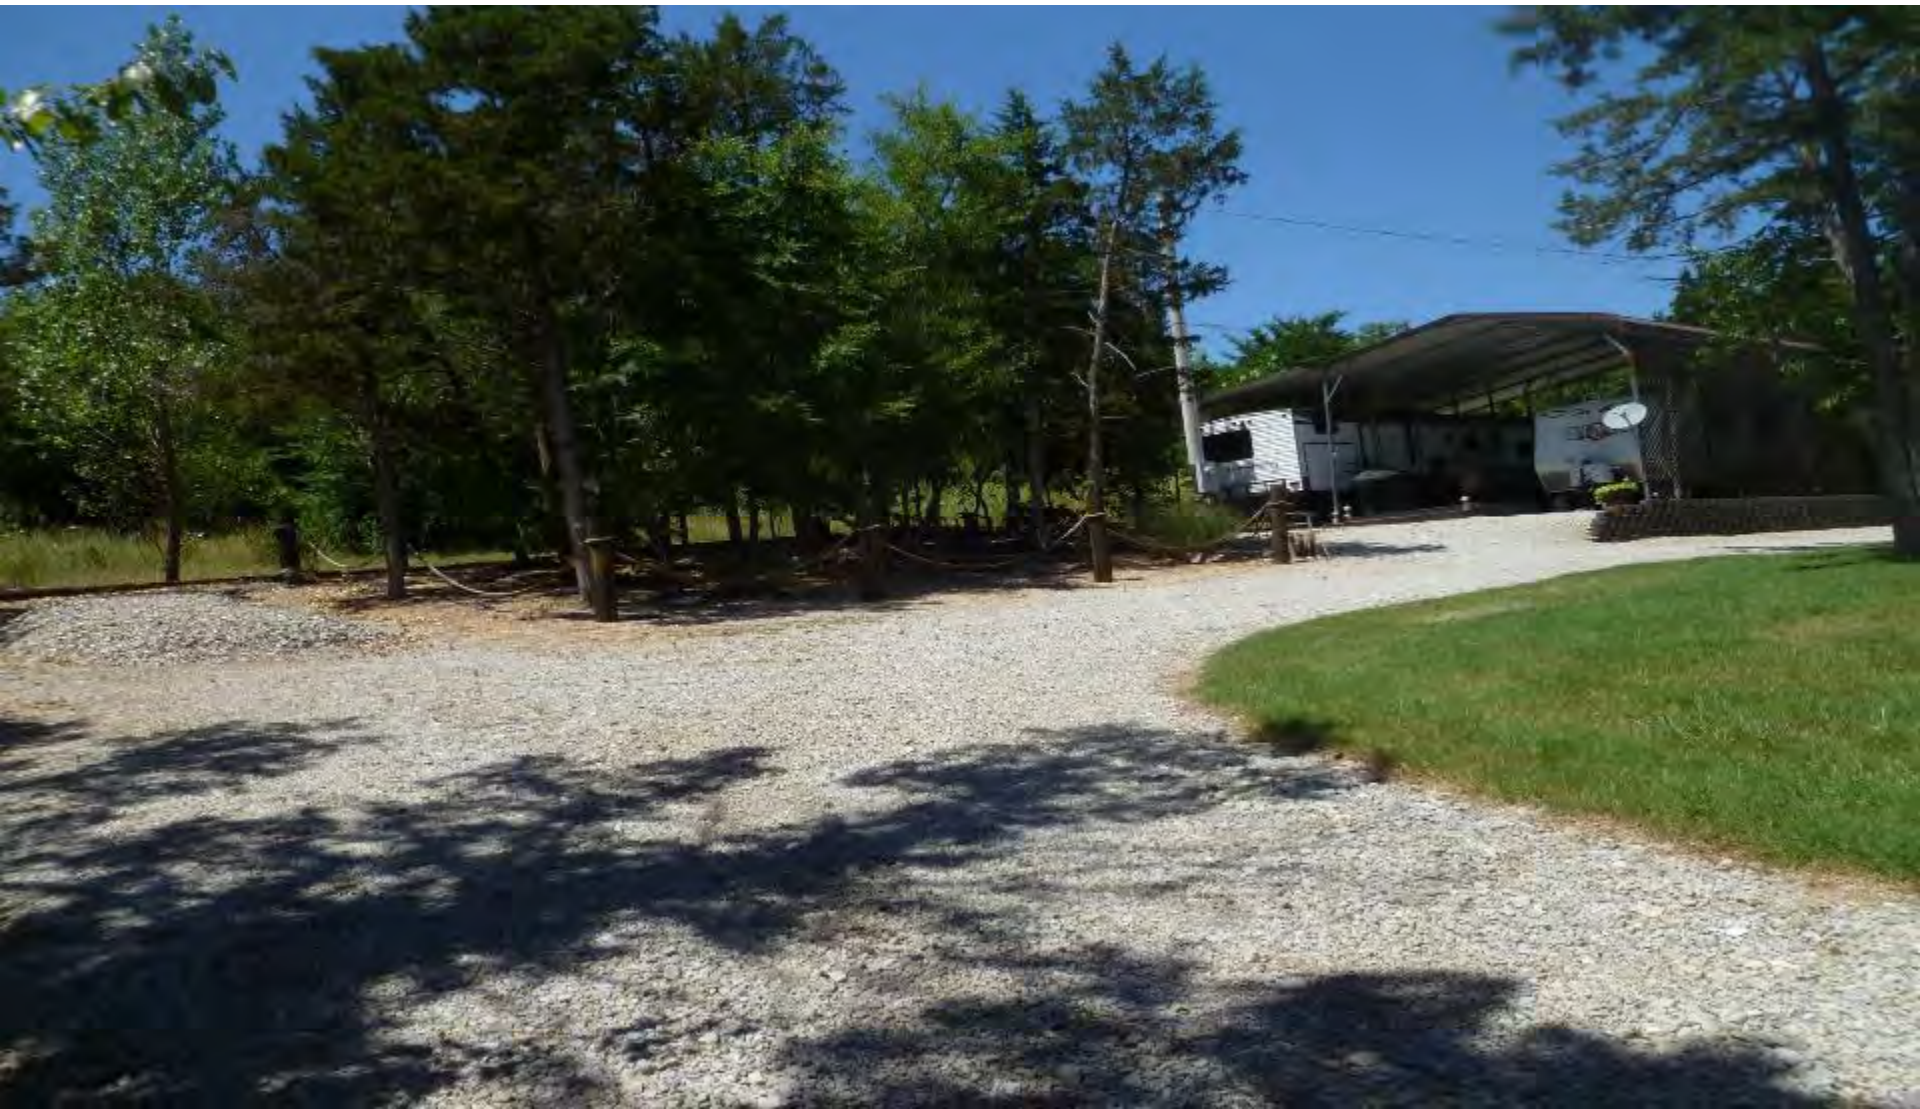
# Photo T15-2. Horseshoe Surface Diversion Hollister, MO

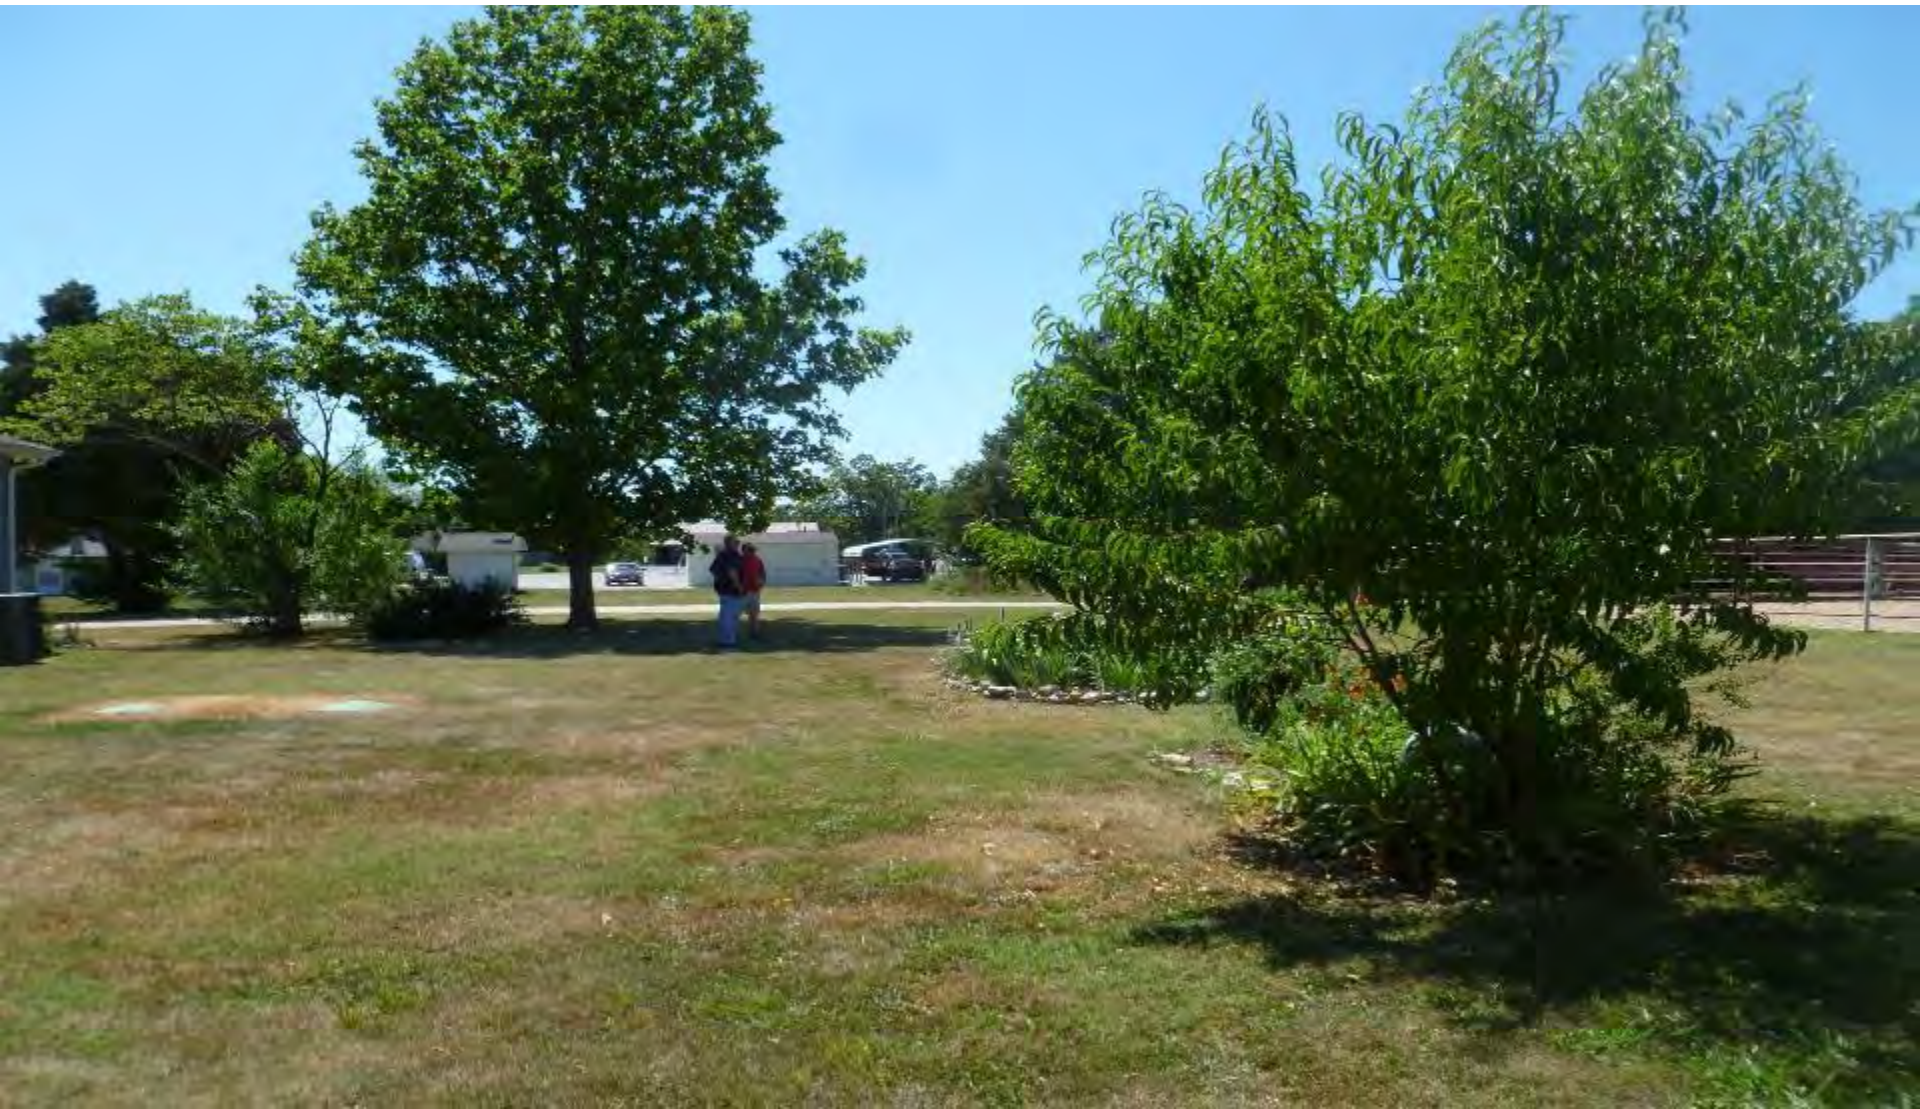
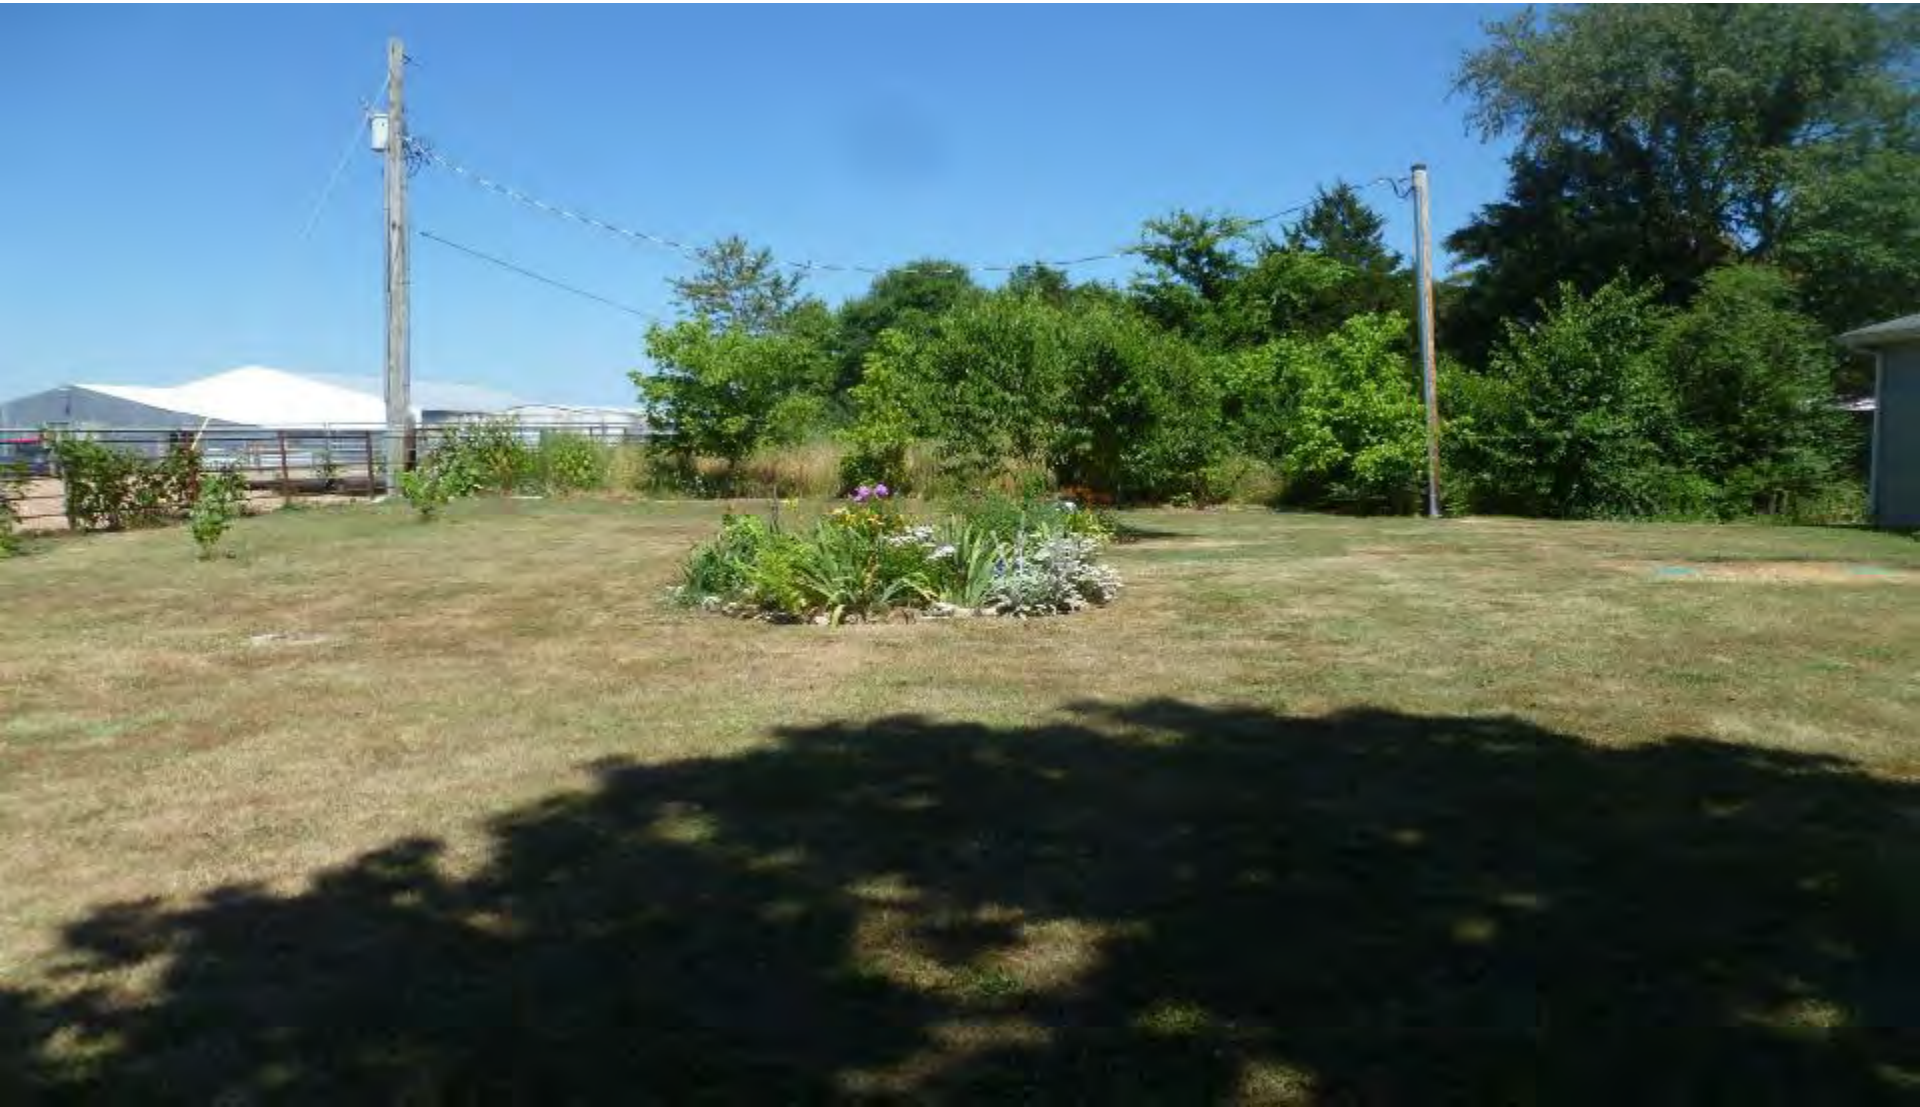
Site T16 located at 193 Star, Forsythe, MO had a design soil loading rate of 0.40 gpd/sqft and 120 linear feet of AES (3 lines of 40 ft of product) (Table 1). Photos of this site and system are provided in photos T16-1 through T16-3 (Appendix B). This system was installed in May 2019. The summary of the field evaluation observed no current surfacing effluent over any part of the system or evidence of past surfacing. There was no surfacing of sewage with pressure of footwear. No straight pipe discharges were found and no visible signs of malfunction were observed (Table 1 and Appendix A, Table T16). There was no effluent odor within 10 feet of the system and no vegetative striping. Vegetation on the system was consistent as the system had
