## **Final Report**

### **Field Performance Assessment of the Advanced Enviro-Septic Wastewater Treatment and Dispersal System in Missouri, 2022**

**Dr. Randall J. Miles, Soil Scientist, Emeritus Associate Professor**

**February 7, 2023**

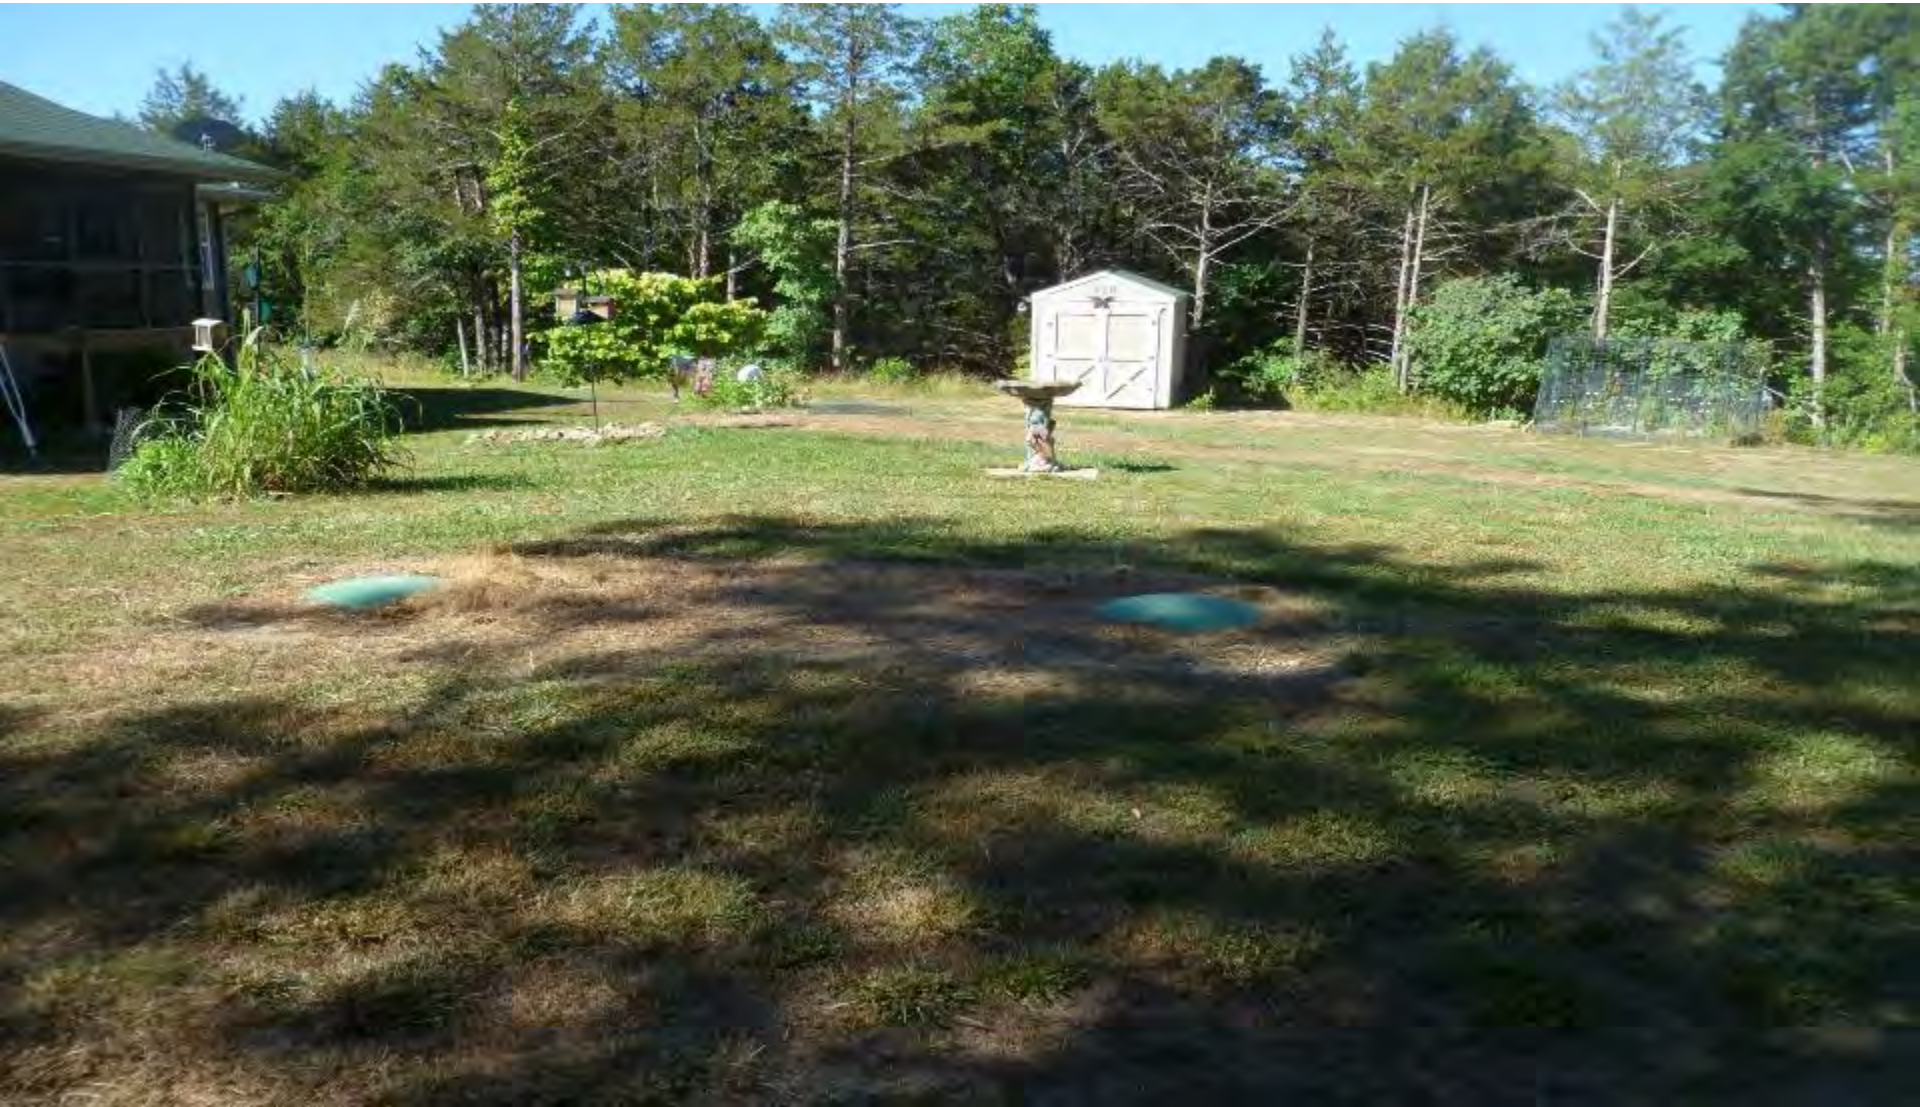
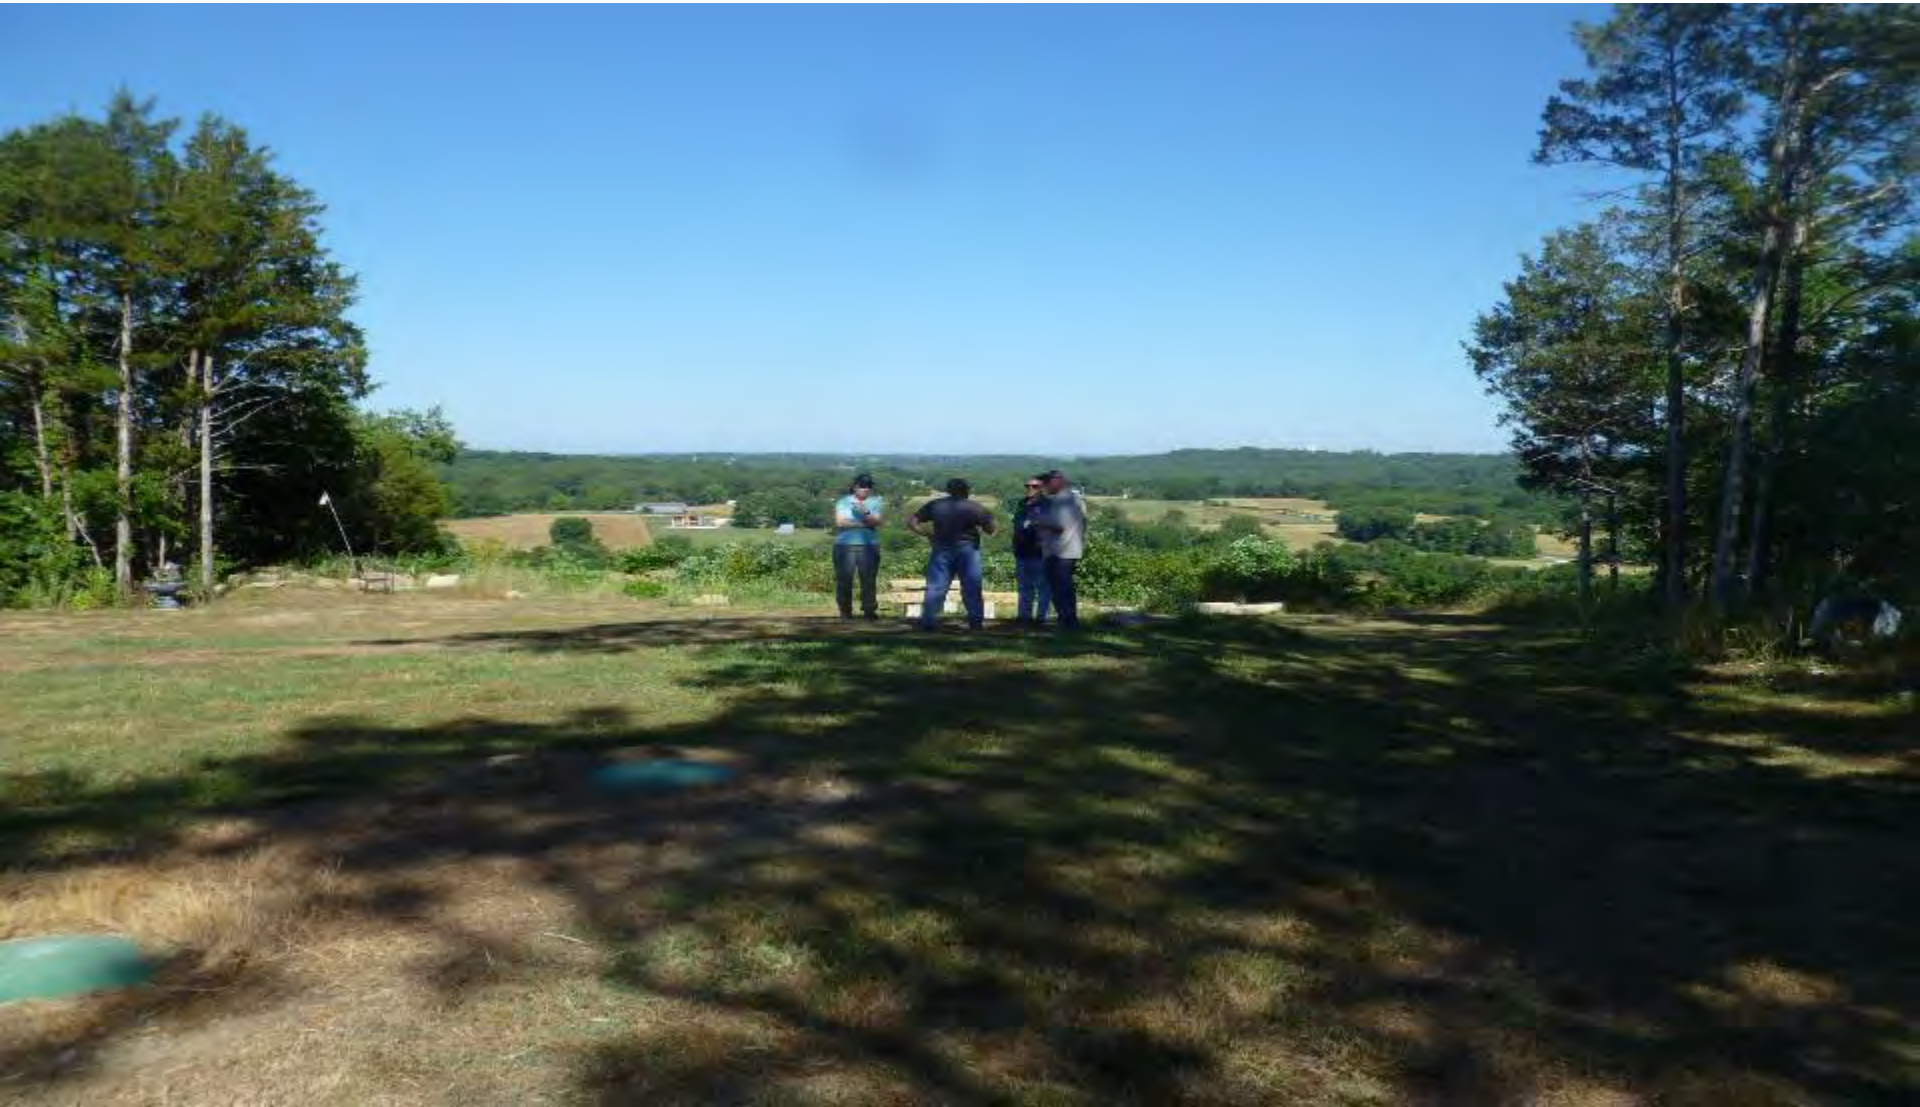
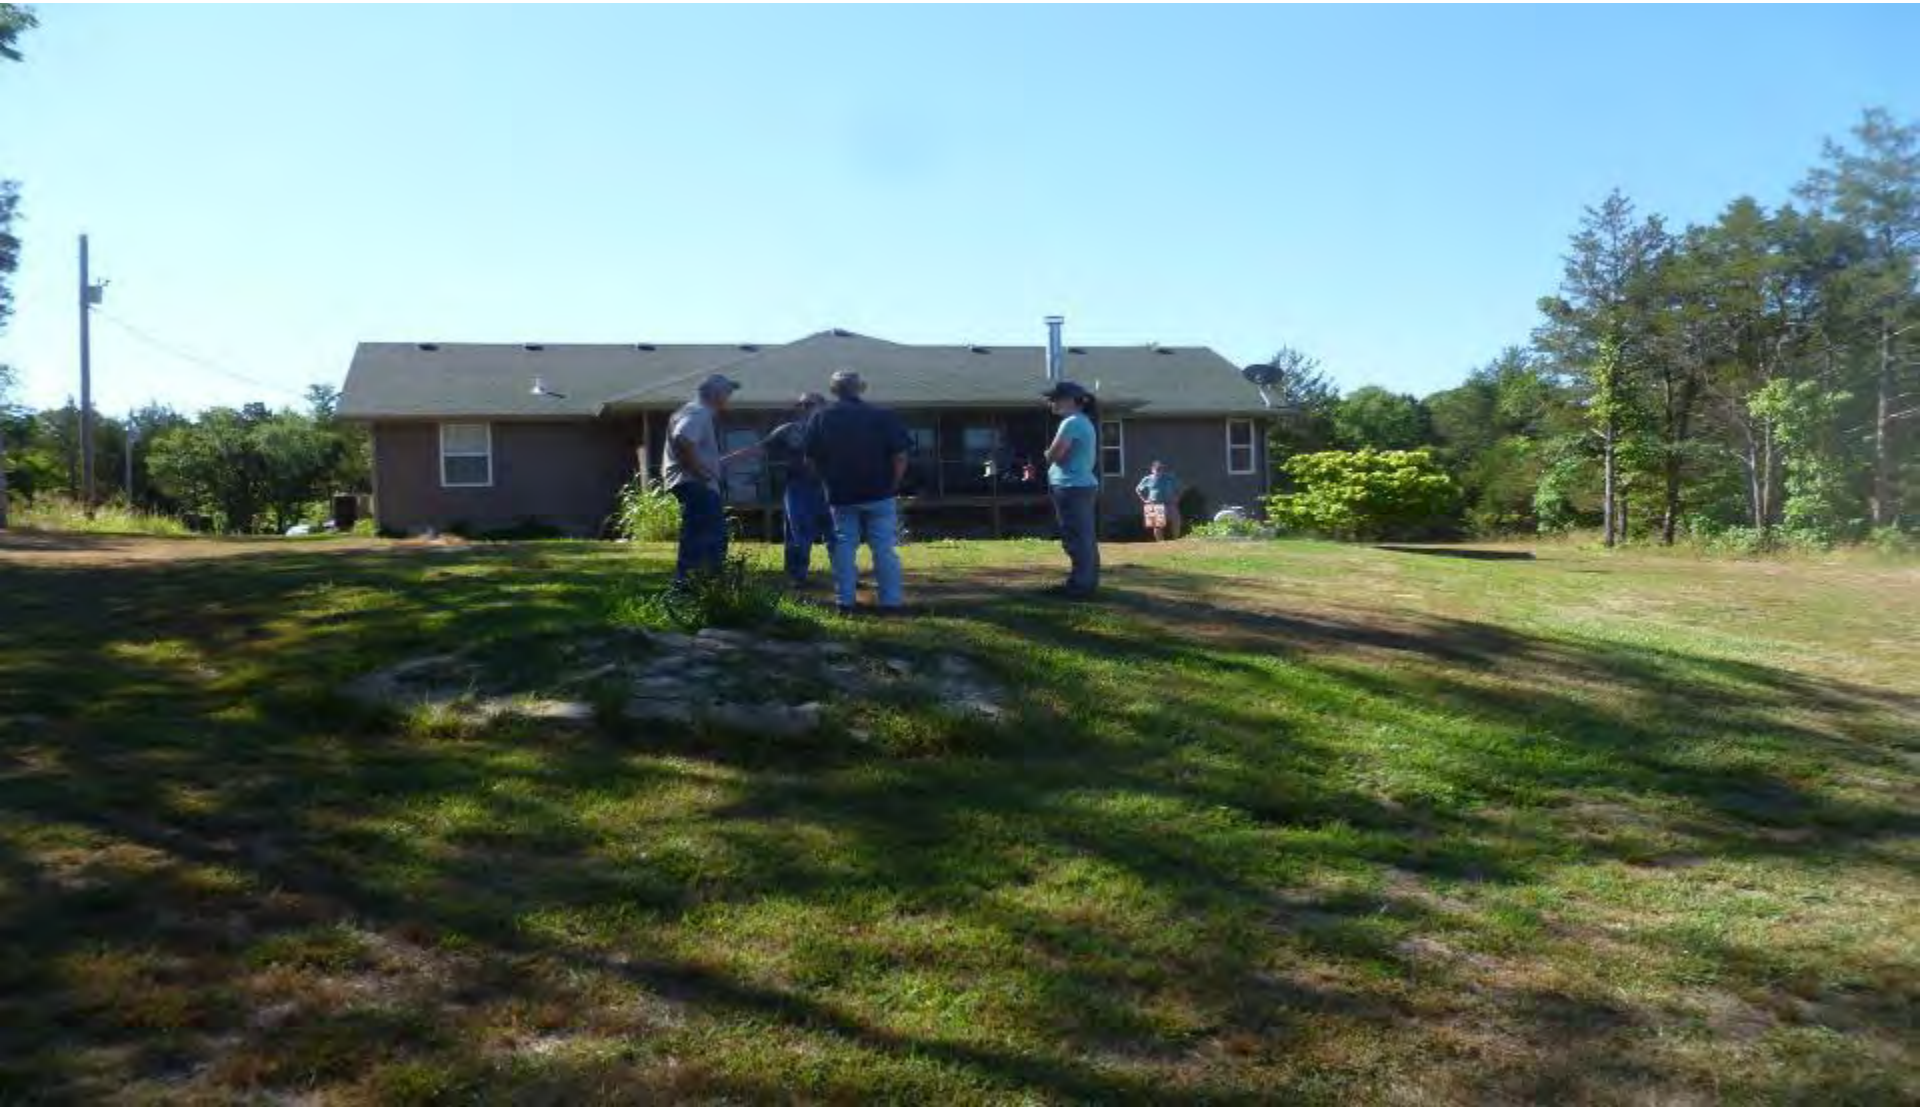
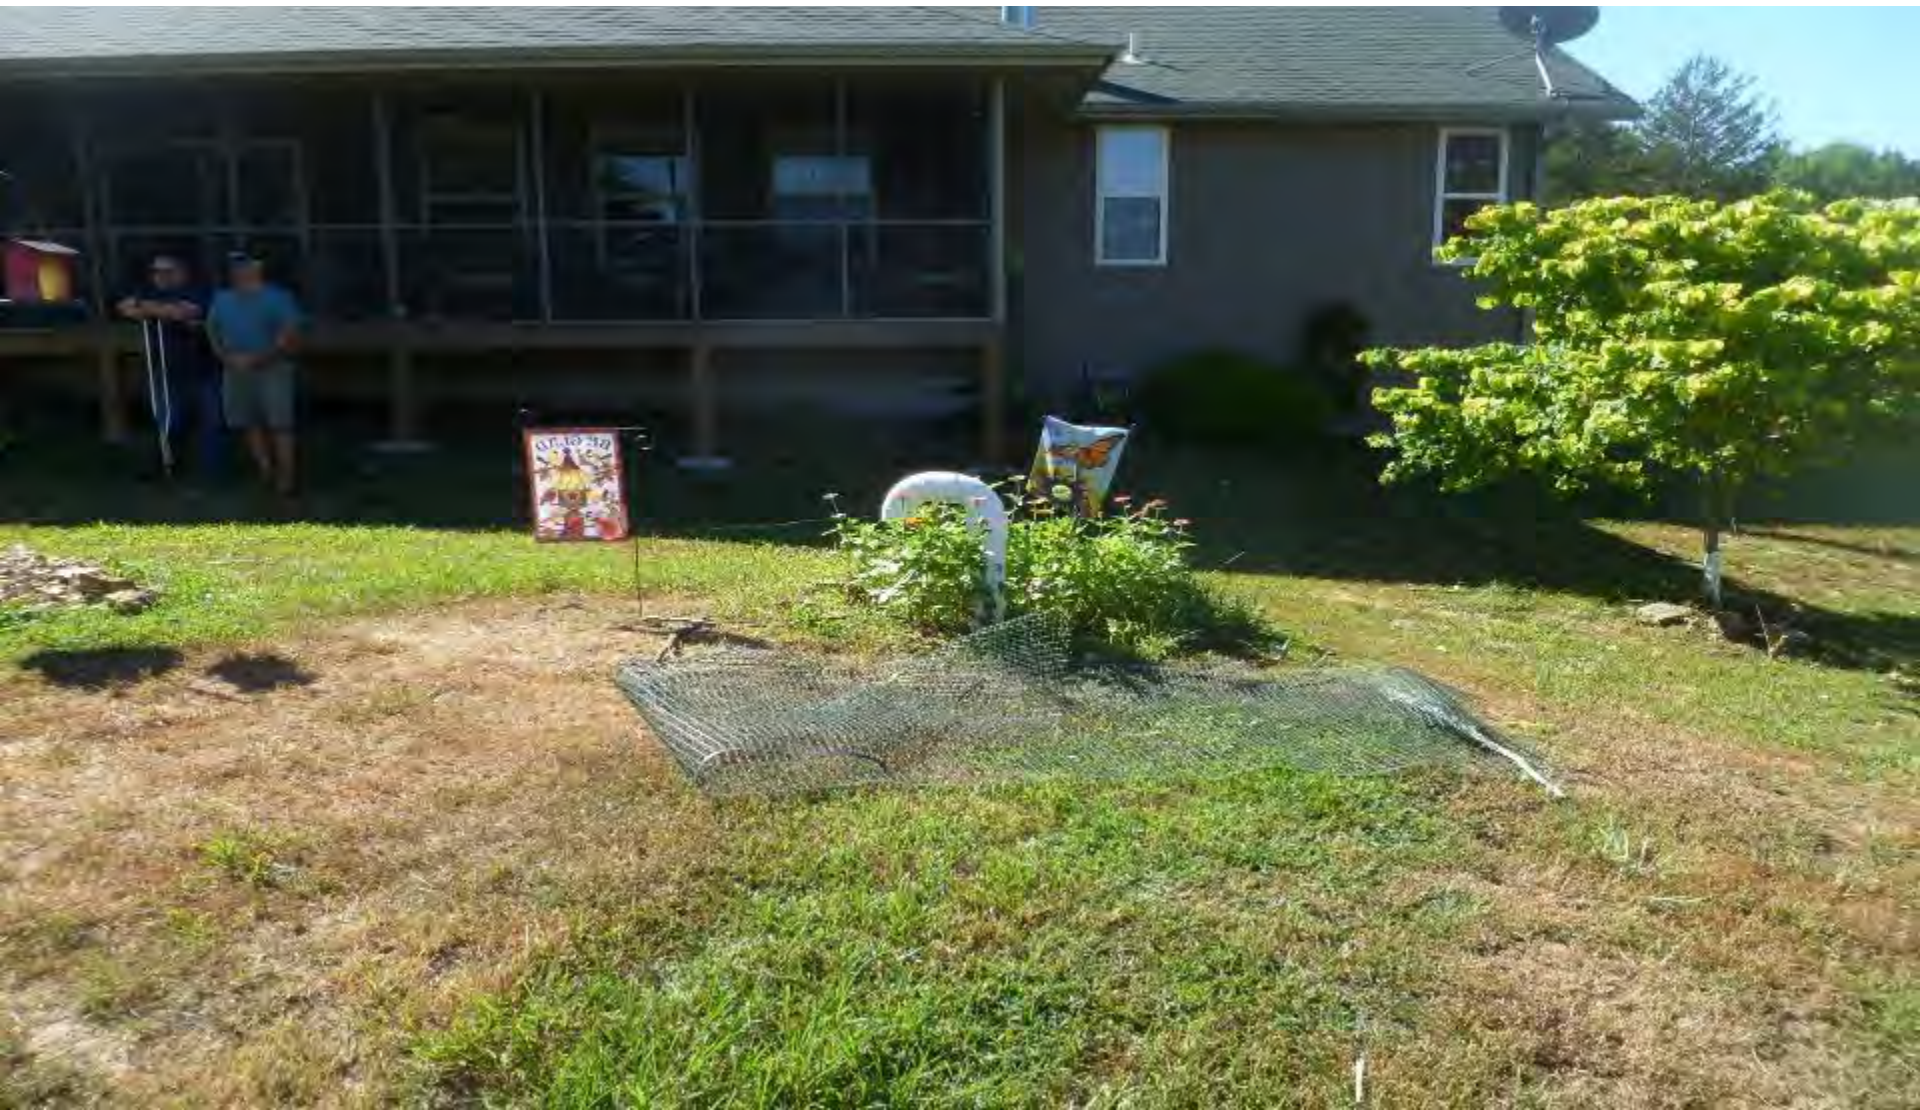
Site W17 located at 1196 Lakeway Road, Kisse Mill, MO had a design soil loading rate of 0.20 gpd/sqft and 150 linear feet of AES (3 lines of 50 ft of product) (Table 1). Photos of this site and system are provided in photos W17-1 through M17-5) (Appendix B). This system was installed in March 2015. The summary of the field evaluation observed no current surfacing effluent over any part of the system, nor evidence of past surfacing. There was no surfacing of sewage with pressure of footwear. No straight pipe discharges were found and no visible signs of malfunction were observed (Table 1 and Appendix A, Table W17). There was no effluent odor within 10 feet of the system and no vegetative striping. Vegetation on the system was consistent as the system had sufficient vegetative cover. No surface diversion was observed. Vegetation was brown over the septic tank. The occupants of this home were not available for an interview (Appendix A, Table W17).

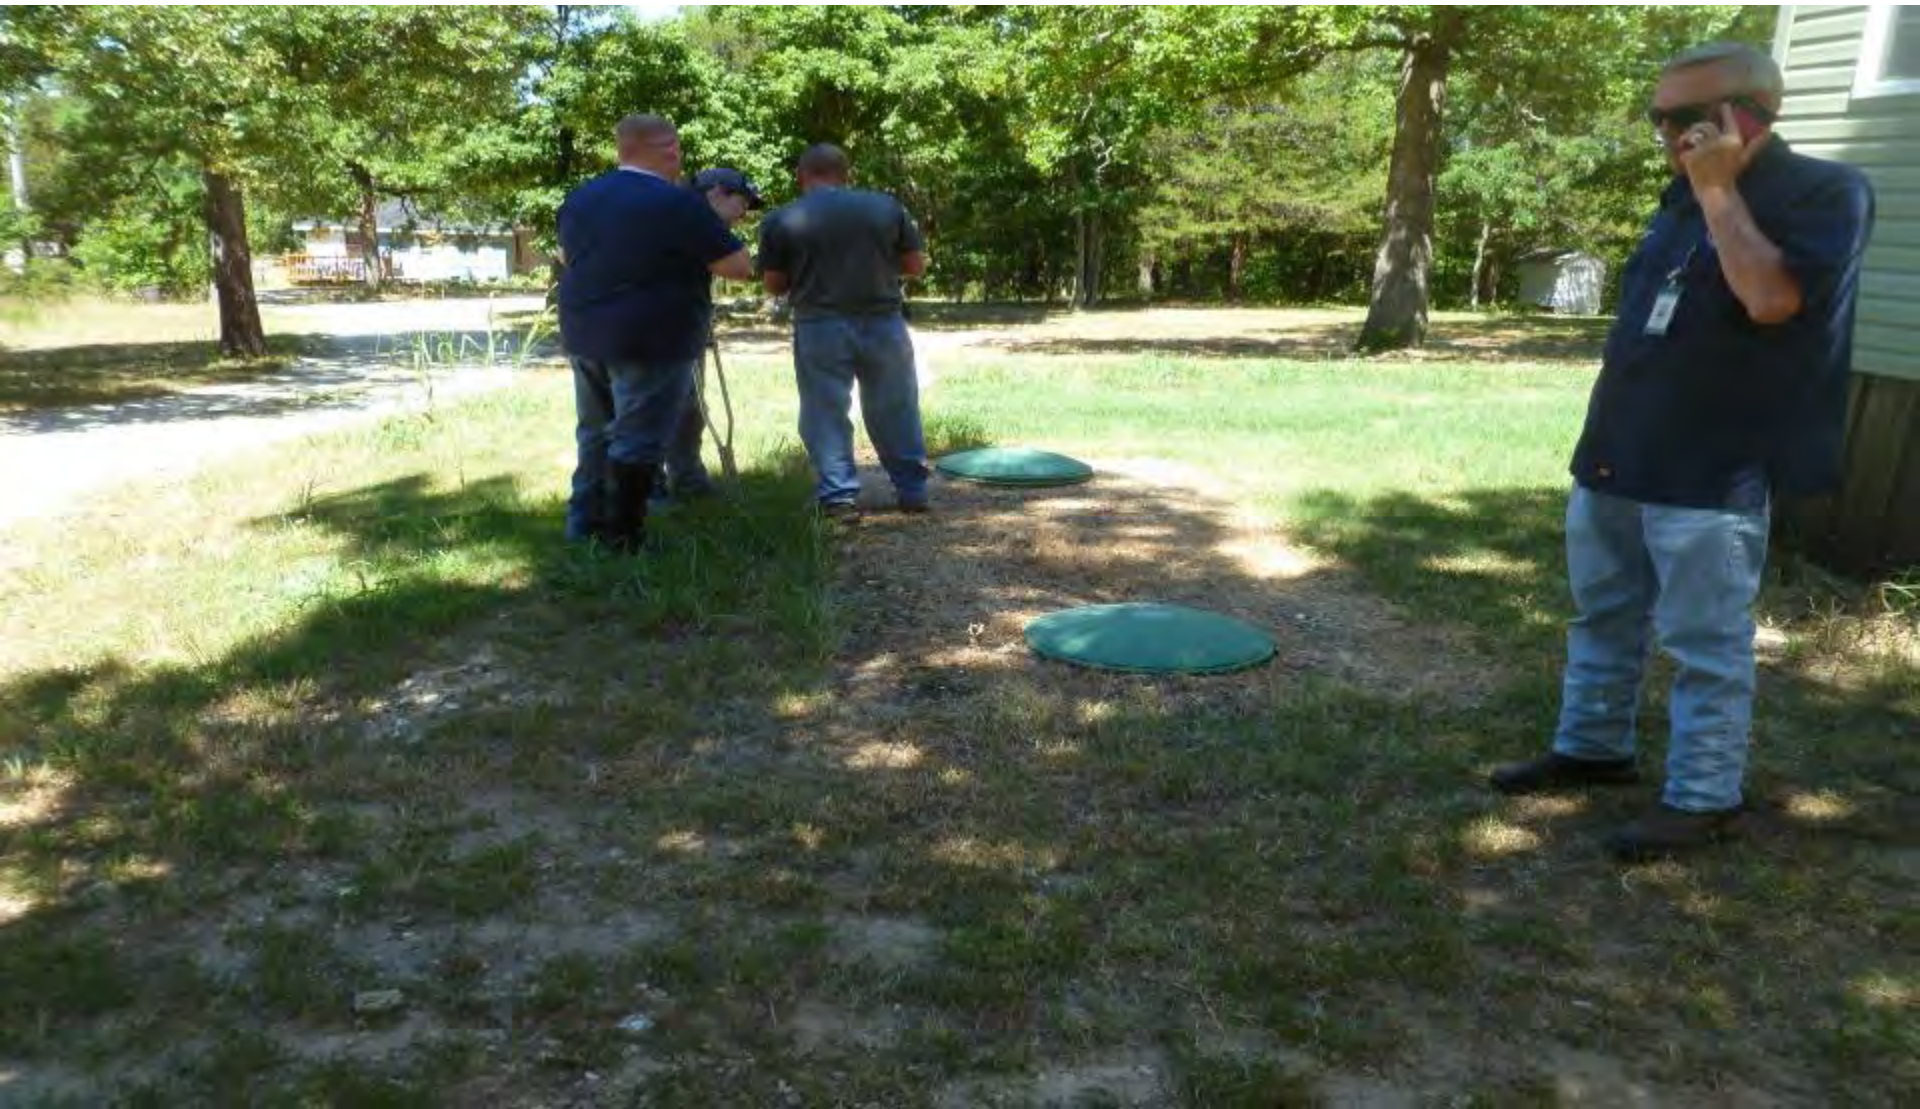
Site W19 located at 2213 Highway KK, Cedar Creek, MO had a design soil loading rate of 0.20 gpd/sqft and 100 linear feet of AES (2 lines of 50 ft of product) (Table 1). Photos of this site and system are provided in photos W19-1 through W19-4 (Appendix B). This system was installed in October 2018. The summary of the field evaluation observed no current surfacing effluent over any part of the system, nor evidence of past surfacing. There was no surfacing of sewage with pressure of footwear. No straight pipe discharges were found and no visible signs of malfunction were observed (Table 1 and Appendix A, Table W19). The system was sufficiently vegetated and there was no effluent odor within 10 feet of the system and no outbreaks of sewage. The septic tank lid was at the soil surface and there was no cap on the outlet to the tank. The homeowner was available to be interviewed and expressed no problems with the system (Appendix A, Table W19).

# Photo W19-1. Sewage Tanks Cedar Creek, MO

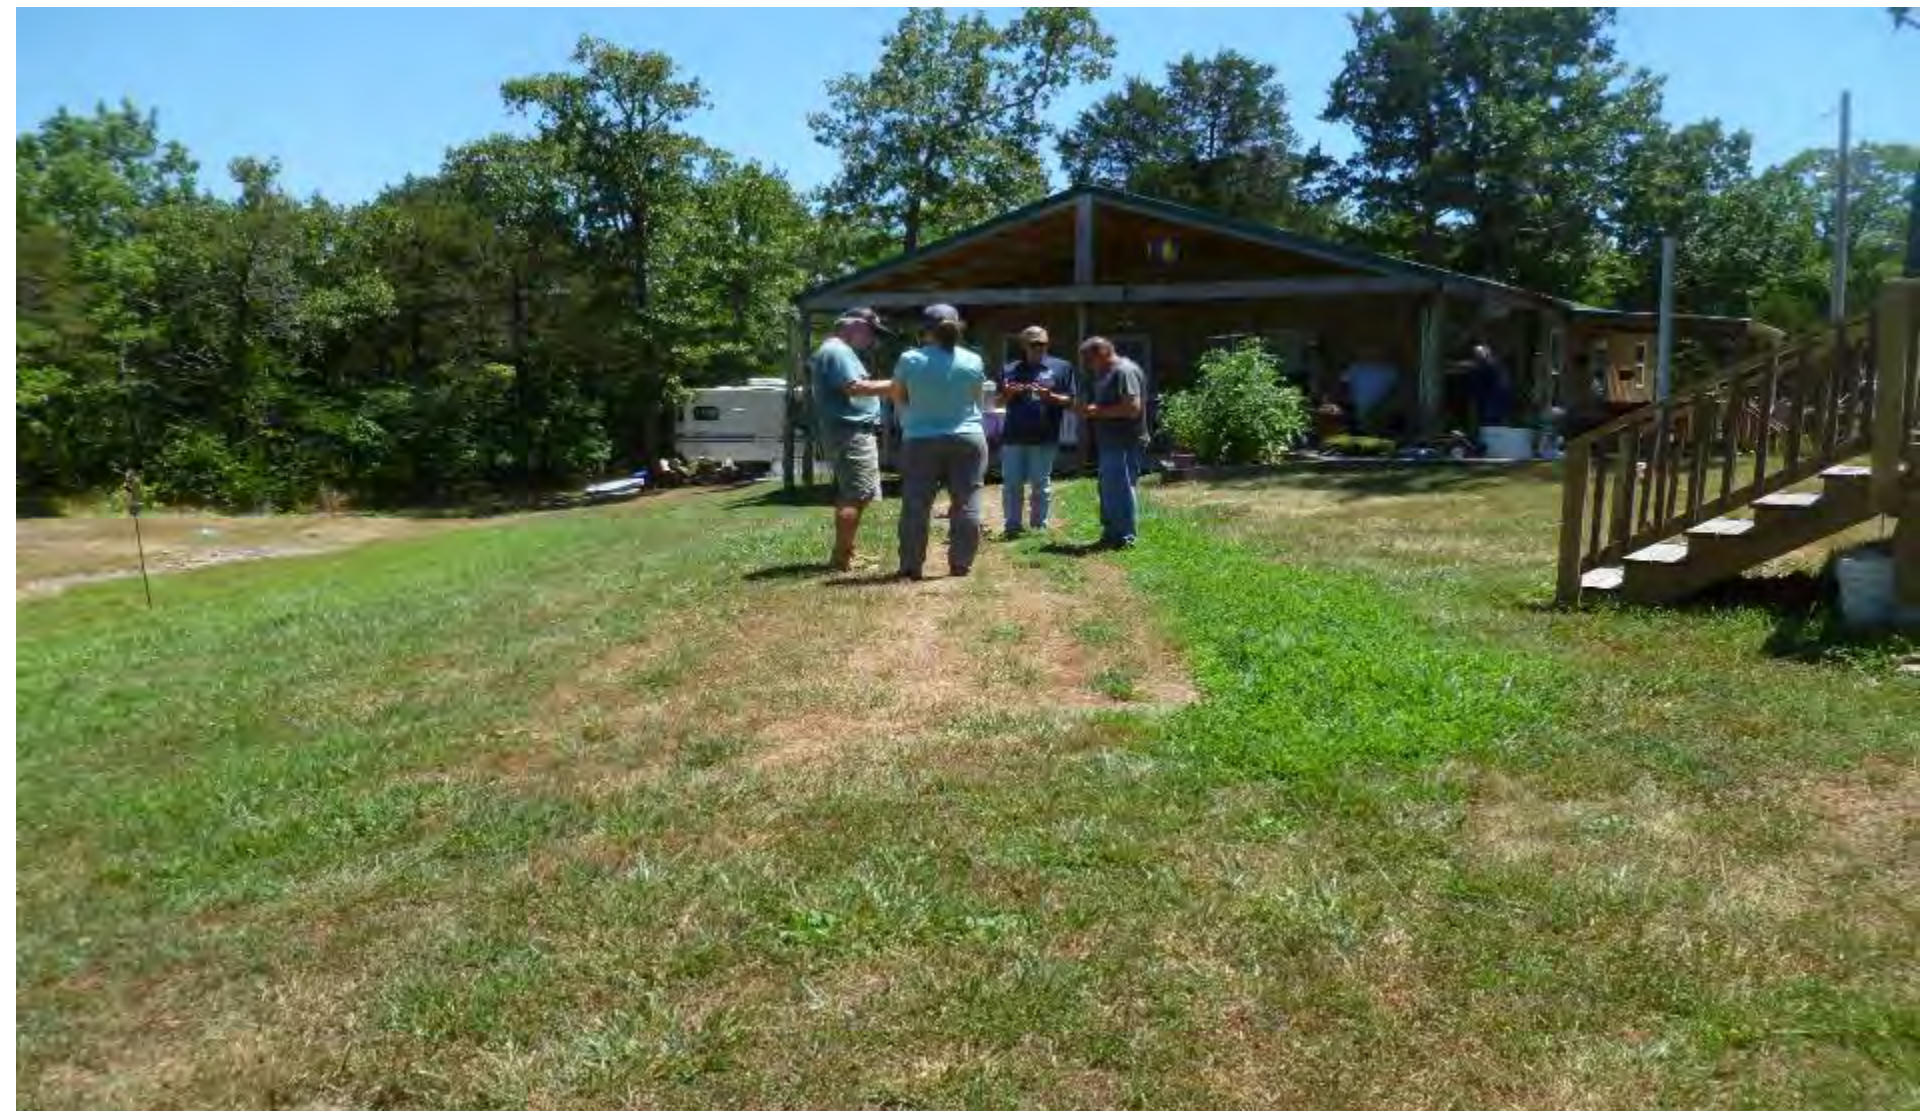
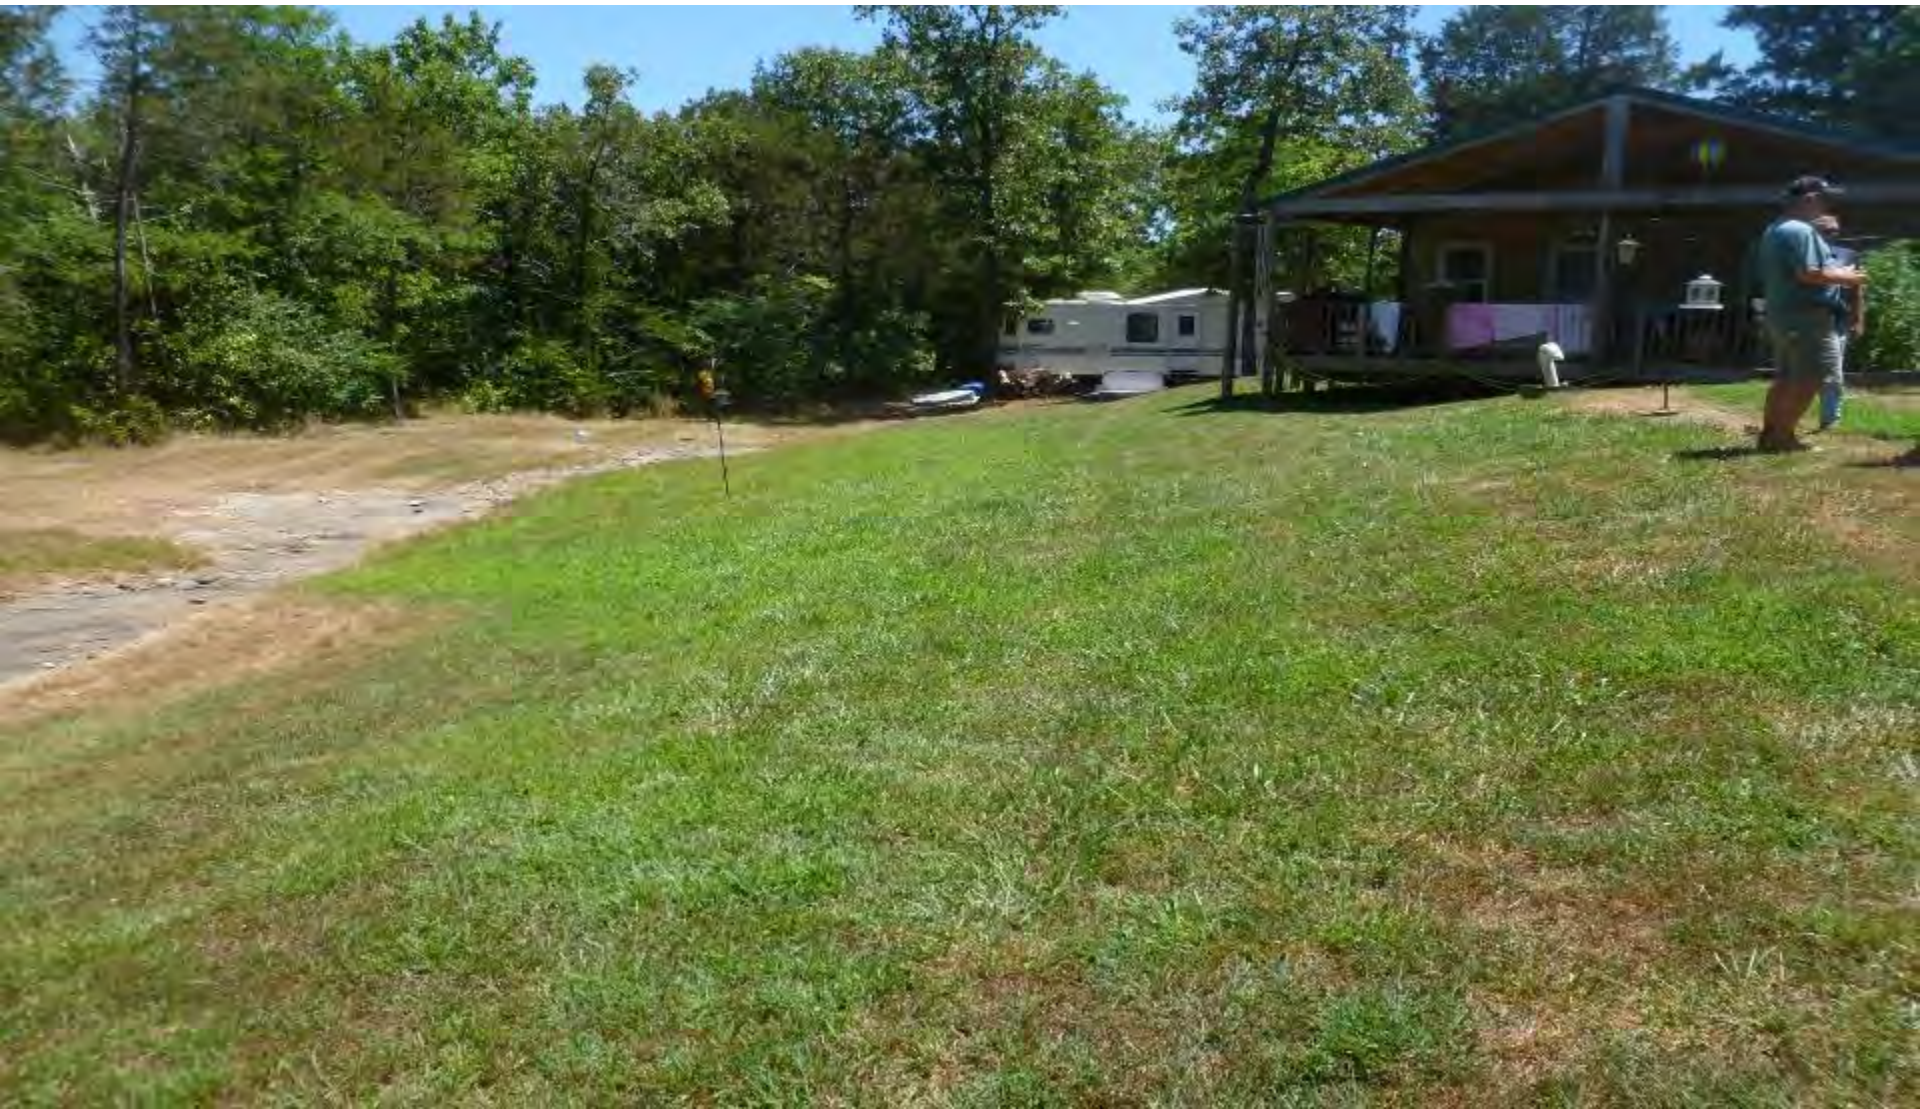
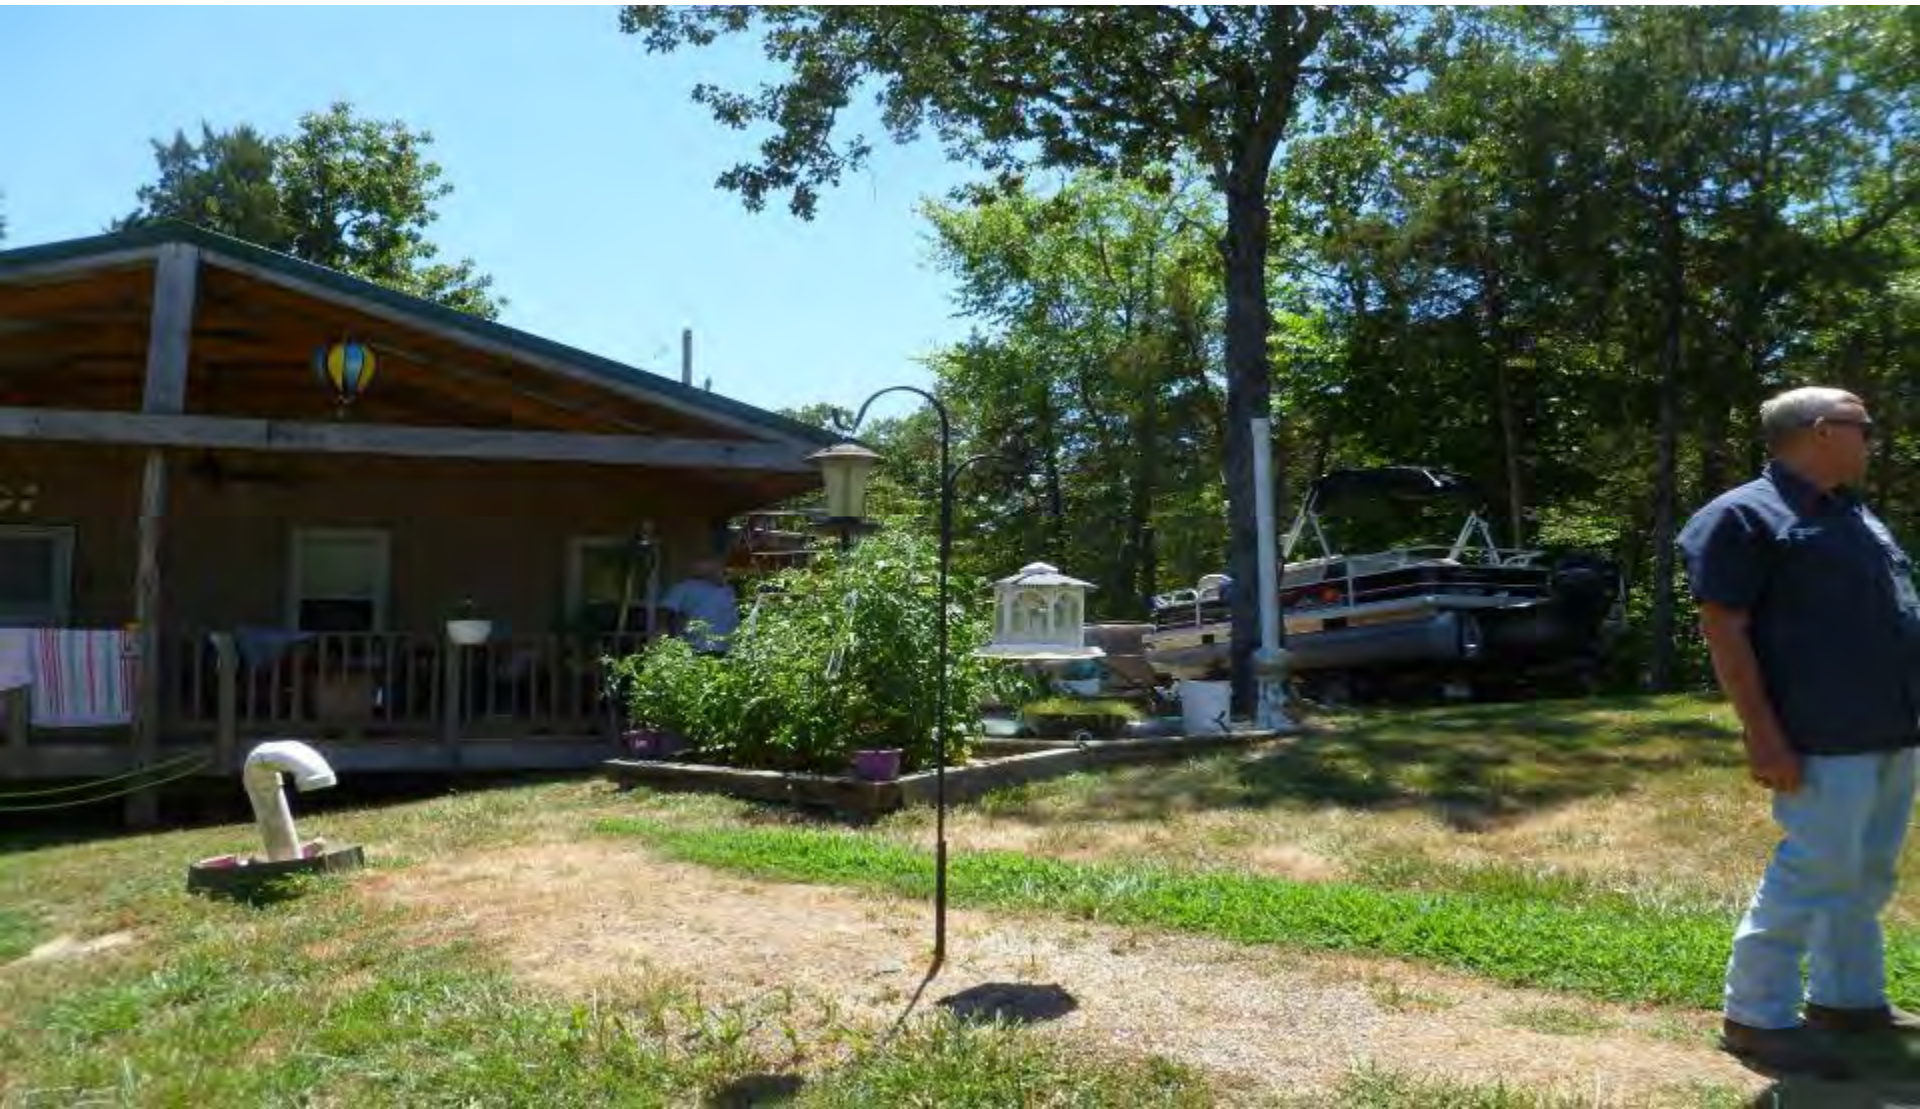
Site W23 located at 475 Shady Lane, Protem, MO had a design soil loading rate of 0.25 gpd/sqft and 140 linear feet of AES (2 lines of 70 ft of product) (Table 1). Photos of this site and system are provided in photos W23-1 through W23-5 (Appendix B). This system was installed in April 2018. The summary of the field evaluation observed no current surfacing effluent over any part of the system nor evidence of past surfacing. There was no surfacing of sewage with pressure of footwear. No straight pipe discharges were found and no visible signs of malfunction were

observed (Table 1 and Appendix A, Table W23). There was no effluent odor within 10 feet of the system and no vegetation striping, although there was dormant vegetation over the crown of the AES technology. A surface diversion could be placed above the system to divert surface run-on away from the AES technology. There is some shelf rock below the system but no observed associated operational issues. The homeowner was available to be interviewed and expressed no problems with the system (Appendix A, Table W23).

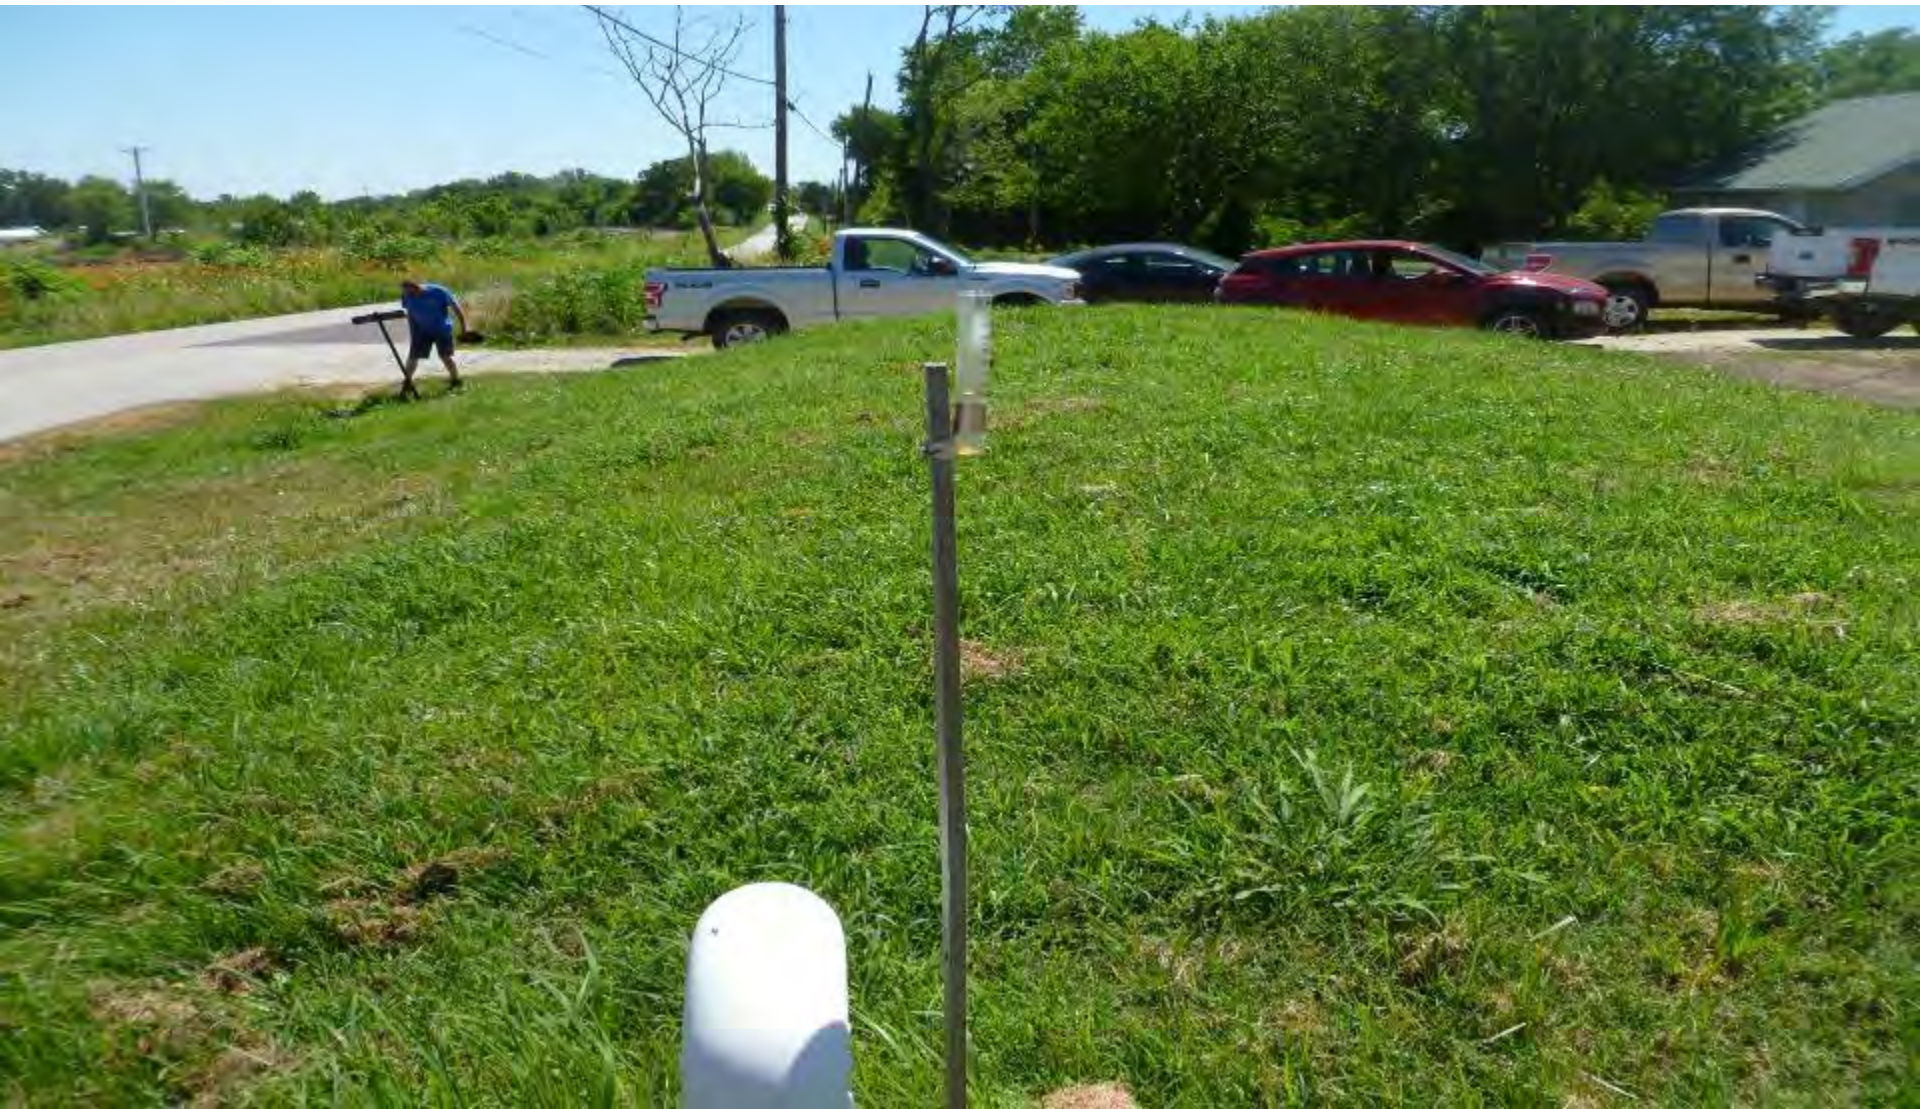
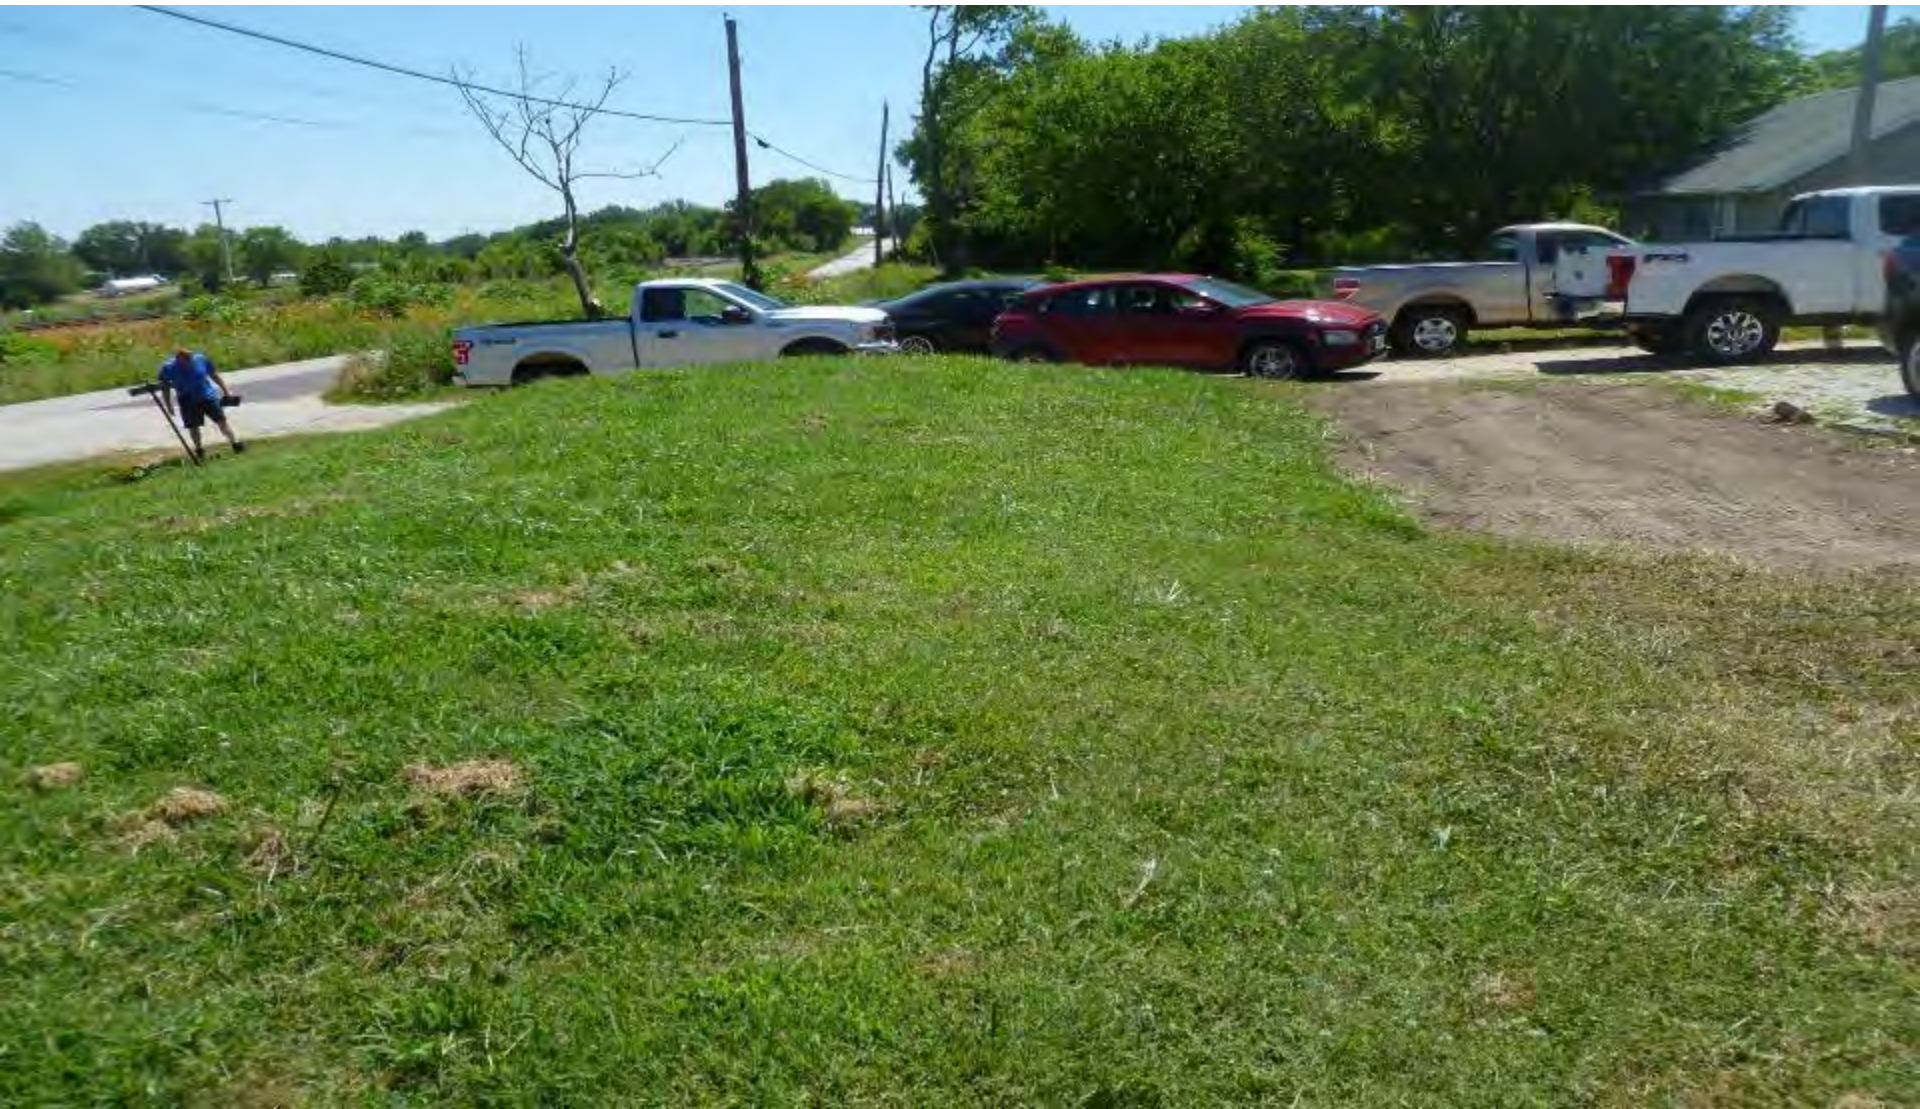
Site R24 located at 642 W. Springfield Road, St. Claire, MO had a design soil loading rate of 0.65 gpd/sqft and 240 linear feet of AES (6 lines of 40 ft of product) (Table 1). Photos of this site and system are provided in photos R24-1 through R24-7 (Appendix B). This system was installed before May 2015. The summary of the field evaluation observed current surfacing effluent over part of the system and evidence of past surfacing. There was surfacing of sewage with pressure of footwear. No straight pipe discharges were found, however, visible signs of malfunction were observed (Table 1 and Appendix A, Table R24). There was no effluent odor within 10 feet of the system and no striping. Dark-colored vegetation covered most of the soil treatment area. There were mower tracks up and down the backslope of the breakout area. Additionally, there was compaction on the uphill side due to the parking of vehicles (Photo R24-3). This area of compaction would likely direct increased surface runoff onto the AES technology. The backslope had a very steep configuration of greater than 3 to 1 and possessed the greatest component of the breakout from the system, especially in the north to northeast facing areas (Photo 24-6). The homeowner was available to be interviewed, and expressed no problems, from their perspective, with the system (Appendix A, Table R24).
