## **Final Report**

### **Field Performance Assessment of the Advanced Enviro-Septic Wastewater Treatment and Dispersal System in Missouri, 2022**

**Dr. Randall J. Miles, Soil Scientist, Emeritus Associate Professor**

**February 7, 2023**

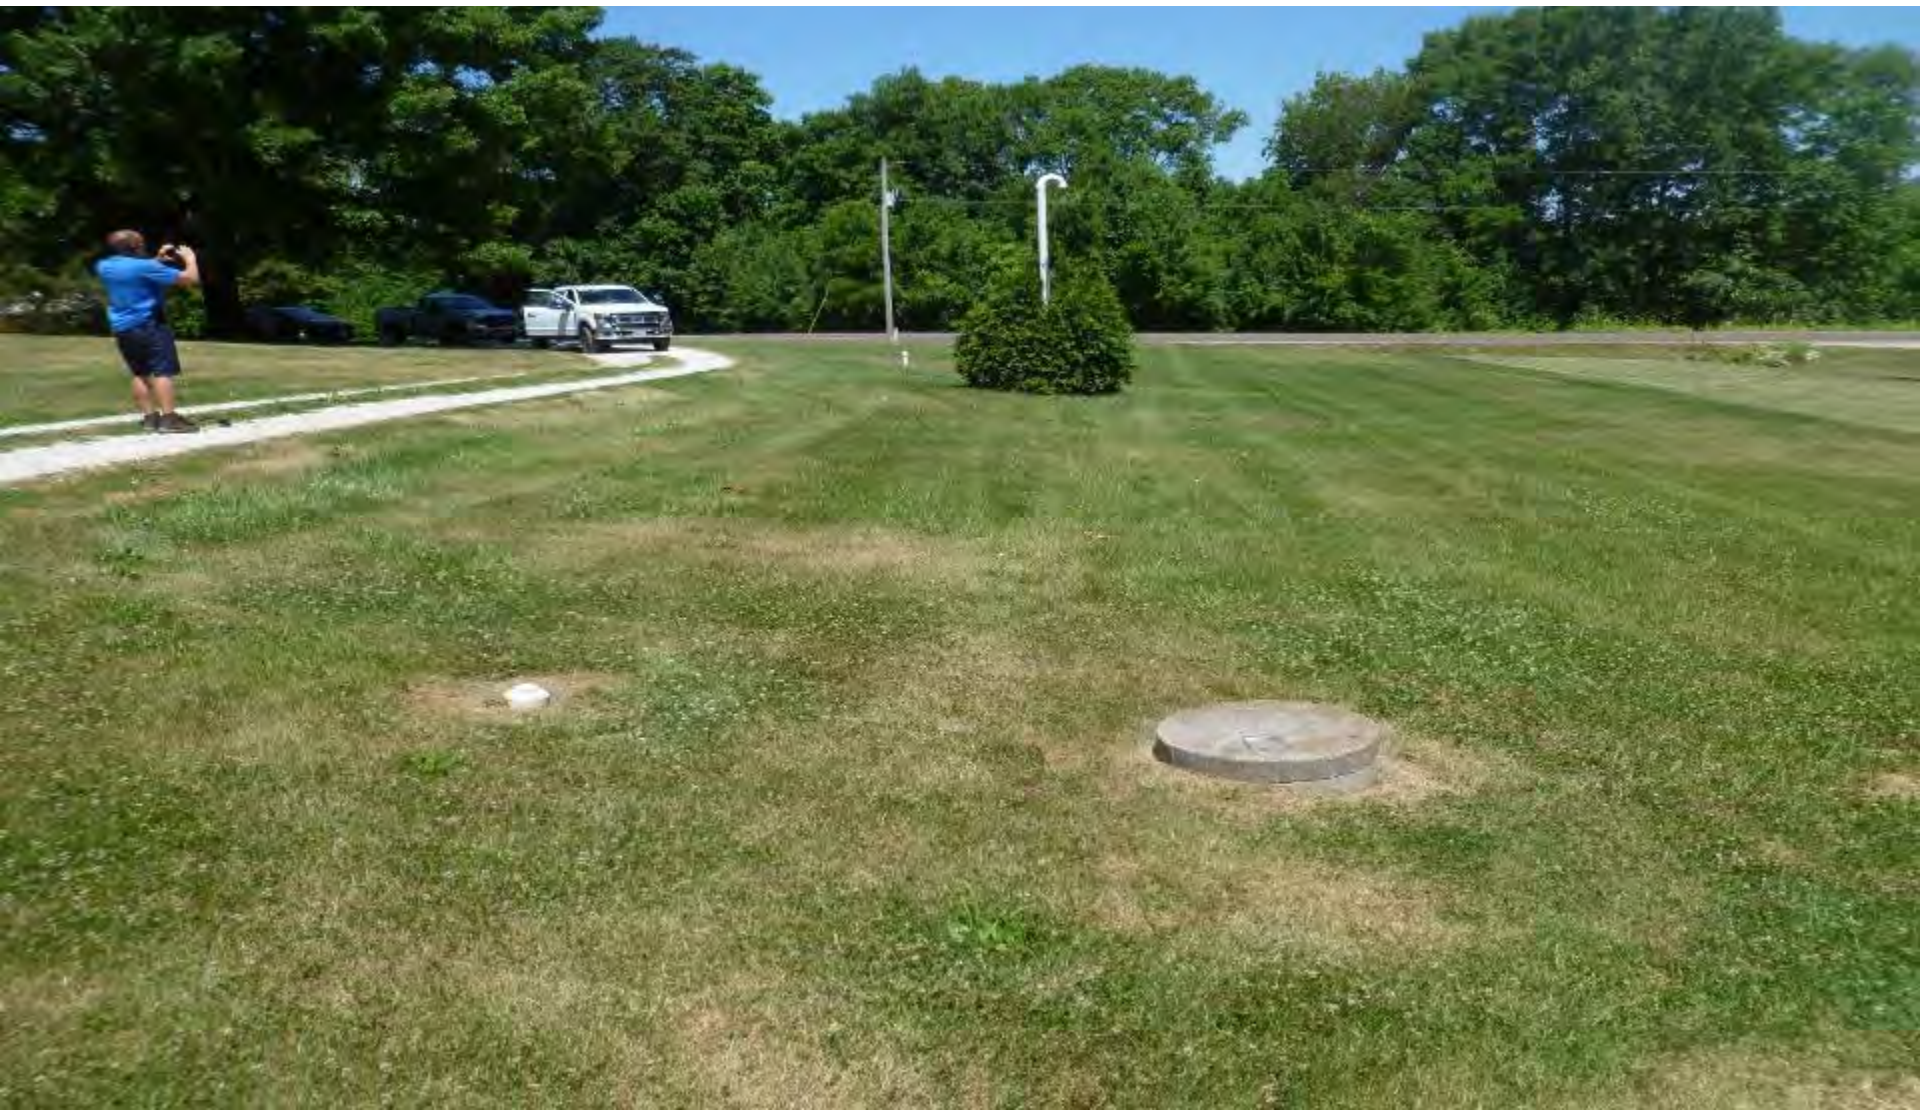
# Photo R25-1. AES Technology Villa Ridge, MO

Site R25 located at 4934 Highway B, Villa Ridge, MO had a design soil loading rate of 0.30 gpd/sqft and 200 linear feet of AES (4 lines of 50 ft of product) (Table 1). Photos of this site and system are provided in photos R25-1 through R25-3 (Appendix B). This system was installed in November 2016. The summary of the field evaluation observed no current surfacing effluent over any part of the system nor evidence of past surfacing. There was no surfacing of sewage with pressure of footwear. No straight pipe discharges were found and no visible signs of malfunction were observed (Table 1 and Appendix A, Table R25). There were remote vents for the system. There was no effluent odor within 10 feet of the system and no effluent breakout. There was dormant vegetation over the crown of the AES technology. A surface diversion could be placed above the system to divert surface run-on away from the AES technology. Additionally there was no water in the observation ports. The occupants of this home were not available for an interview (Appendix A, Table R25).

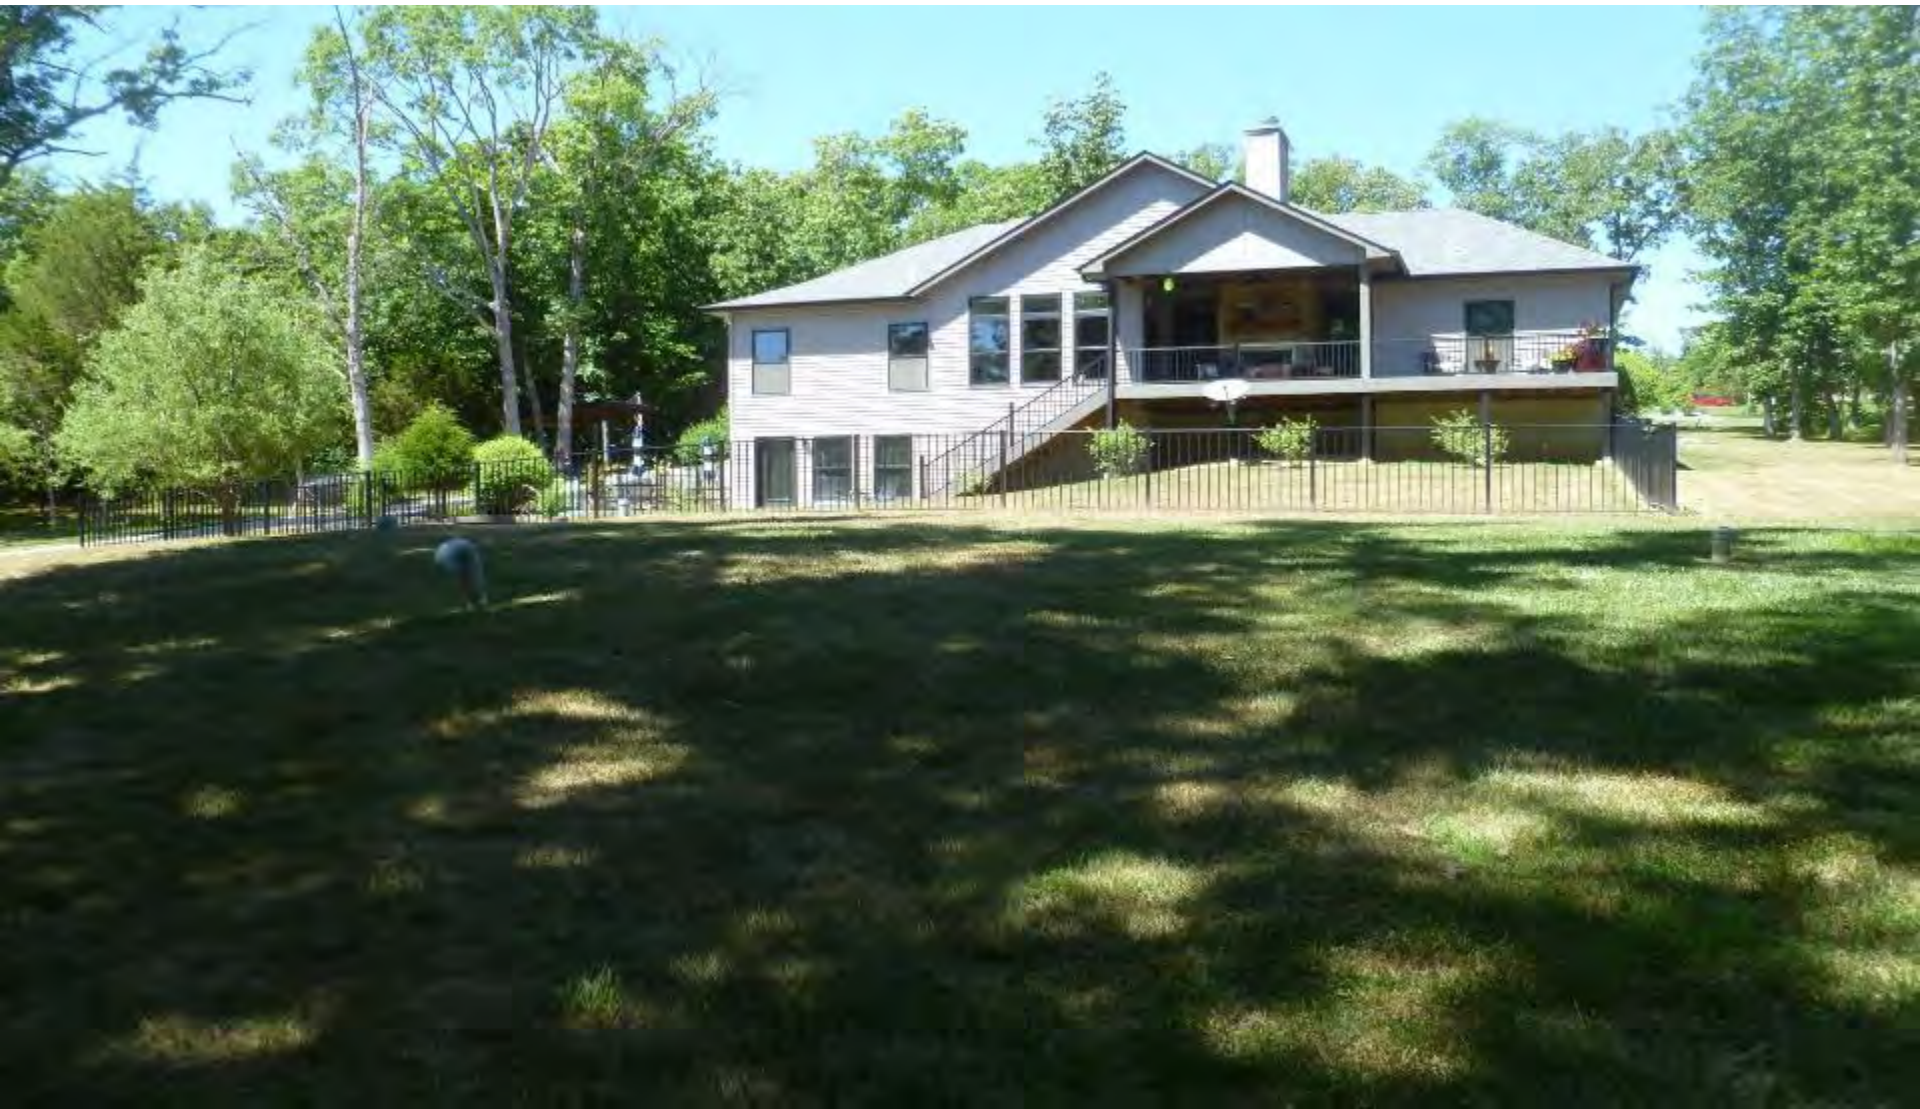
# Photo R26-3. AES Technology Troy, MO

Site R26 located at 43 Persimmon Court, Troy, MO had a design soil loading rate of 0.20 gpd/sqft and 210 linear feet of AES (3 lines of 70 ft of product) (Table 1). Photos of this site and system are provided in photos R26-1 through R26-3 (Appendix B). This system was installed in September 2016. The summary of the field evaluation observed no current surfacing effluent over any part of the system nor evidence of past surfacing. There was no surfacing of sewage

with pressure of footwear. No straight pipe discharges were found and no visible signs of malfunction were observed (Table 1 and Appendix A, Table R26). There was no effluent odor within 10 feet of the system and no effluent breakout. Good vegetative cover was observed, with no striping. There were dryness cracks over the septic tank. A surface diversion could be placed above the system to divert surface run-on away from the AES technology. The occupants of this home were not available for an interview (Appendix A, Table R26).

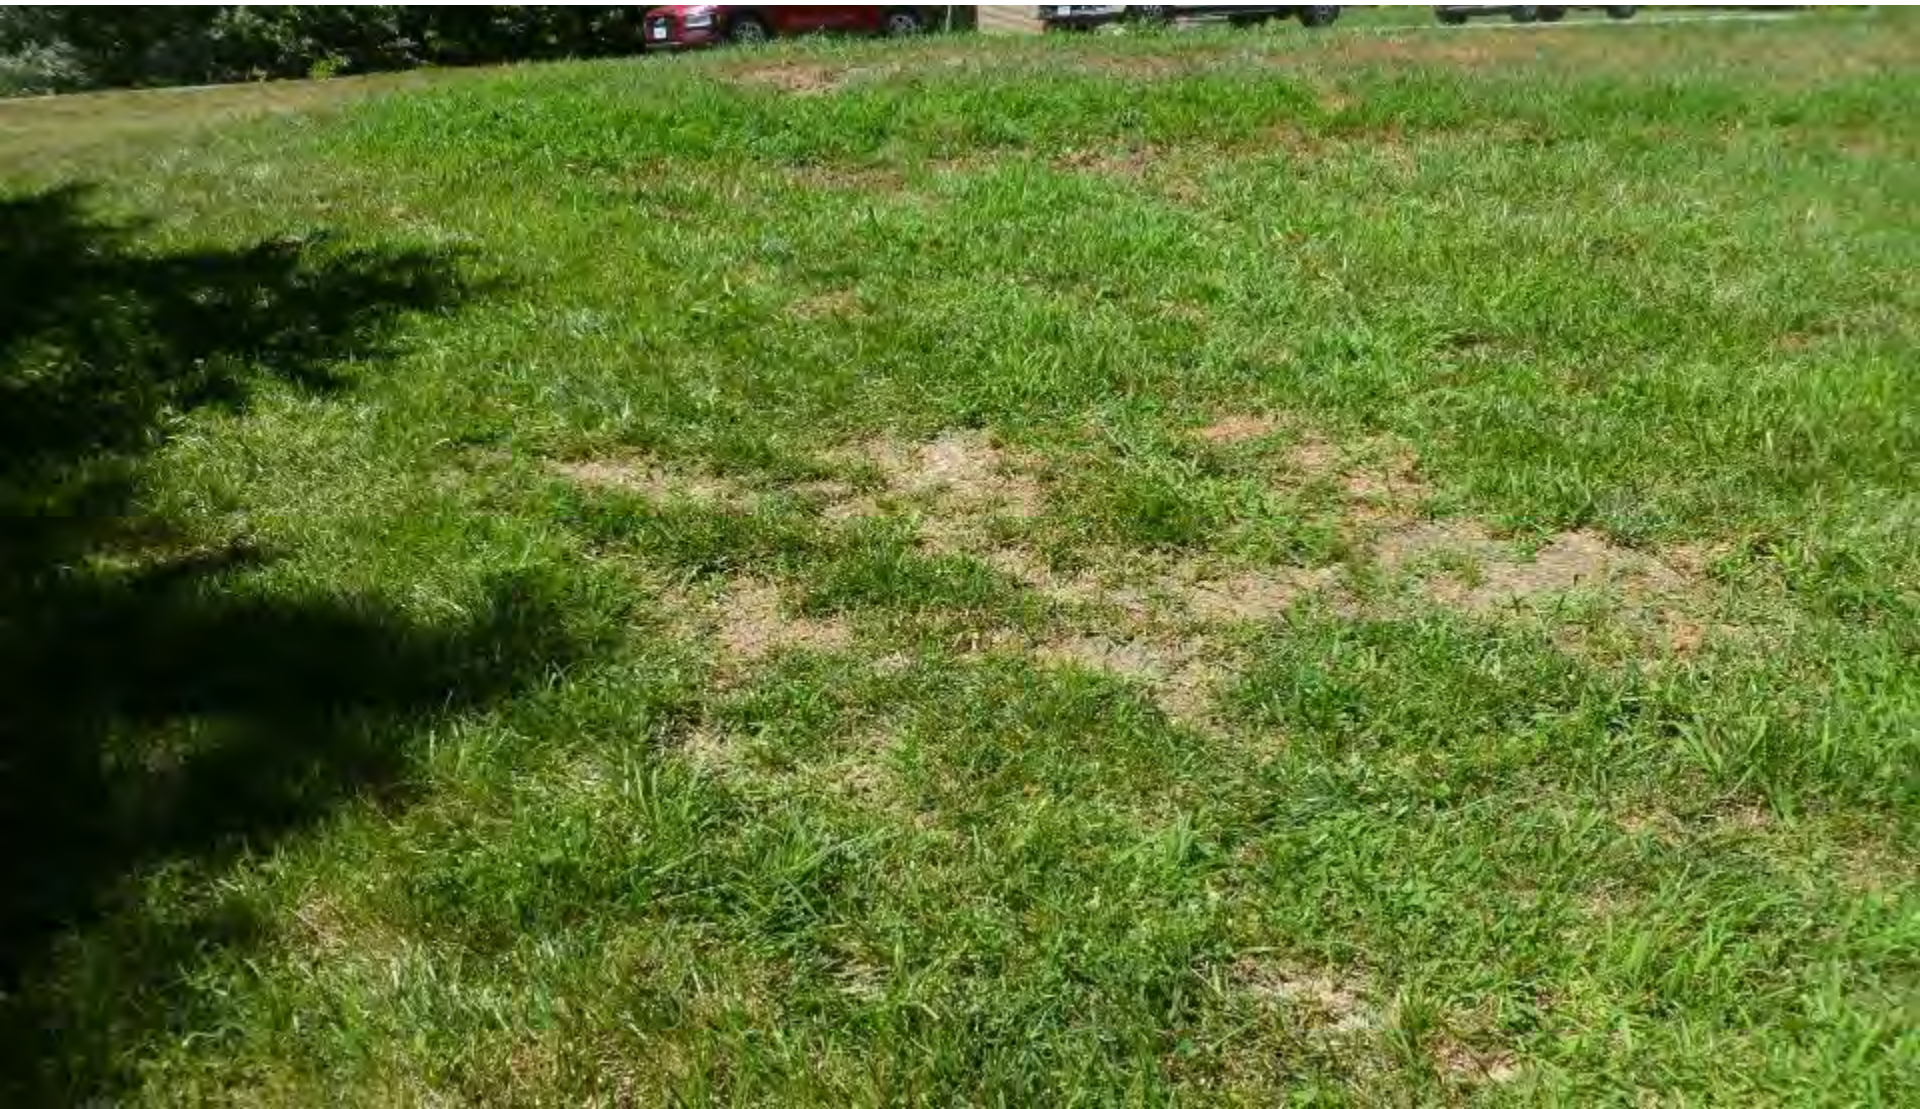
Site R27 located at 41 Persimmon Court, Troy, MO had a design soil loading rate of 0.25 gpd/sqft and 200 linear feet of AES (4 lines of 50 ft of product) (Table 1). Photos of this site and system are provided in photos R27-1 through R27-6) (Appendix B). This system was installed in November 2015. Repairs to this system were performed in October 2019 by Infiltrator utilizing AES installation protocols and specified soil material to cover exposed system sand on the downslope portion of the AES technology. Repairs were undertaken to complete the installation, which had been left unfinished relative to the AES manufacturer's installation instructions. The summary of the current field evaluation observed no surfacing effluent over any part of the system nor evidence of past surfacing. There was no surfacing of sewage with pressure of footwear. No straight pipe discharges were found and no visible signs of malfunction were observed (Table 1 and Appendix A, Table R27). This system pumps to a distribution box (Photo R27-6). There was no effluent odor within 10 feet of the system, and adequate vegetative cover. There was no evidence of past breakout and the system did not have any failure indicators at the time of assessment (Photo R27-4). There were many mole holes and ruts near the distribution box end of the system. This system has a sharp drop off on the absorption/treatment side that appears to be greater than 3 to 1, as required by the manufacturer. This area was very green, but was not excessively wet, just moist. The occupants of this home were not available for an interview (Appendix A, Table R27).

# Photo R27-4. Past Breakout Area Troy, MO

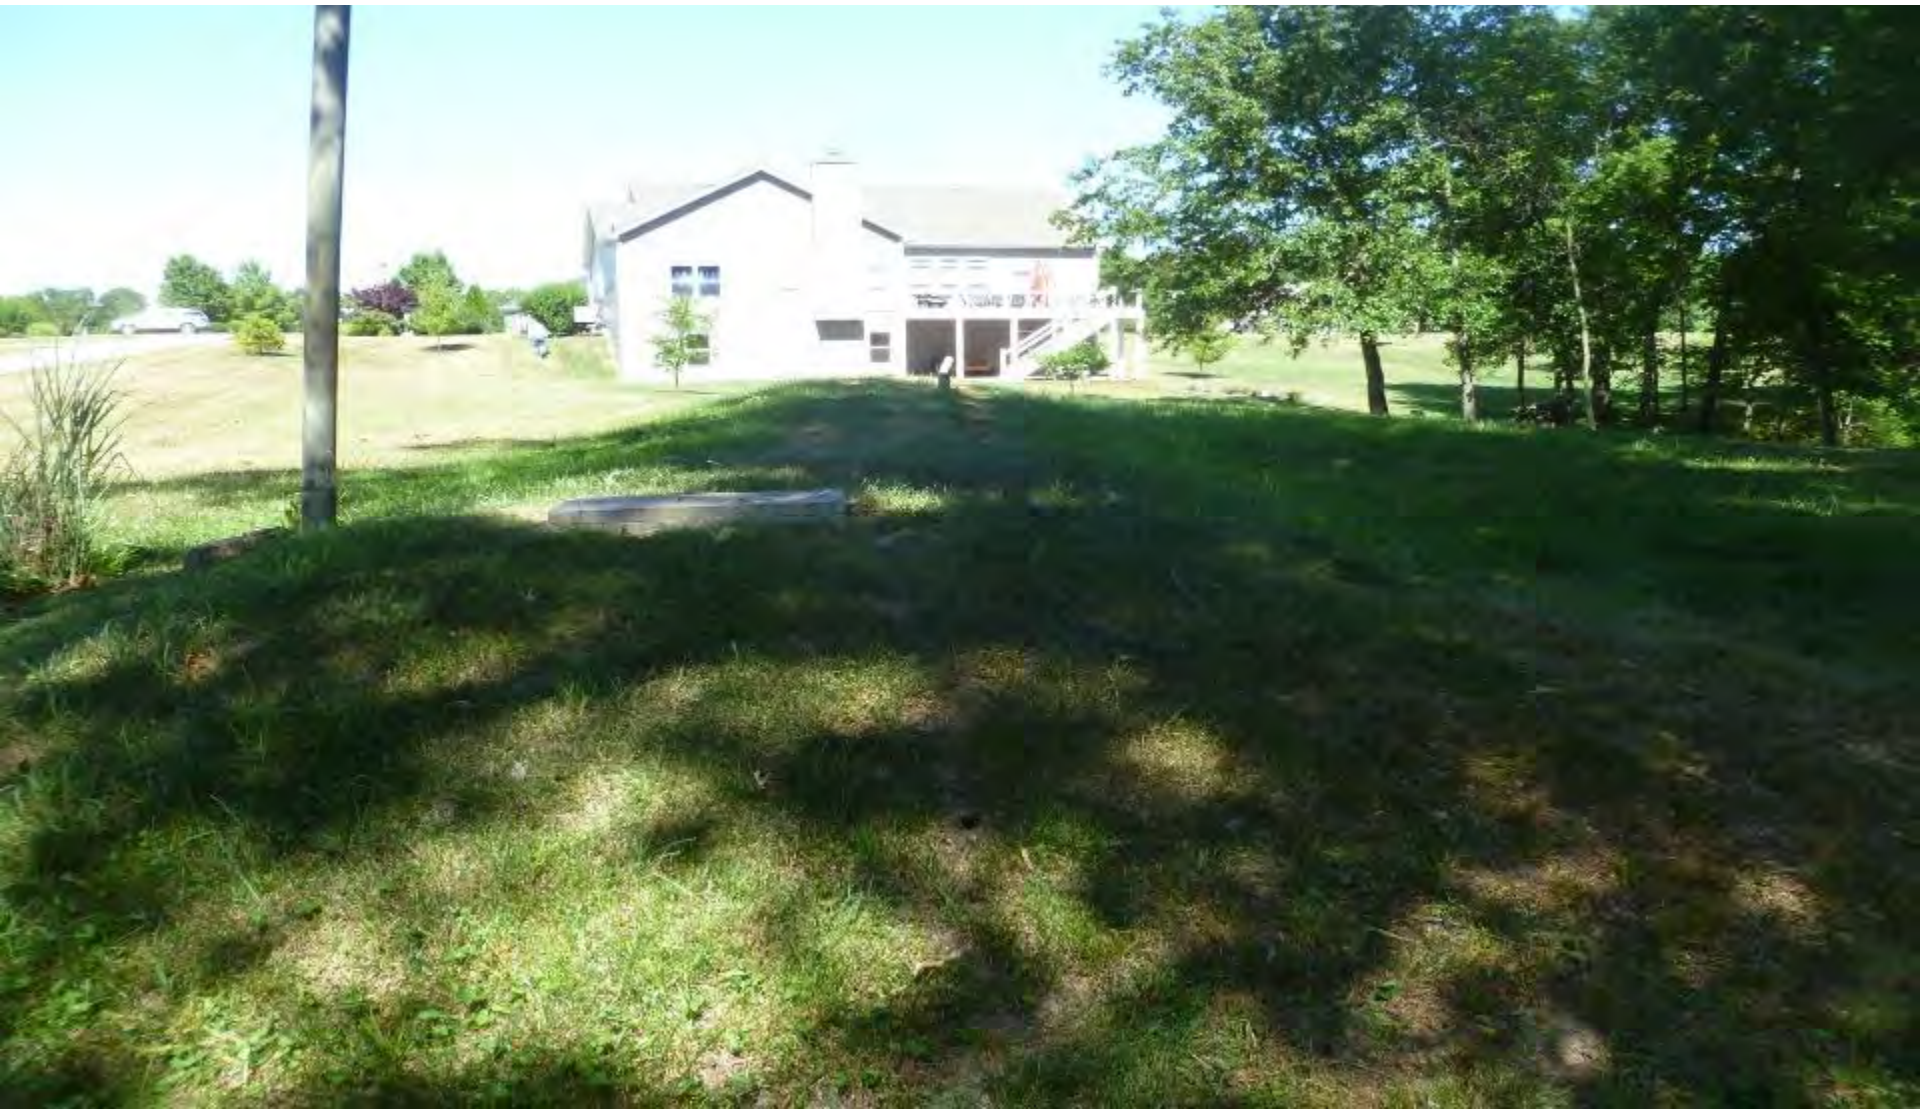
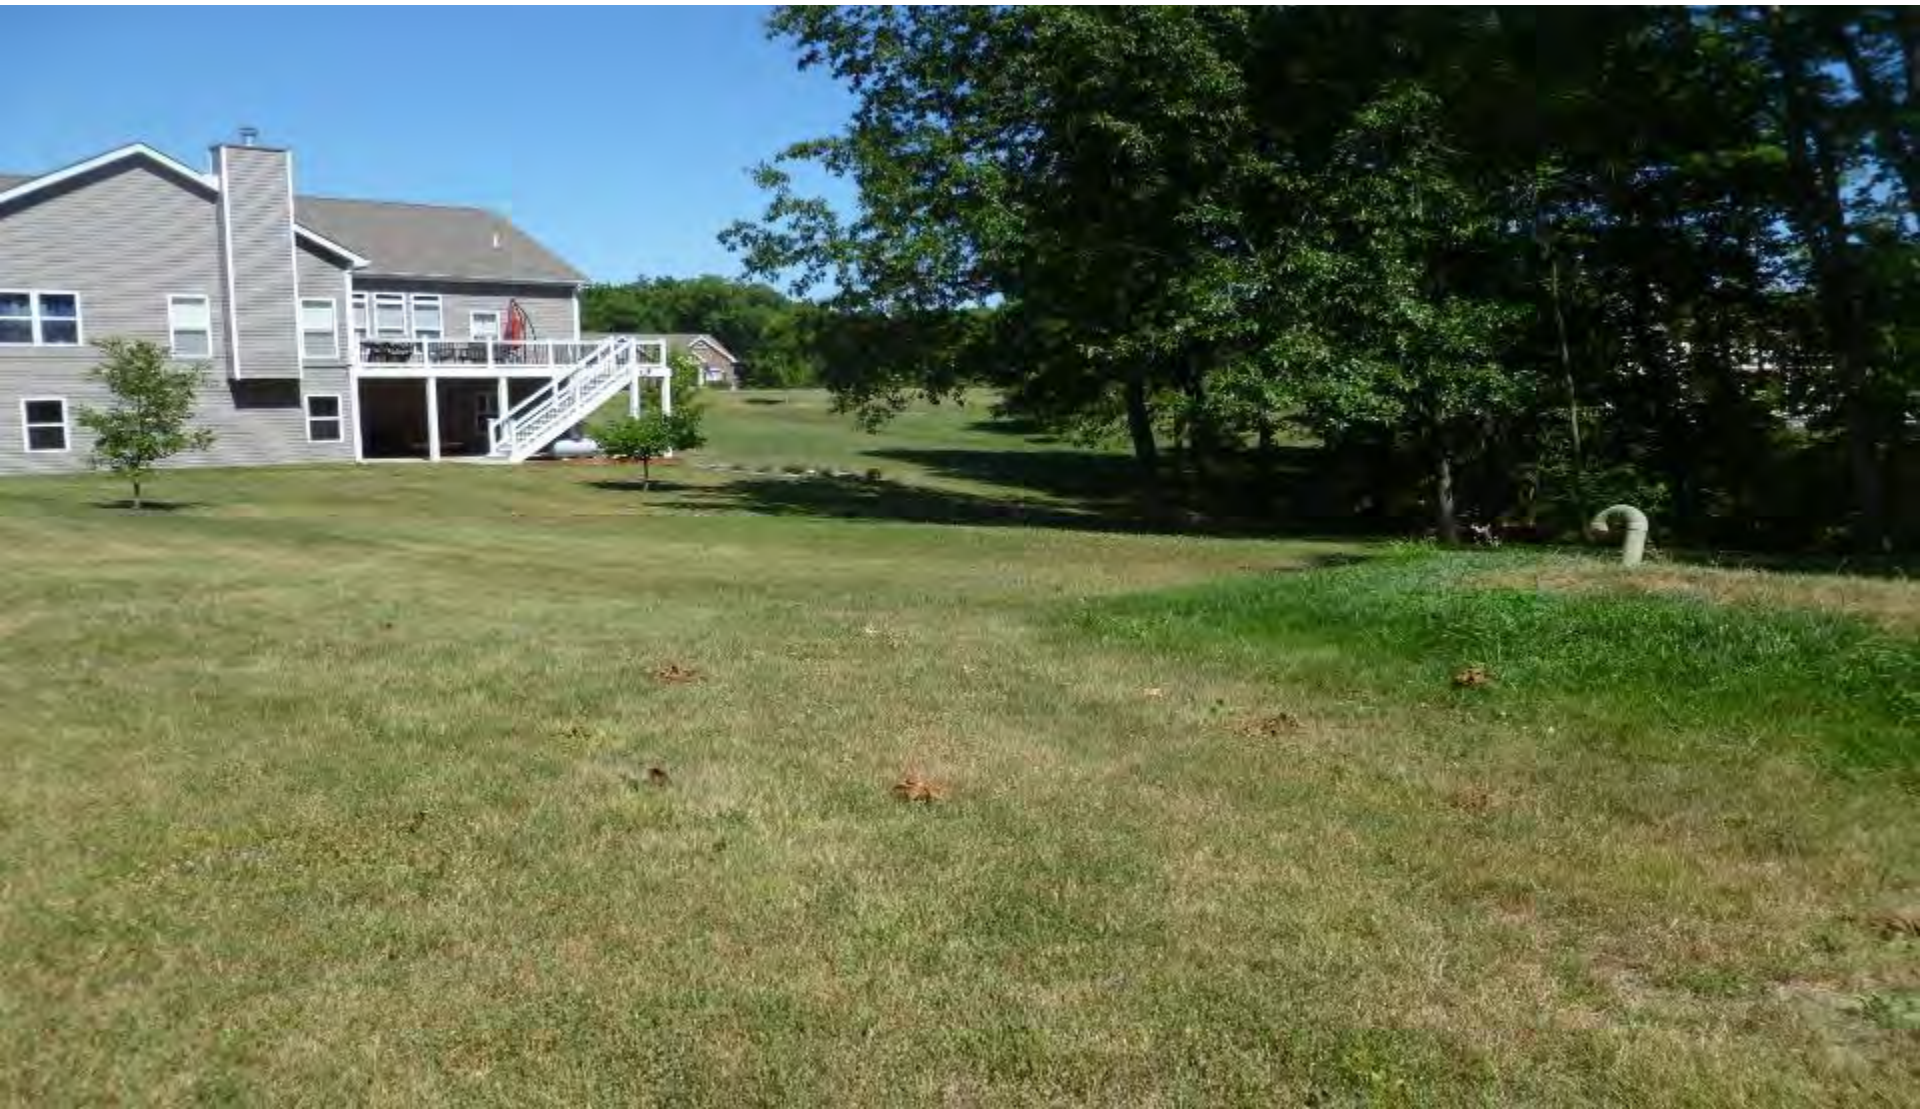
Site R28 located at 160 E. Pine Lake Drive, Troy, MO had a design soil loading rate of 0.20 gpd/sqft and 150 linear feet of AES (3 lines of 50 ft of product) (Table 1). Photos of this site and system are provided in photos R28-1 through R28-3 (Appendix B). This system was installed in January 2017. Repairs to this system were performed in October 2019 by Infiltrator utilizing AES installation protocols and specified soil material to cover exposed system sand on the downslope side of the AES technology. Repairs were undertaken to complete the installation, which had been left unfinished relative to the AES manufacturer's installation instructions, to place soil backfill over exposed system sand. The summary of the current field evaluation observed no surfacing effluent over any part of the system nor evidence of past surfacing. There was no surfacing of sewage with pressure of footwear. No straight pipe discharges were found and no visible signs of malfunction were observed (Table 1 and Appendix A, Table R28). There was no effluent odor within 10 feet of the system. Good vegetative cover was observed, with the vegetation on the crown of structure being dormant. This site could use a surface diversion to stop the intrusion of run-on water from higher elevations. The homeowner was available to be interviewed. He was dissatisfied with the original system installer, who did not answer calls

relative to the past breakout and trouble with the pump. These issues occurred prior to the 2019 repair work that completed the installation requirements (Appendix A, Table R28).

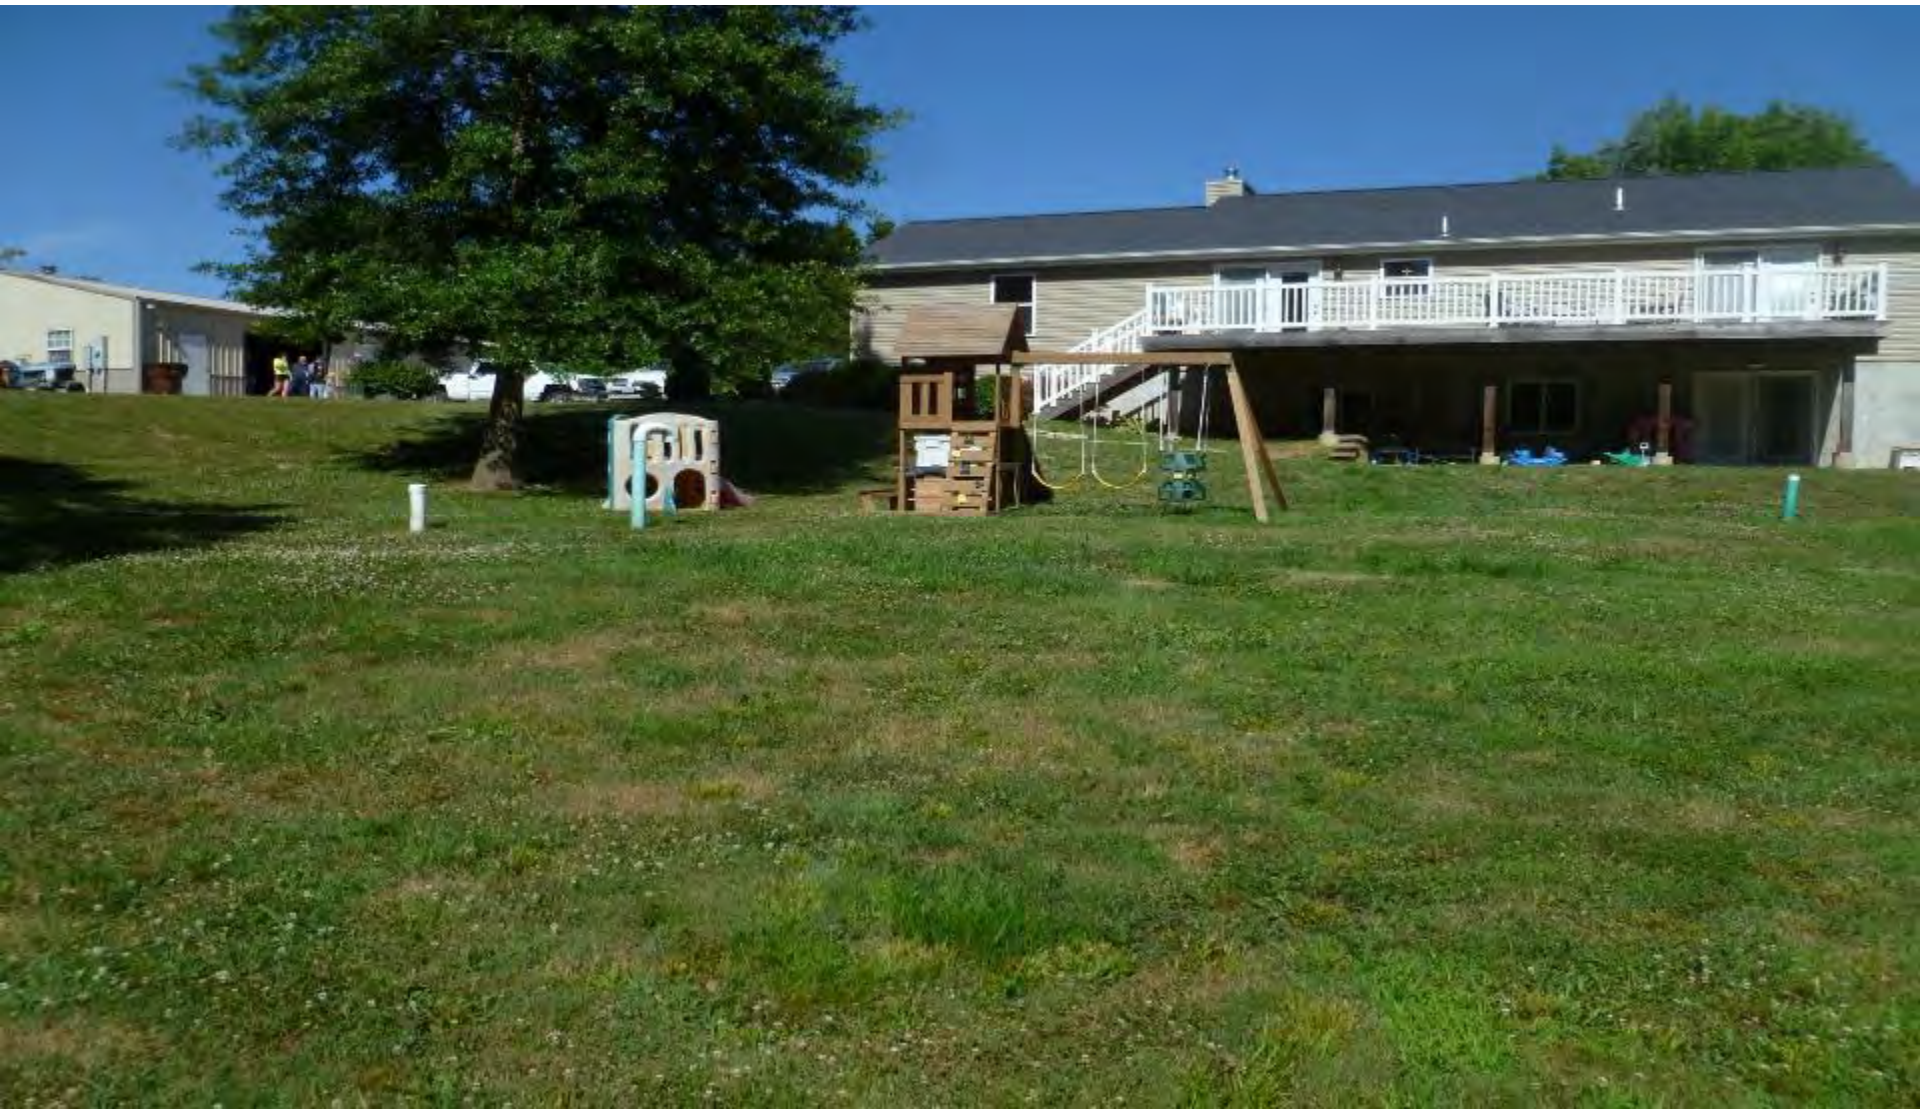
# Photo R29-2. AES Technology and Playground Equipment Moscow Mills, MO

Site R29 located at 1565 Rahmier Road, Moscow Mills, MO had a design soil loading rate of 0.30 gpd/sqft and 162 linear feet of AES (2 lines of 81 ft of product) (Table 1). Photos of this site and system are provided in photos R29-1 through R29-3 (Appendix B). This system was installed in September 2016. The summary of the field evaluation observed no current surfacing effluent over any part of the system, nor evidence of past surfacing. There was no surfacing of sewage with pressure of footwear. No straight pipe discharges were found and no visible signs of malfunction were observed (Table 1 and Appendix A, Table R29). There was no indication of effluent breakout and no striping of vegetation. Some effluent odor that had a slight fats, oil, and grease (FOG)-like smell was evident in the observation port. A surface diversion could be placed above the system to divert surface run-on away from the AES technology, as well as moving the playground equipment off of the crown to prevent compaction (Photo 29-1). The homeowner was available to be interviewed and expressed no problems with the system (Appendix A, Table R29).
