COMPLEX CULVERT REPAIR

Pipe withstands weight of railroad & threat of contamination

By Steve Cooper

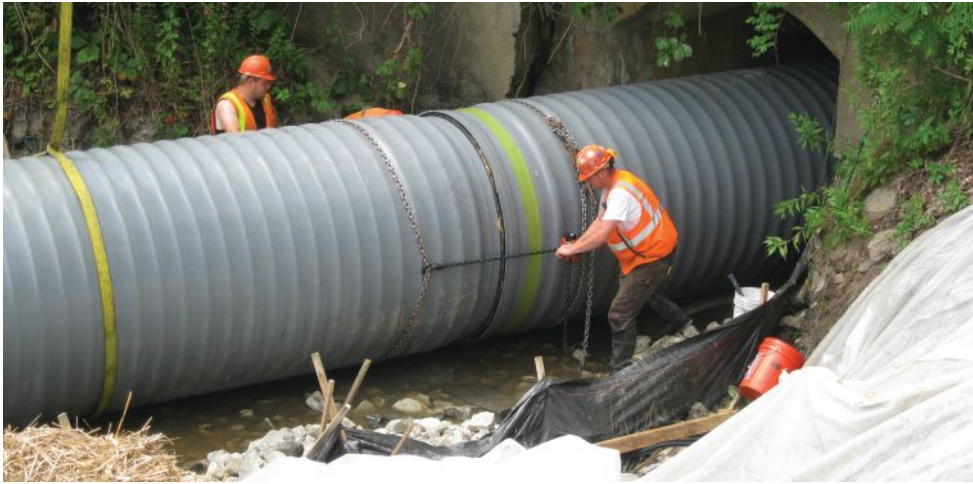
A contractor assembles the field joint with ratchet straps.

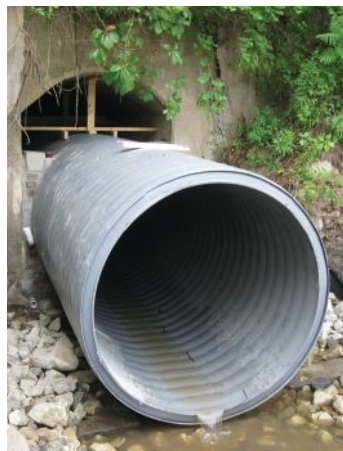
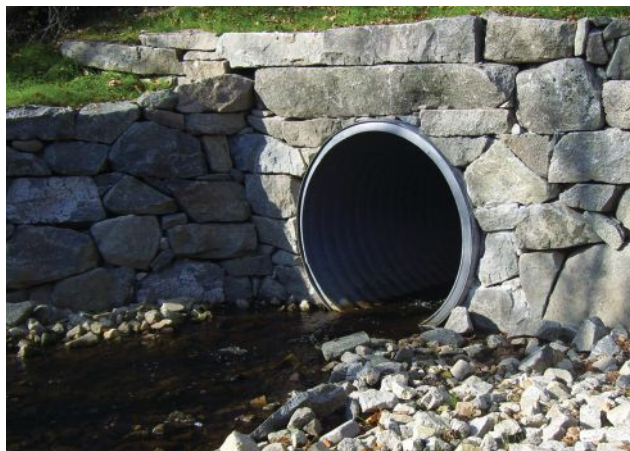
“The old concrete headwall also had some real structural issues. It had a very large crack and a large portion was tipping forward. In addition, the slope above the headwall [was] steeper than 1:1,” Cedarholm said. “So the SaniTite HP pipe actually stuck out beyond the old pipe by about 10 ft, which allowed us to build the new headwall in front of the old one,”

The final headwall and the 60-in.-diameter pipe blend in with the surrounding area.

Compacted fill between the two headwalls supports the slope as well as the failing

headwall. Installation was completed without disturbing potentially contaminated soils or stable vegetation in the area above the old headwall. The headwall’s stonework blends in with the existing landscape.
