Short-Run Pipe, Long-Term Results

High-density polyethylene (HDPE) pipe installation serves a coal mining flood zone more than 25 years later

By Stephen C. Cooper

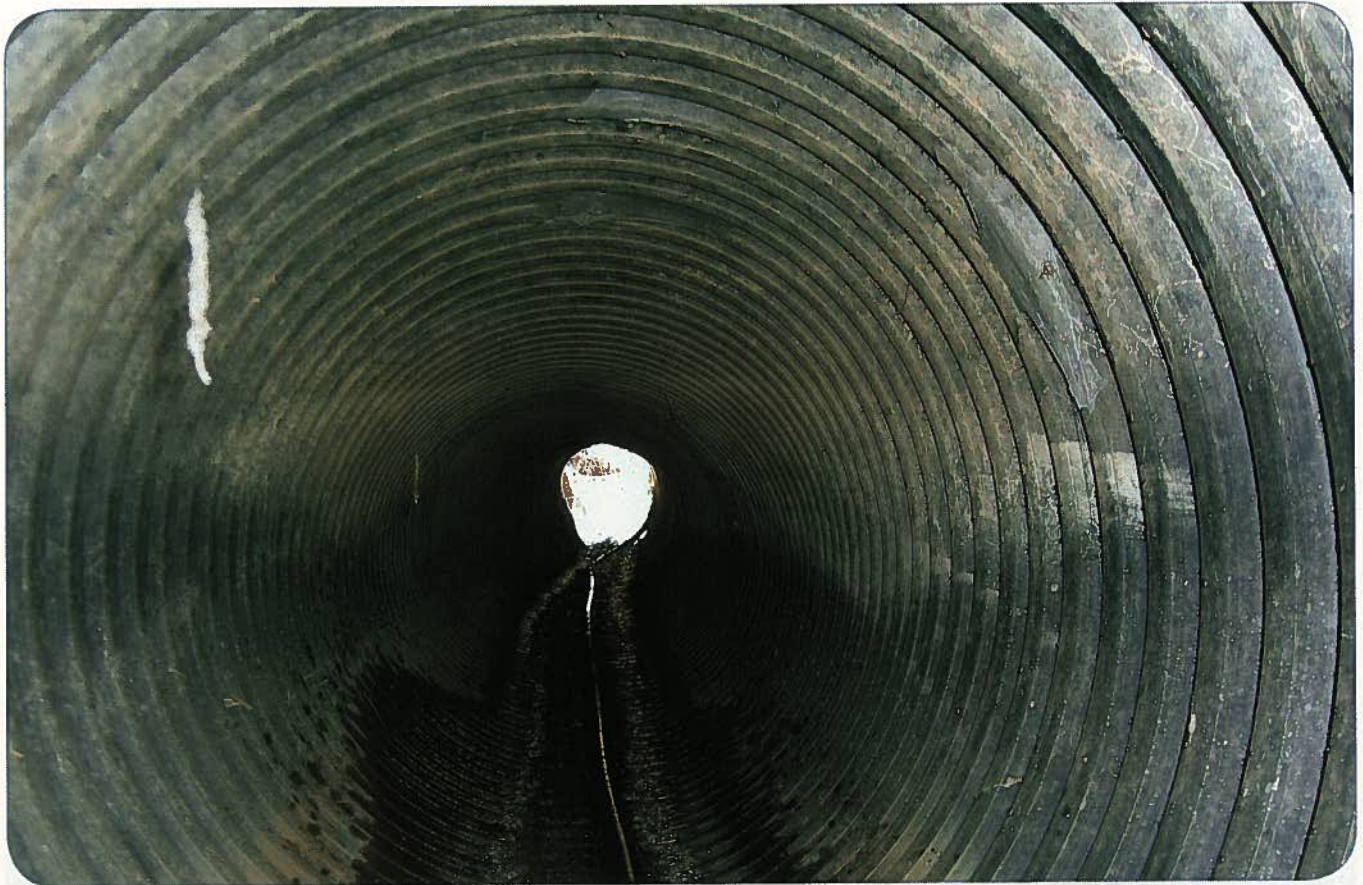
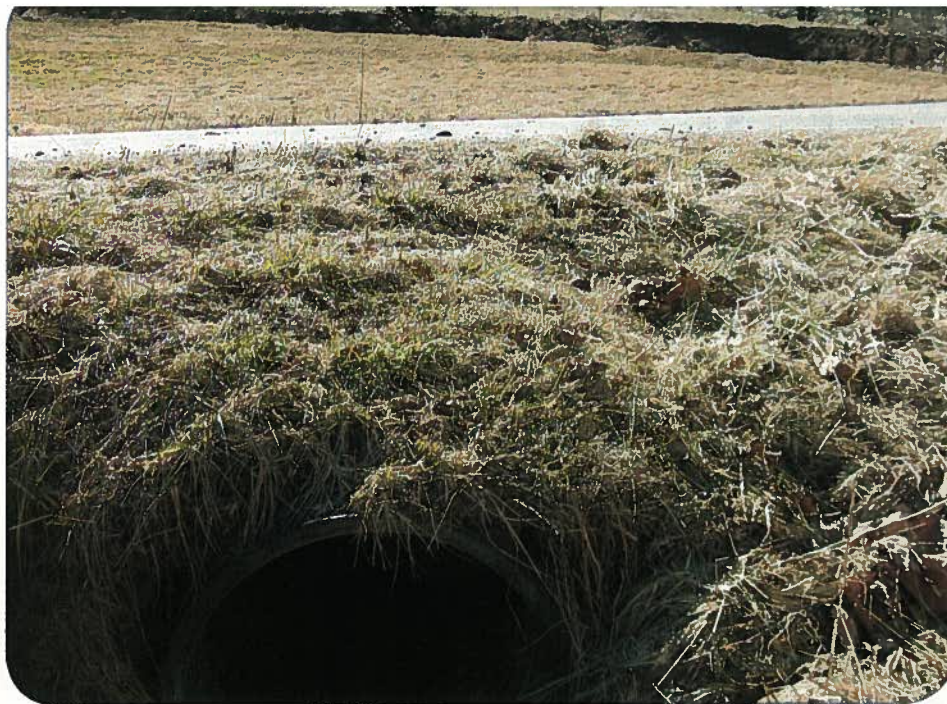
The HDPE pipe runs under Rte. 145 and collects acidic runoff from abandoned strip mines.
