Underground Obstacles

Pipe Rehabilitation

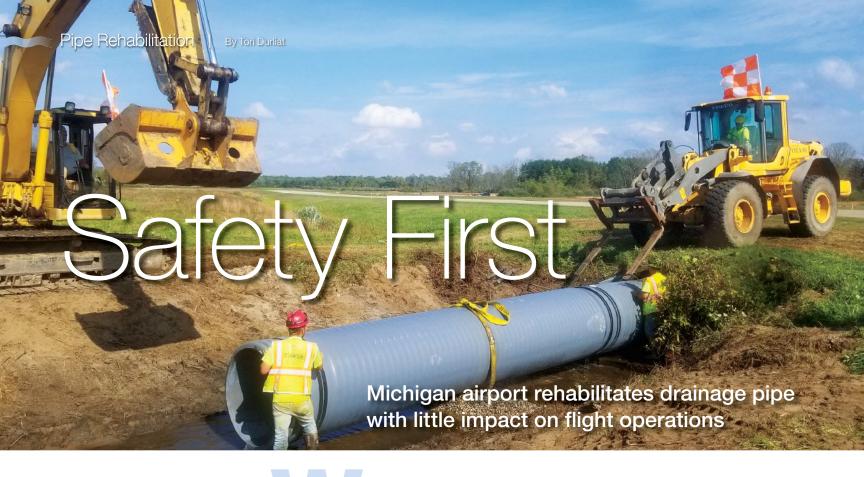
Above: A 300-ft pipeline was installed below the South **Haven Regional Airport's** main runway without impacting flight operations.
