CASE STUDY

H-20 Chambers & Orenco AX-100 Used in System for New Group Home

Boulder, CO

2,000 GPD Wastewater Treatment System

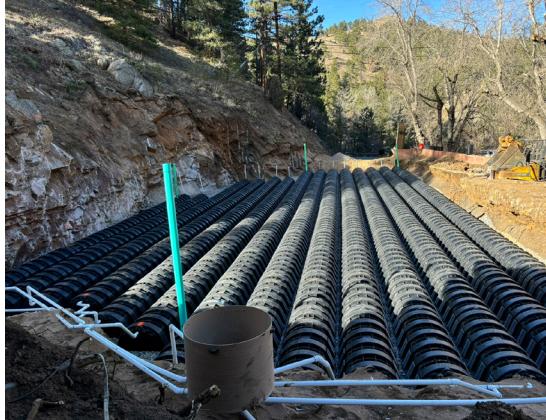
The system needed to be installed outside of the Colorado Department of Transportation (CDOT) right of way. The cost to build a road and blast the rock on top of the mountain was not feasible.

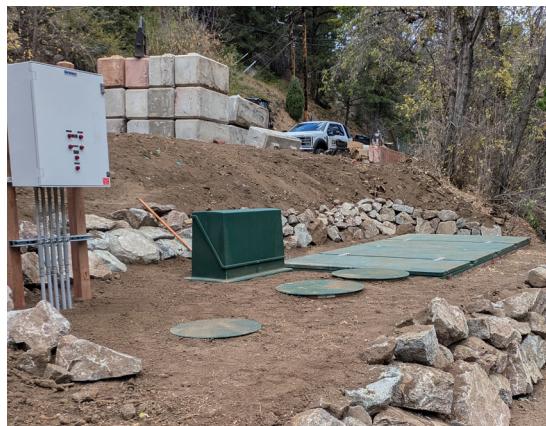
The installation included craning the septic tanks over the building to avoid shutting down the busy road. There was limited area for the tanks to be installed outside of the CDOT right of way. Access to import sand to the area was affected by the busy road and entrance on a curve. Due to limited access, CWS Excavating had to first install the water cistern tanks before the soil treatment area.
