WATER & WASTES DIGEST

a concrete upgrade

Collapse of sewer line
leads to upsize
with plastic pipe

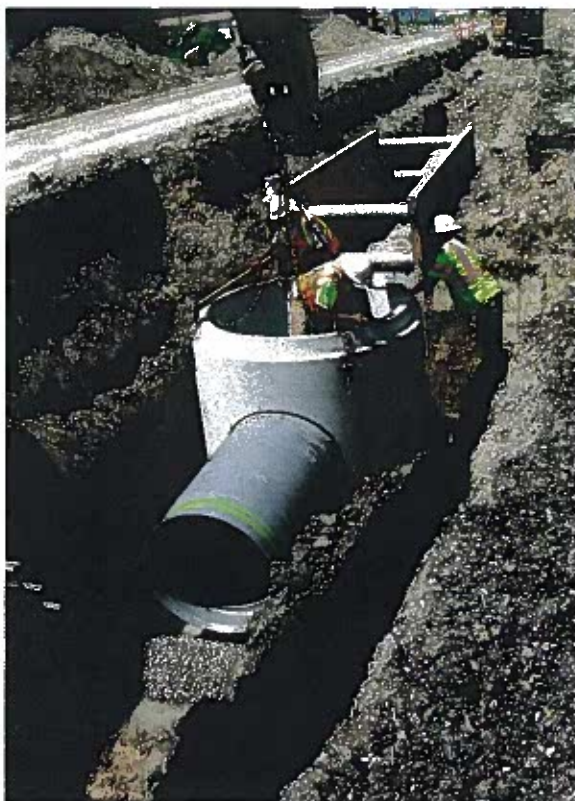
Overall project depth measured 10 to 12 ft and was completed in eight weeks.

Lateral runs were made up of 15-, 18- and 24-in. pipe. Burial depth of 36-in.-diameter pipe ranged from 9 to 12 ft, while the 48-in. pipe's burial depth ranged from 11 to 13 ft. Overall project depth measured 10 to 12 ft. Construction commenced in July and took eight weeks.

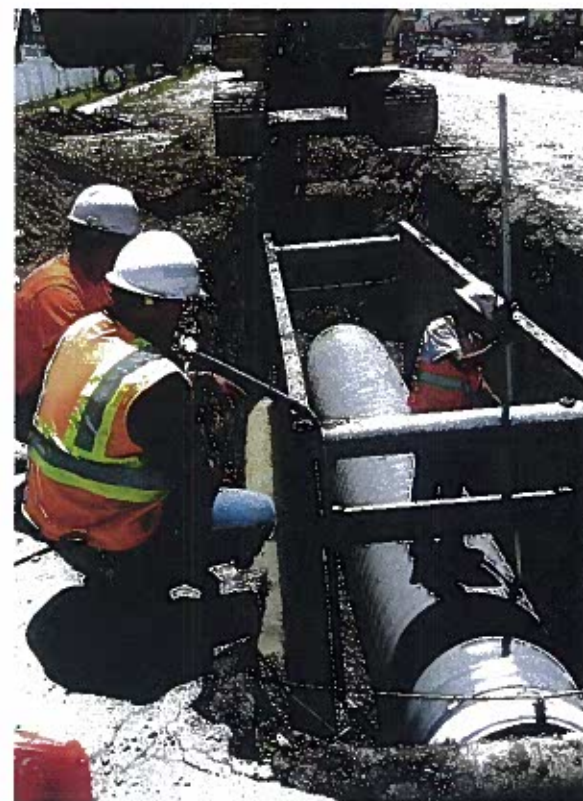
The existing 18-in. trunk line was upgraded to 36-in. pipe, and the existing 36-in. line to 48-in. pipe to accommodate the city's build-out projections.

"We upsized the existing 18-in. trunk line to 36 in. and upsized the existing 36-in. line to 48 in.,"

Lindhardt said. "We knew that if we used the same size pipe it would have capacity issues, not immediately, but in the future. Additionally, because it's a state highway, we upsized the pipe to meet the ultimate build-out projections of the city. This way it shouldn't have capacity issues in the future. The planned peak flow rate is about 5,100 gal per minute [gpm] in the 36-in. pipe and approximately 10,000 gpm in the 48-in. pipe portion."

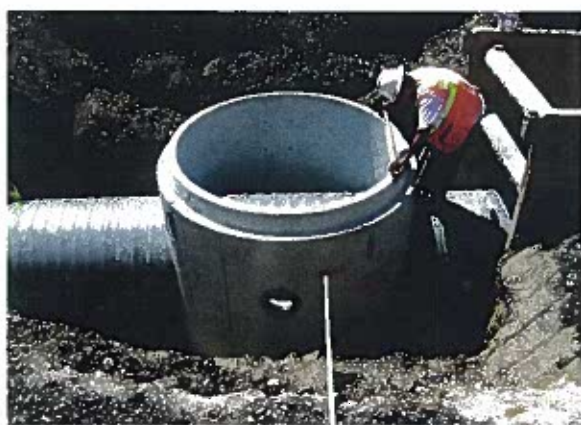
Polypropylene is highly resistant to the hydrogen sulfide gas found in sewers.

Manufactured in 30- to 60-in. diameters, the pipe is available in triple-wall construction that provides a smooth interior- and exterior-wall design supported by a corrugated structural core for improved stiffness and greater beam strength to minimize deflection and enhance long-term performance. It meets the ASTM F2764 regulation and exceeds the requirements of ASTM D3212 for water tightness with dual gaskets and banded reinforced bell. Rugged and lightweight, the pipe is easily handled with minimal equipment and crew. Its long "stick" length reduces the number of joints, which also saves time and labor and makes for a more secure system versus the several ton weight of each short section of comparable reinforced concrete pipe.
