CASE STUDY

Infiltrator Products Used in Residential System Installation on Remote Island

Farm Island, MN

Residential Wastewater Treatment System

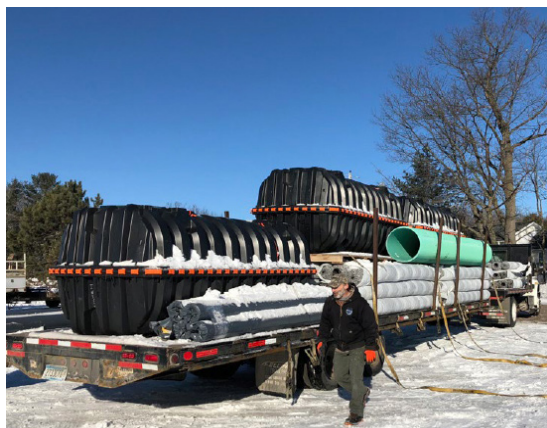
Equipment and supplies were driven across the frozen lake on a trailer and technicians commuted by snowmobile. An auger was used regularly to bore holes to check the thickness and quality of the ice and ensure safety.

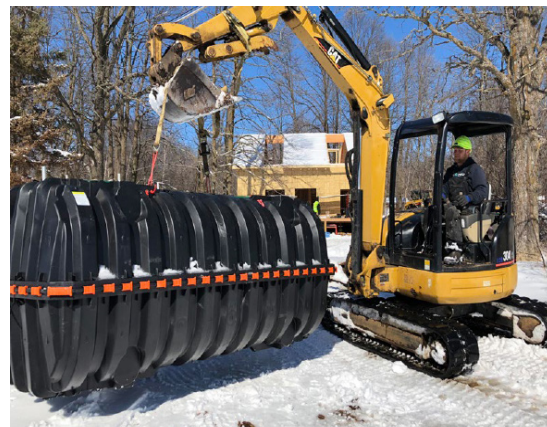
The wastewater treatment system is 250 feet from the lakeshore. Wastewater exits the house via 12 feet of PVC pipe to the first of three Infiltrator IM-1060 1,000-gallon tanks, where settling and anaerobic treatment occurs. Wastewater then flows by gravity into the second tank where a ECOPOD E50 ATU provides aerobic processing. It leaves the ECOPOD and flows by gravity through a SALCOR UV light to the last Infiltrator tank and is then pumped 65 feet through a 2-inch pipe to the absorption field. The 585-square foot absorption field uses 200 linear feet of EZflow by Infiltrator geosynthetic aggregate divided into three beds fed by a manifold of 2-inch pipe. Varying bed sizes maximized the small patch of good soil available on the one-acre lot. The system is controlled by an Infiltrator CPR52RCT15SUV control panel.
