## **Final Report**

### **Field Performance Assessment of the Advanced Enviro-Septic Wastewater Treatment and Dispersal System in Missouri, 2022**

**Dr. Randall J. Miles, Soil Scientist, Emeritus Associate Professor**

**February 7, 2023**

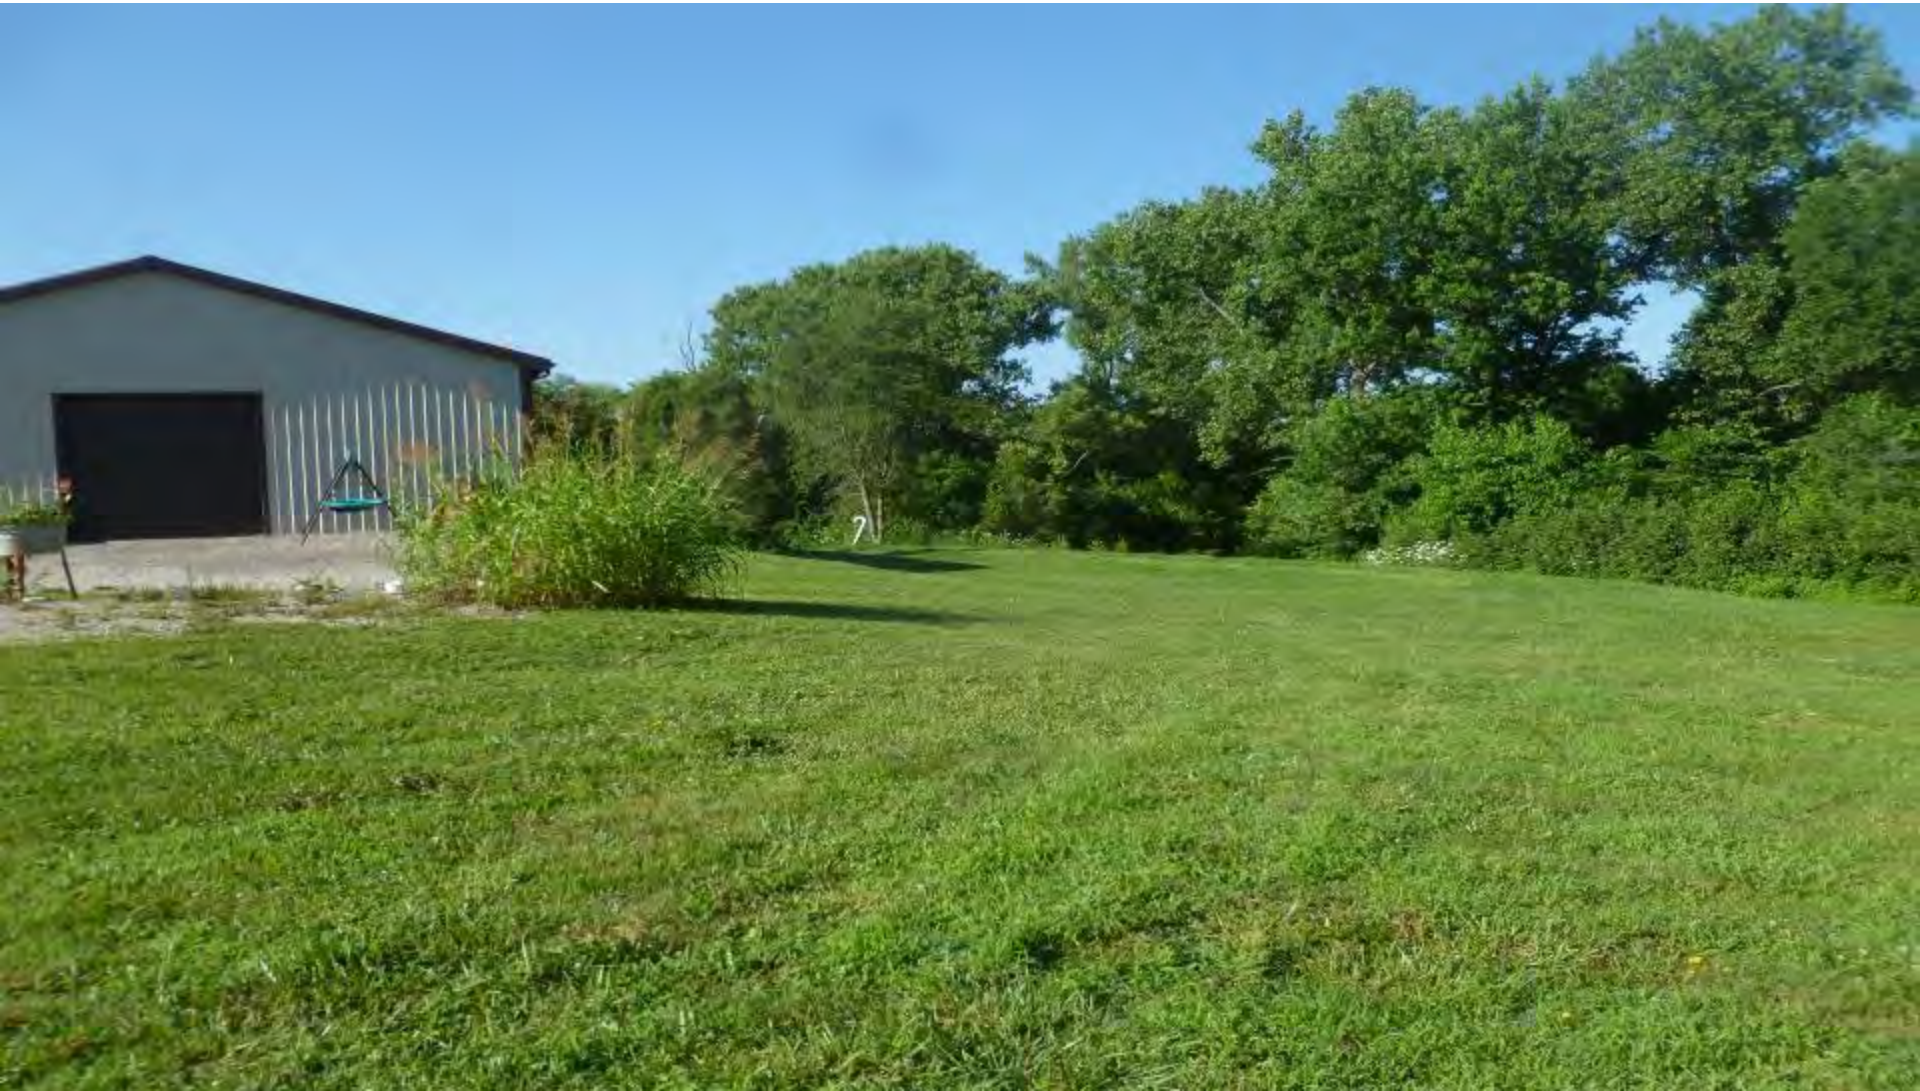
# Photo M2-1. AES Technology Kearney, MO

Site M2 located at 23810 Highway, MM, Kearney, MO had a design soil loading rate of 0.30 gpd/sqft and 150 linear feet of AES (2 lines of 75 ft of product) (Table 1). Photos of this site and system are provided in photos M2-1 and M2-2 (Appendix B). This system was installed in November 2016. The summary of the field evaluation observed no current surfacing effluent over any part of the system nor evidence of past surfacing. There was no surfacing of sewage

with pressure of footwear. No straight pipe discharges were found and no visible signs of malfunction were observed (Table 1 and Appendix A, Table M2). Additionally, thistle and milkweed were observed on the summit of the system and grass on the side slope with some clover on the foot slope. There was no effluent odor within 10 feet of the system and no seepage of effluent observed. The occupants of this home were not available for an interview.

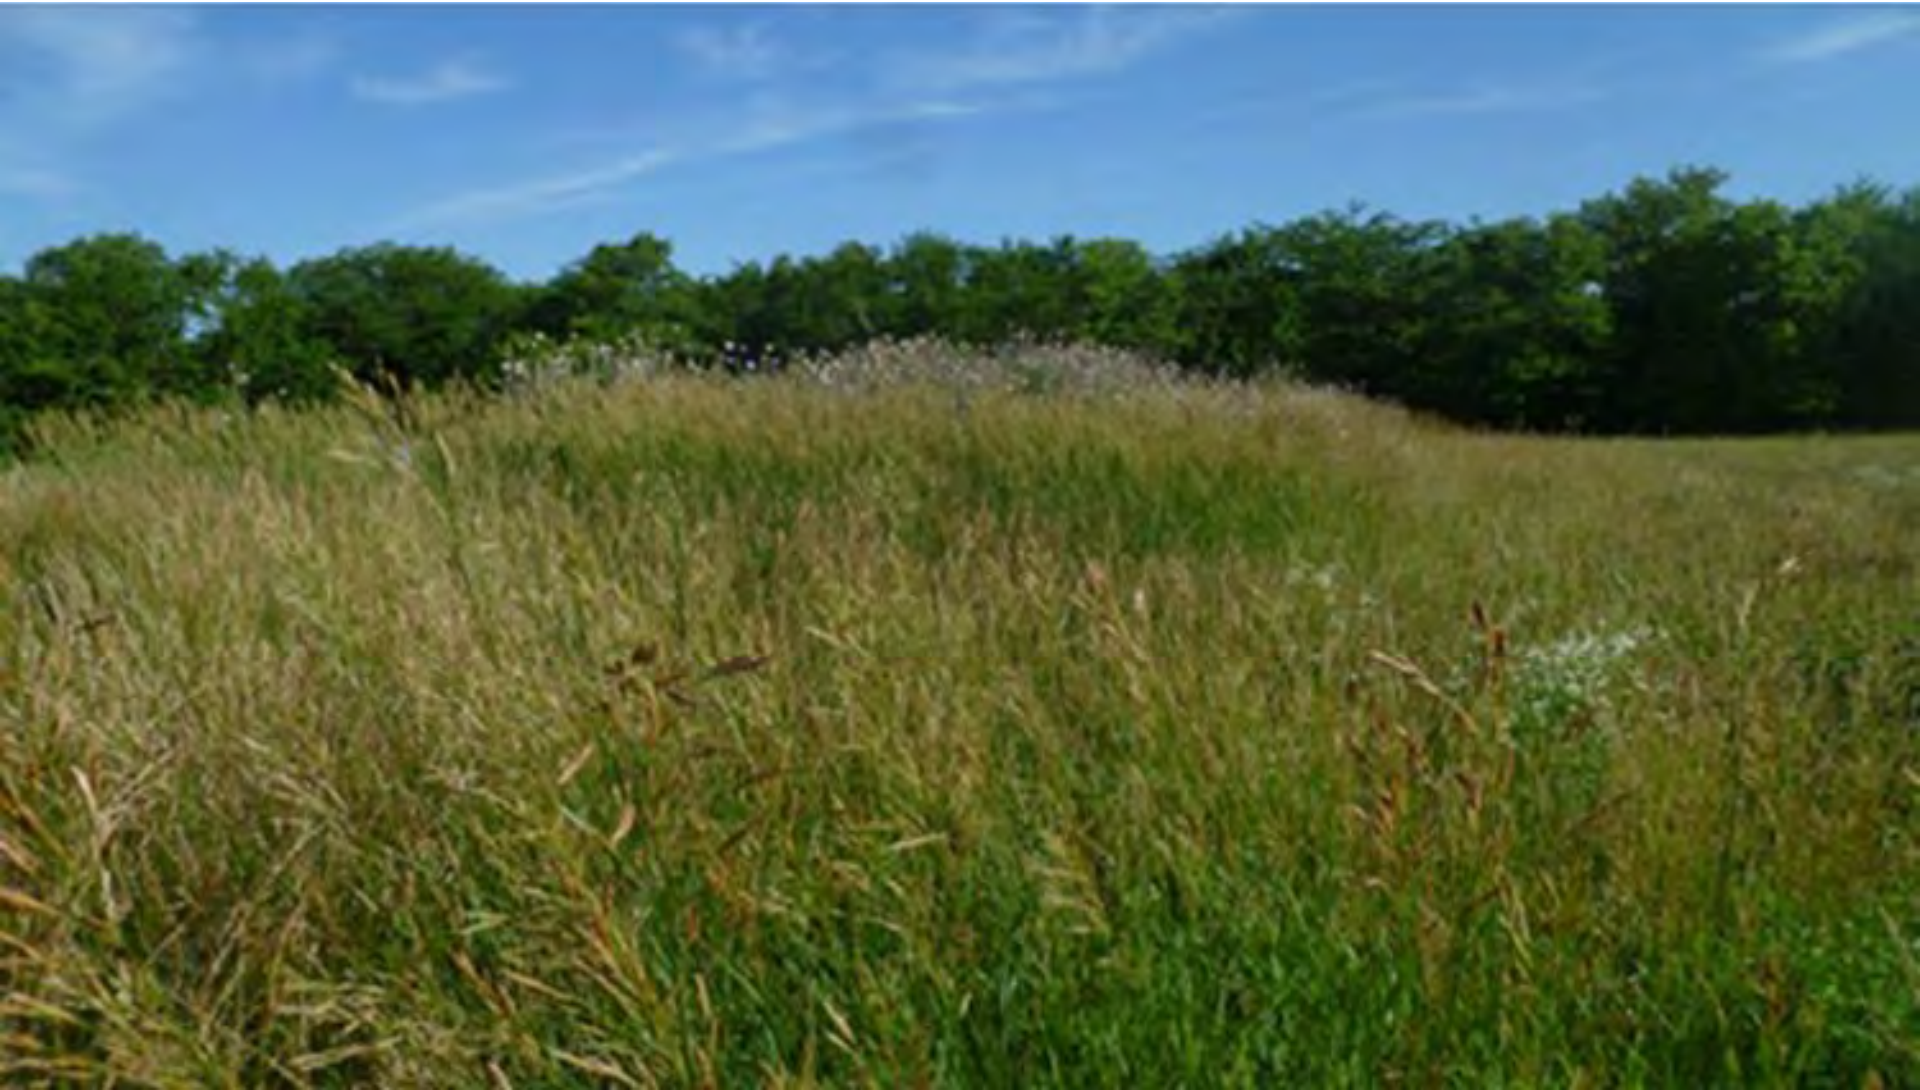
# Photo M3-1. AES Technology Lawson, MO

Site M3 located at 100 Shepherd Lane, Lawson, MO had a design soil loading rate of 0.20 gpd/sqft and 280 linear feet of AES (4 lines of 70 ft of product) (Table 1). Photos of this site and system are provided in photos M3-1 and M3-2 (Appendix B). This system was installed in August 2017. The summary of the field evaluation observed no current surfacing effluent over any part of the system nor evidence of past surfacing. There was no septic odor, and no green striping. Instead, a consistent green color was observed over the technology. Infiltrator was informed of a breakout in the northern end of the system in 2019, and in response made a site visit. It was determined that a lawn mower had created ruts from its tires on the downslope taper. Infiltrator placed cover material on the damaged areas. No evidence either of this damage or of a breakout was observed during the site inspection. No straight pipe discharges were found and no visible signs of malfunction were observed (Table 1 and Appendix A, Table M3). Additionally, the homeowner expressed that there were no problems with the onsite technology (Appendix A, Table M3).

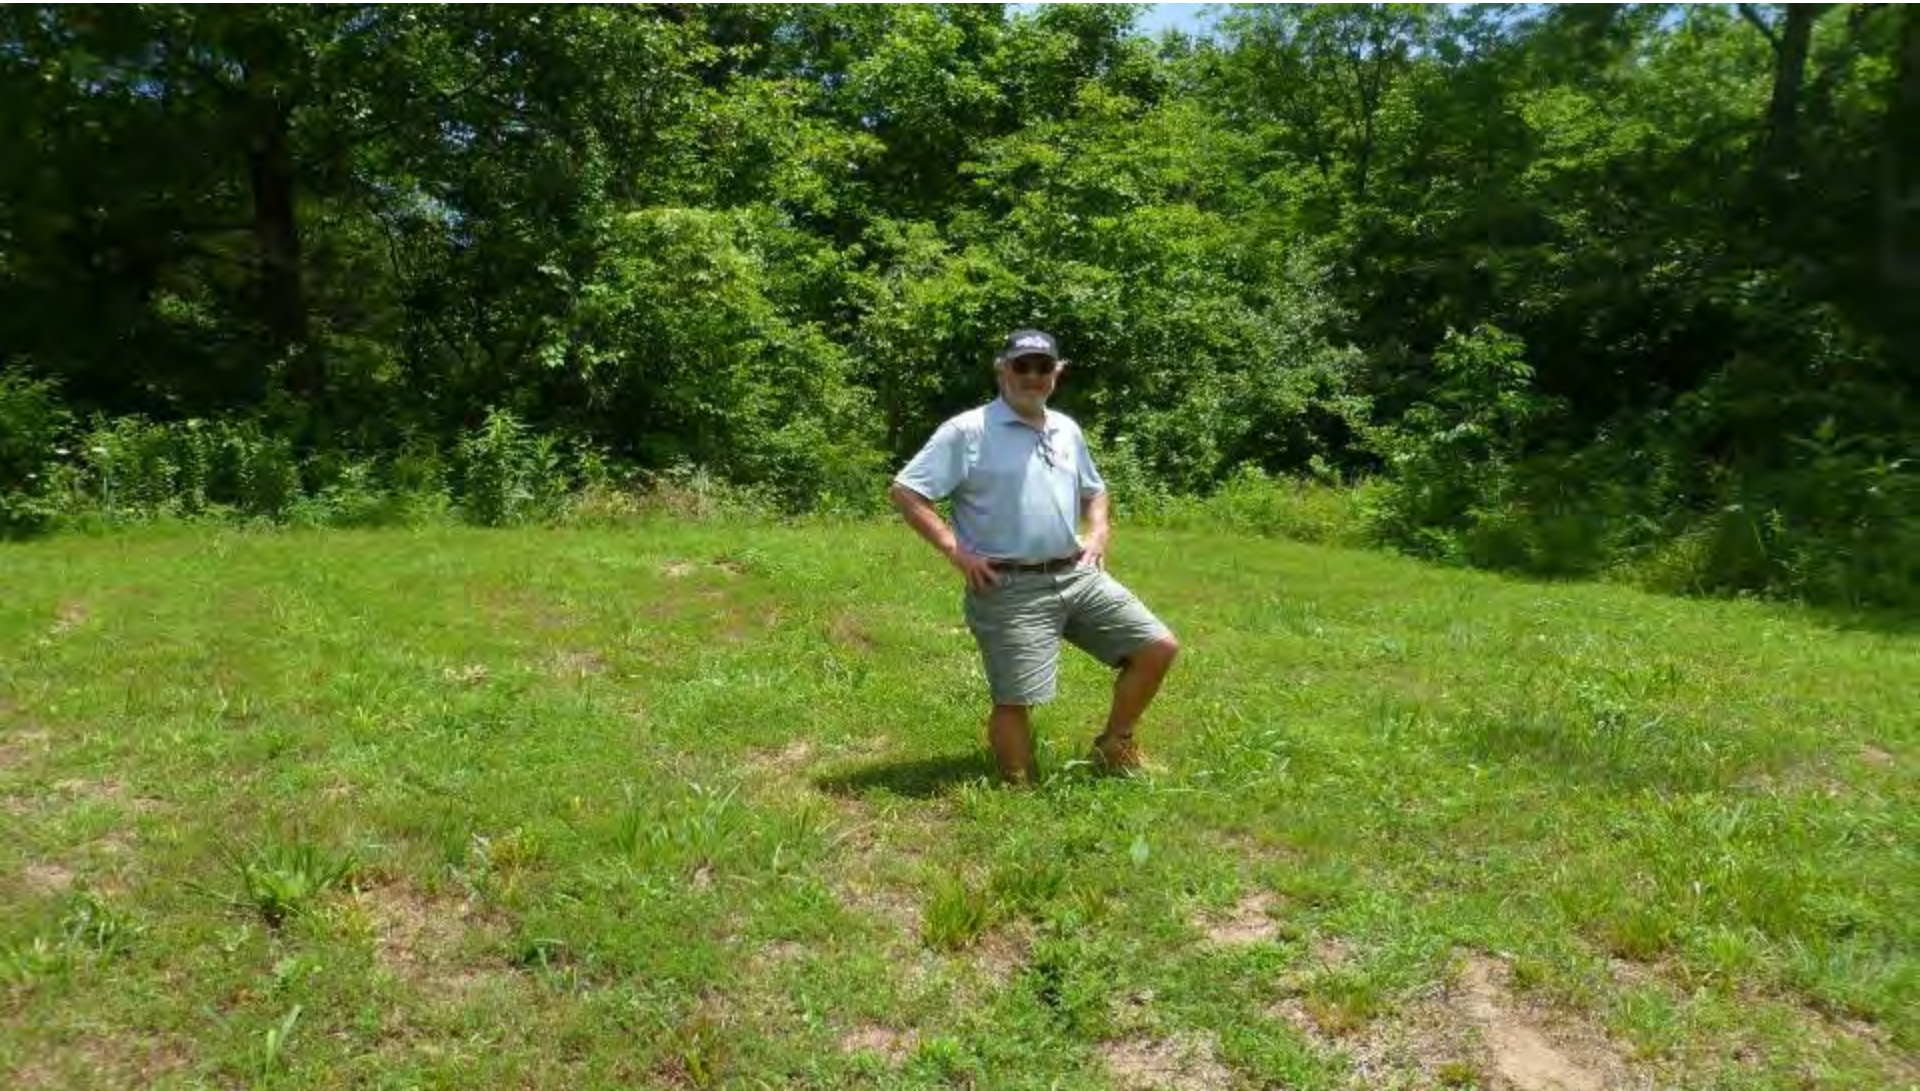
# Photo M6-3. AES Technology Liberty, MO

Site M6 located at 6851 Nebo Hills Road, Liberty, MO had a design soil loading rate of 0.30 gpd/sqft and 225 linear feet of AES (3 lines of 75 ft of product) (Table 1). Photos of this site and system are provided in photos M6-1 through M6-3 (Appendix B). This system was installed in October 2018. The summary of the field evaluation observed no current surfacing effluent over any part of the system, nor evidence of past surfacing. There was no surfacing of sewage with pressure of footwear. No straight pipe discharges were found and no visible signs of malfunction were observed (Table 1 and Appendix A, Table M6). Additionally, field observations indicated that runoff water could be intruding on the system, as there was some rill and sheet erosion (Photo M6-2). The need for consistent vegetative cover upslope to divert water off of the system was strongly suggested. The homeowners were available to interview. They expressed no problems with the system (Appendix A, Table M6).

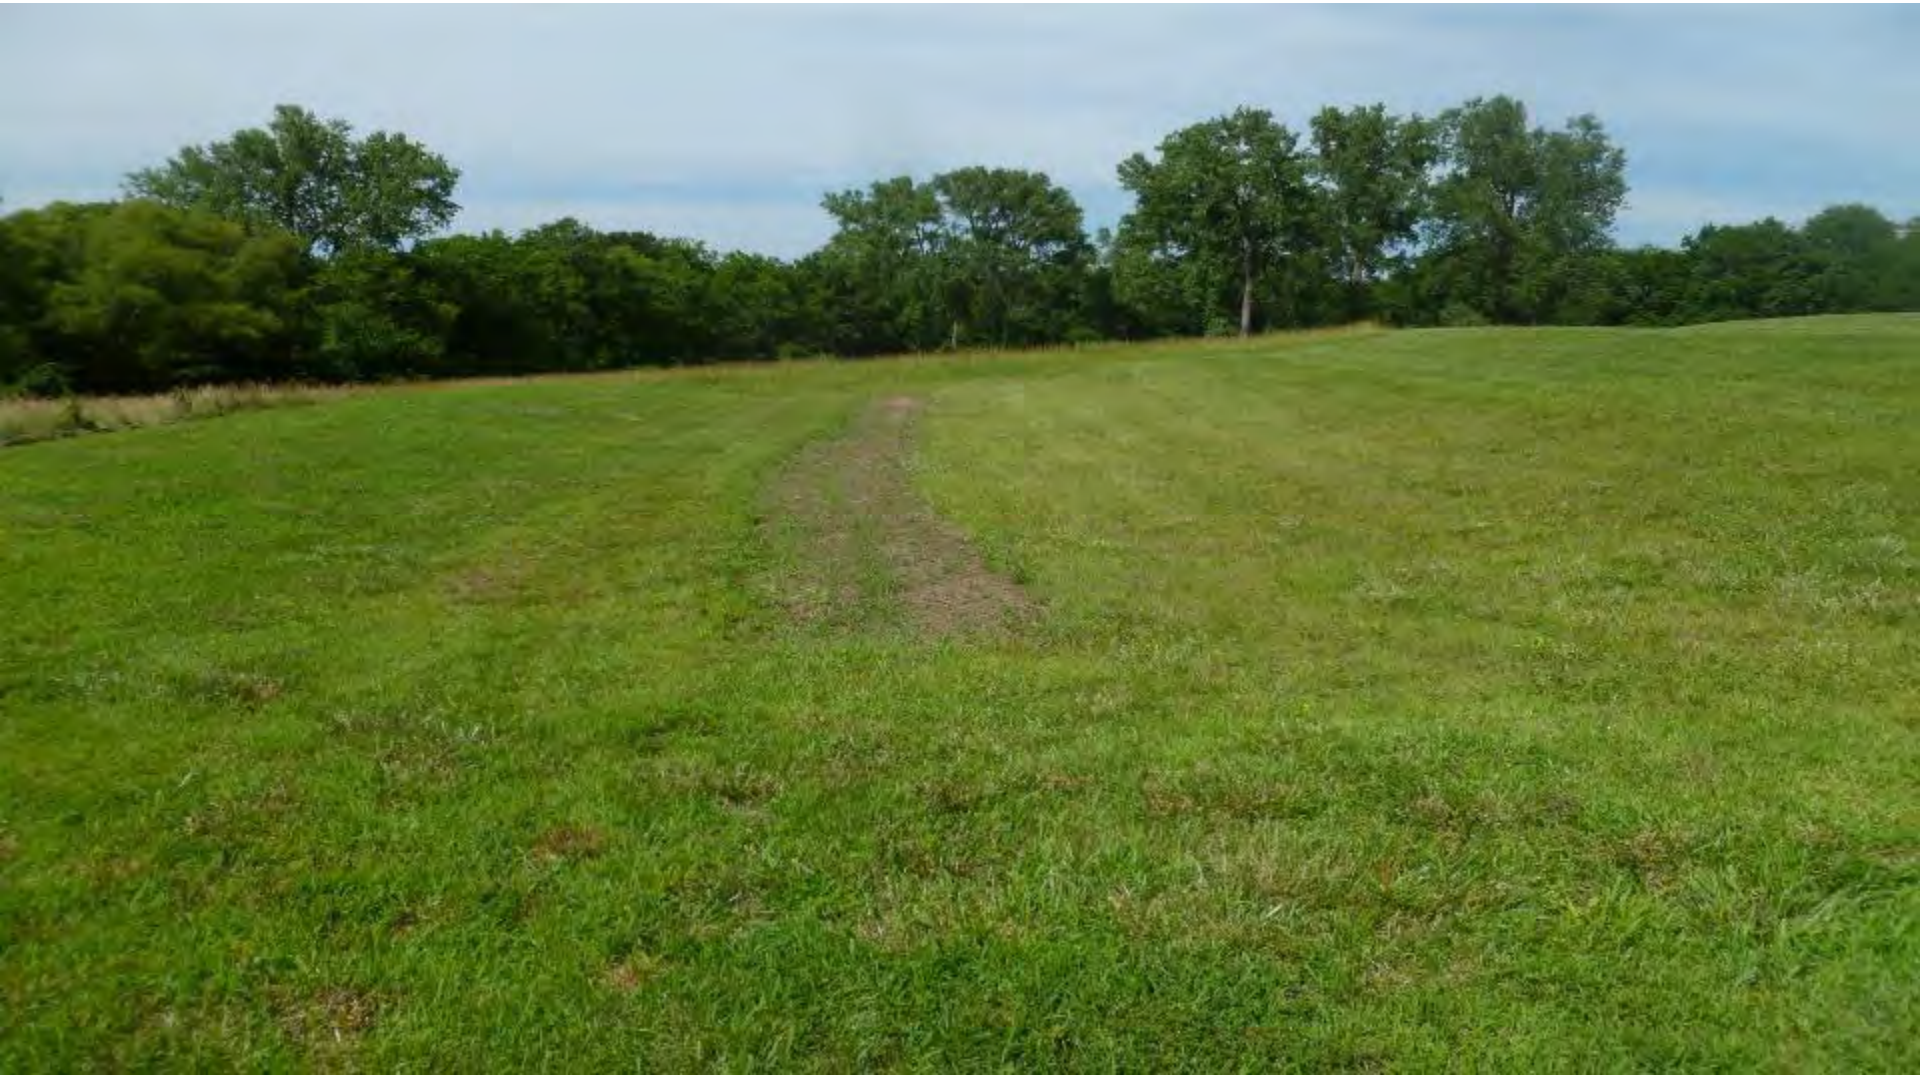
# Photo M10-3. AES Technology Gower, MO

Site M10 located at 9578 SW 247<sup>th</sup>, Gower, MO had a design soil loading rate of 0.30 gpd/sqft and 150 linear feet of AES (2 lines of 75 ft of product (Table 1). Photos of this site and system are provided in photos M10-1 through M10-3) (Appendix B). This system was installed in October 2016. The summary of the field evaluation observed no current surfacing effluent over any part of the system, nor evidence of past surfacing. There was no surfacing of sewage with pressure of footwear. No straight pipe discharges were found and no visible signs of malfunction were observed (Table 1 and Appendix A, Table M10). Additionally, no stripes in the vegetation or effluent odor within 10 feet of the system was noted. An agricultural terrace above the system and a tilled strip in the surface diversion were observed, neither of which were impeding the performance of the system. The homeowners were available to interview. They expressed no problems with the system (Appendix A, Table M10).

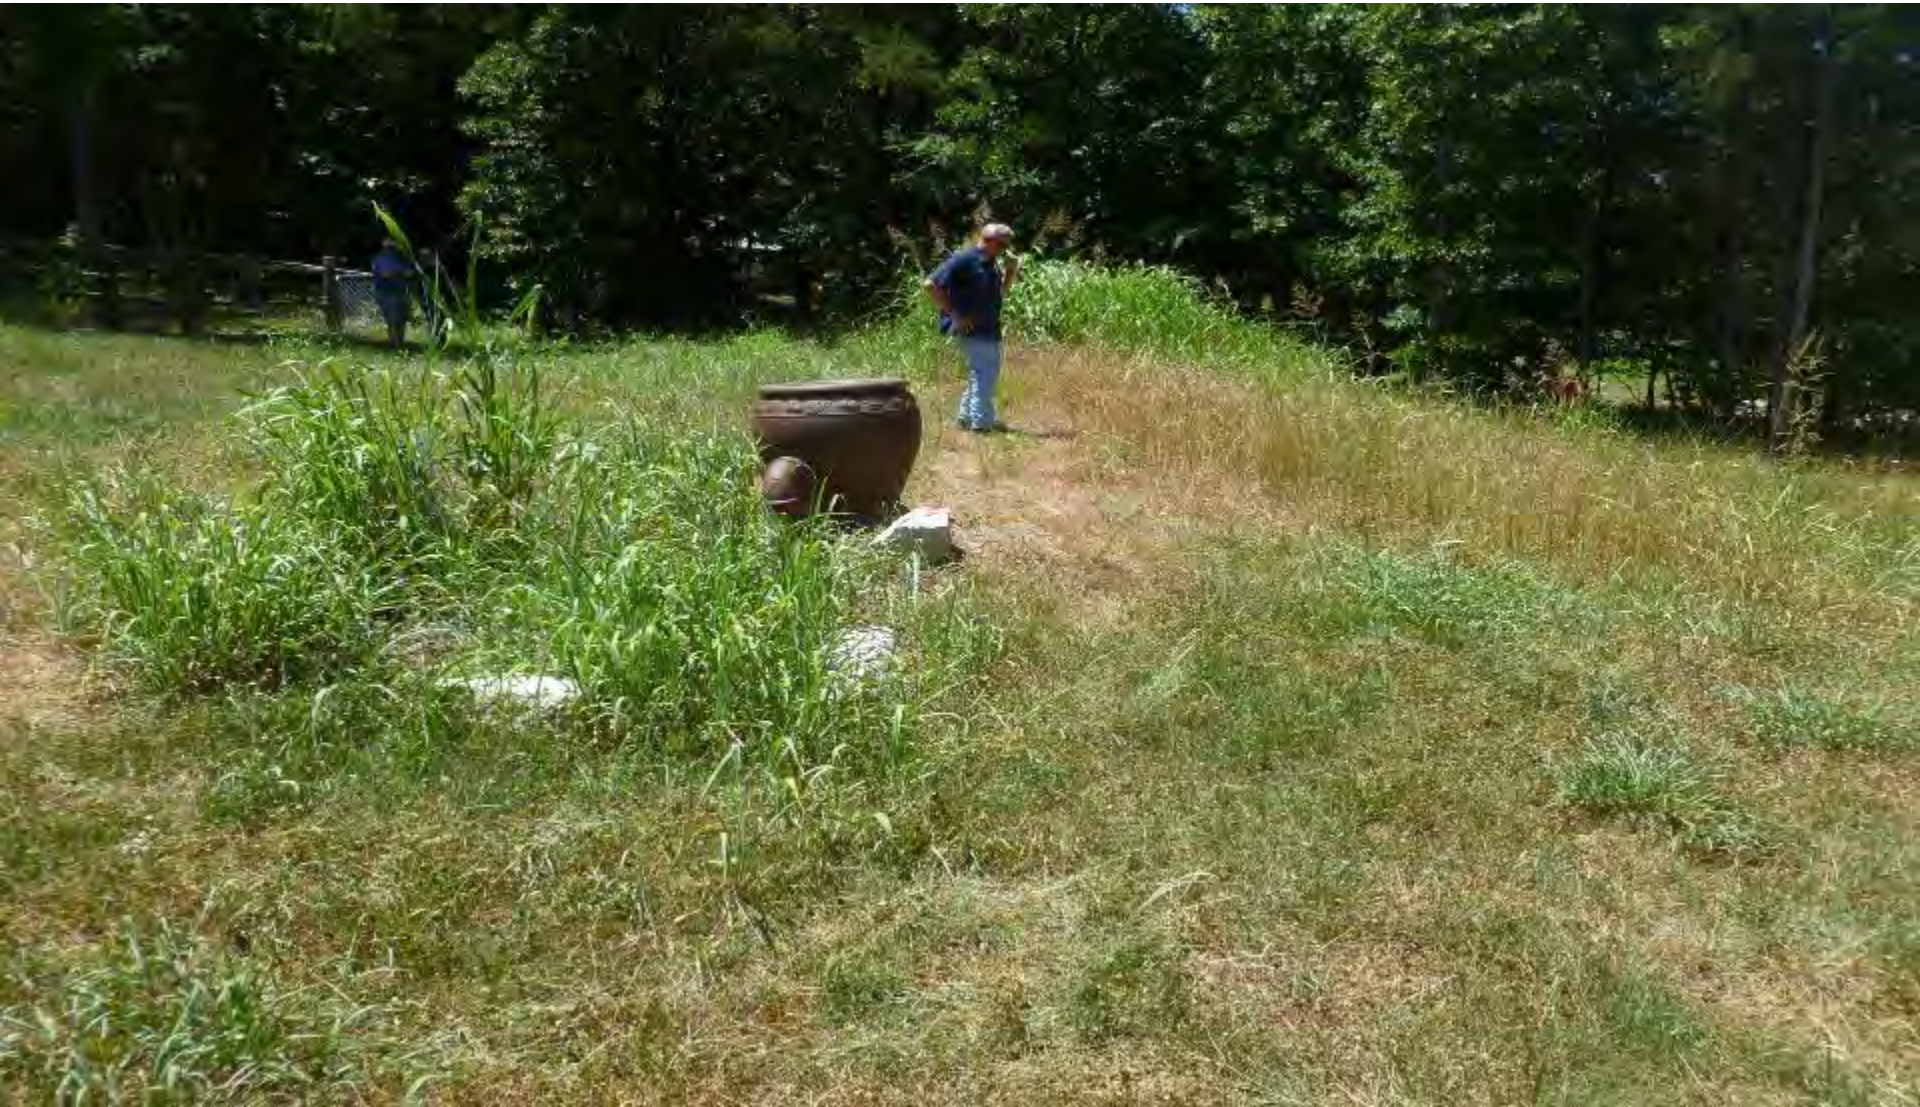
# Photo T13-2. AES Technology Branson, MO

2018. The summary of the field evaluation observed no current surfacing effluent over any part of the system, nor evidence of past surfacing. There was no surfacing of sewage with pressure of footwear. No straight pipe discharges were found and no visible signs of malfunction were observed (Table 1 and Appendix A, Table T13). There was no effluent odor within 10 feet of the system, no vegetative striping, and adequate vegetative cover. A surface diversion should be placed above the site to divert surface and roof runoff away from the system. The homeowner expressed no problems with the system (Appendix A, Table T13).

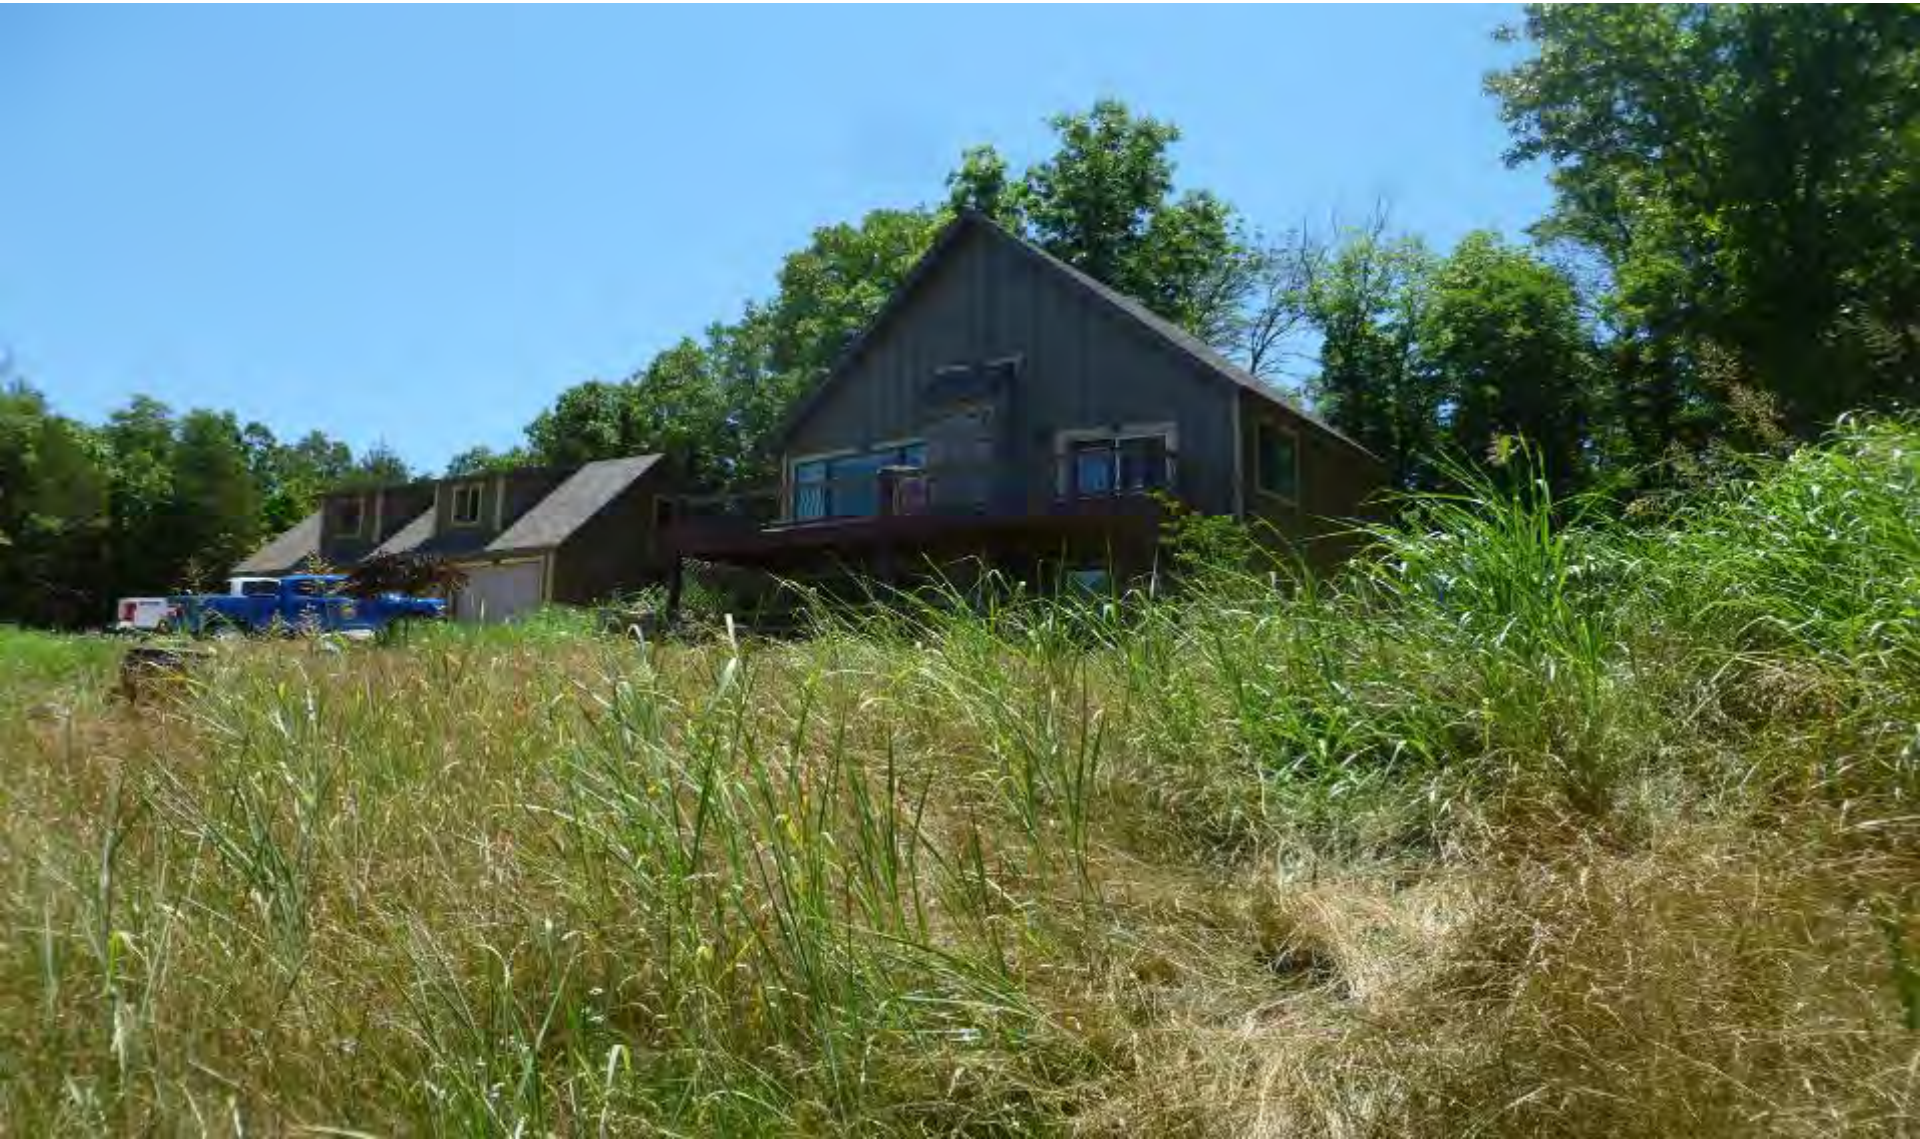
# Photo T14-1. AES Technology Walnut Shade, MO

Site T14 located at 298 Bear Creek Estates, Walnut Shade, MO had a design soil loading rate of 0.30 gpd/sqft and 195 linear feet of AES (3 lines of 65 ft of product) (Table 1). Photos of this site and system are provided in photos T14-1 through T14-3 (Appendix B). This system was installed in June 2018. The summary of the field evaluation observed no current surfacing effluent over any part of the system, nor evidence of past surfacing. There was no surfacing of sewage with pressure of footwear. No straight pipe discharges were found and no visible signs of malfunction were observed (Table 1 and Appendix A, Table T14). There was no effluent odor within 10 feet of the system and no vegetative striping. Vegetation on the system was green, compared to that above or below the system, as the system had adequate vegetative cover. A surface diversion should be placed above the site to divert surface runoff away from the site. The occupants of this home were not available for an interview (Appendix A, Table T14).

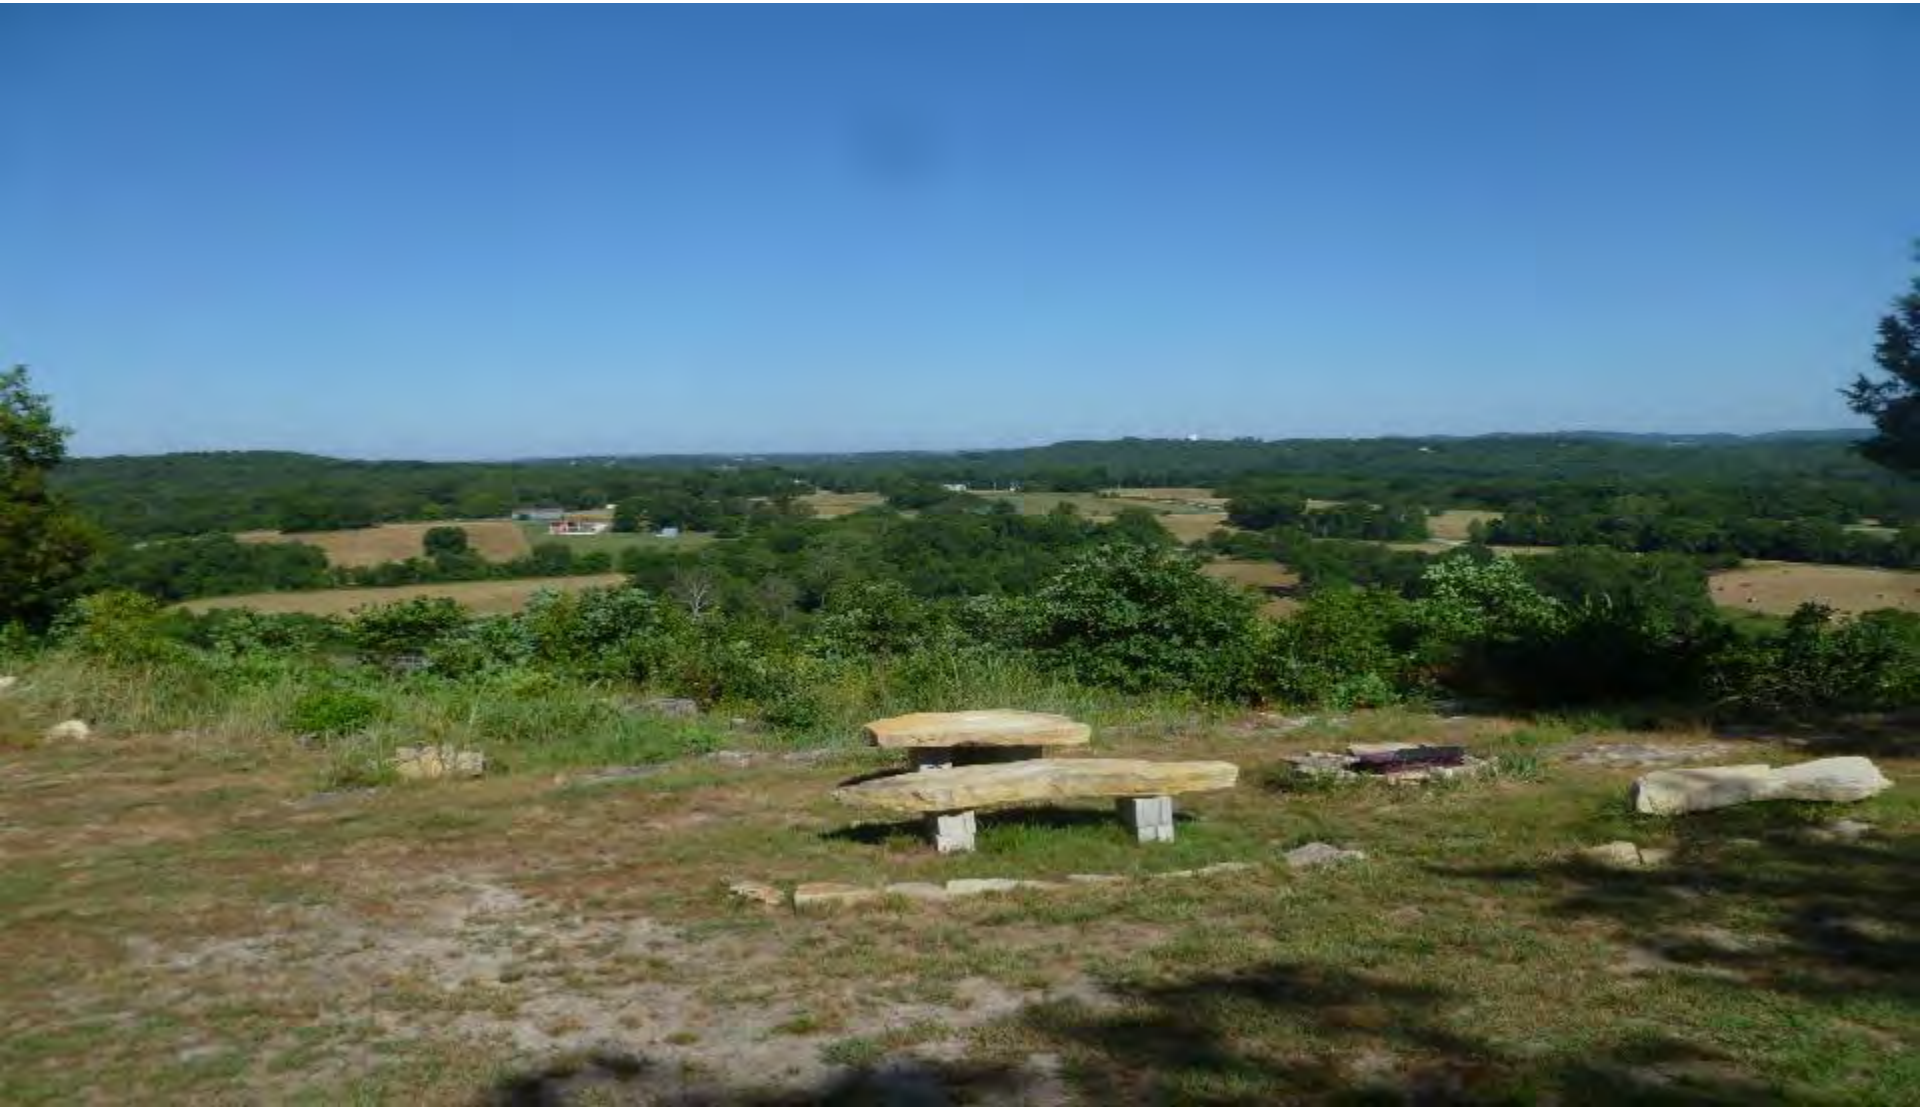
# Photo W18-1. AES Technology Kissee Mill, MO

Site W18 located at 960 Sanders Road, Kisse Mill, MO had a design soil loading rate of 0.40 gpd/sqft and 150 linear feet of AES (3 lines of 50 ft of product) (Table 1). Photos of this site and system are provided in photos W18-1 through W18-3 (Appendix B). This system was installed in December 2017. The summary of the field evaluation observed no current surfacing effluent over any part of the system, nor evidence of past surfacing. There was no surfacing of sewage with pressure of footwear. No straight pipe discharges were found and no visible signs of malfunction were observed (Table 1 and Appendix A, Table W18). There was no effluent odor within 10 feet of the system, and no vegetative striping. There was a fresh tree stump near the distal end of the system. There was some slight physical movement of soil in the northwest corner of the system from erosion that appeared to be caused by tire tracks and scalping during mowing. The occupants of this home were not available for an interview (Appendix A, Table W18).

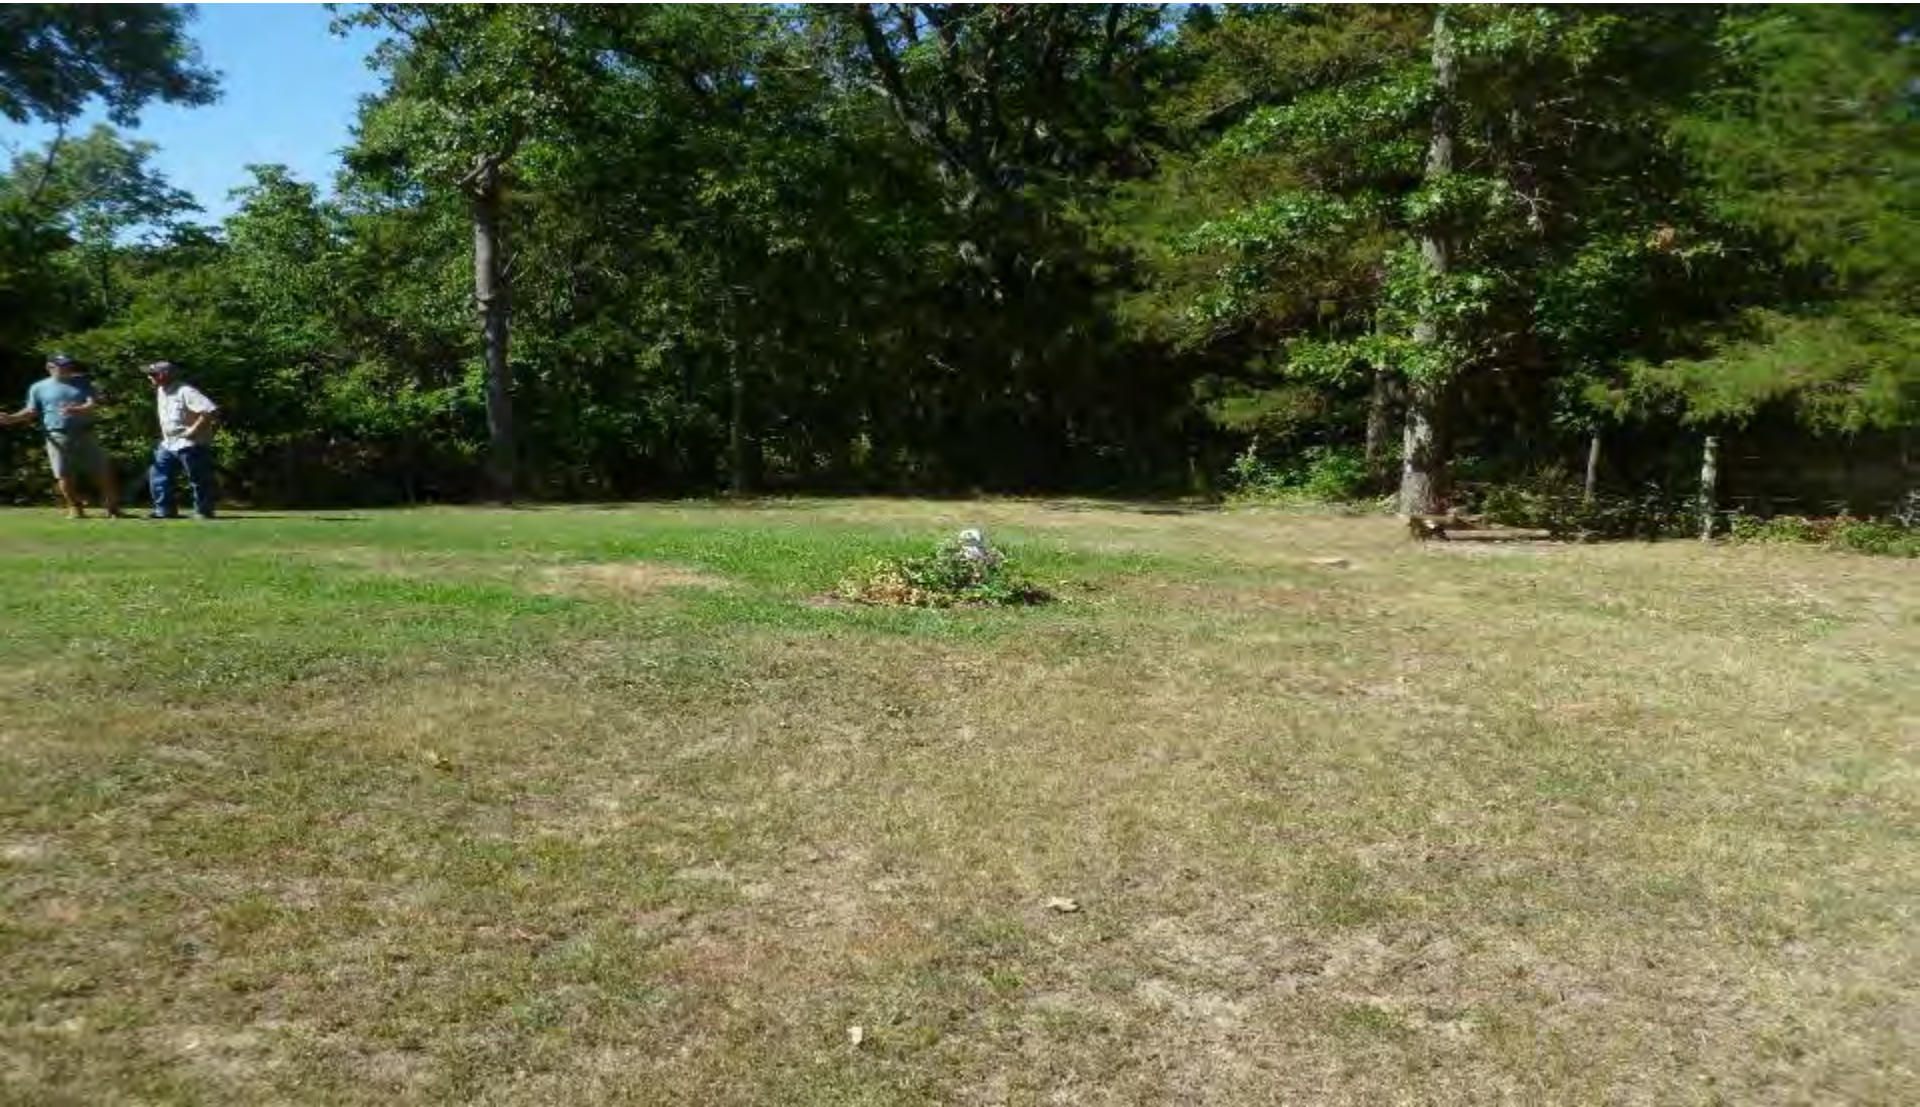
# Photo W19-1. Sewage Tanks Cedar Creek, MO

Site W19 located at 2213 Highway KK, Cedar Creek, MO had a design soil loading rate of 0.20 gpd/sqft and 100 linear feet of AES (2 lines of 50 ft of product) (Table 1). Photos of this site and system are provided in photos W19-1 through W19-4 (Appendix B). This system was installed in October 2018. The summary of the field evaluation observed no current surfacing effluent over any part of the system, nor evidence of past surfacing. There was no surfacing of sewage with pressure of footwear. No straight pipe discharges were found and no visible signs of malfunction were observed (Table 1 and Appendix A, Table W19). The system was sufficiently vegetated and there was no effluent odor within 10 feet of the system and no outbreaks of sewage. The septic tank lid was at the soil surface and there was no cap on the outlet to the tank. The homeowner was available to be interviewed and expressed no problems with the system (Appendix A, Table W19).

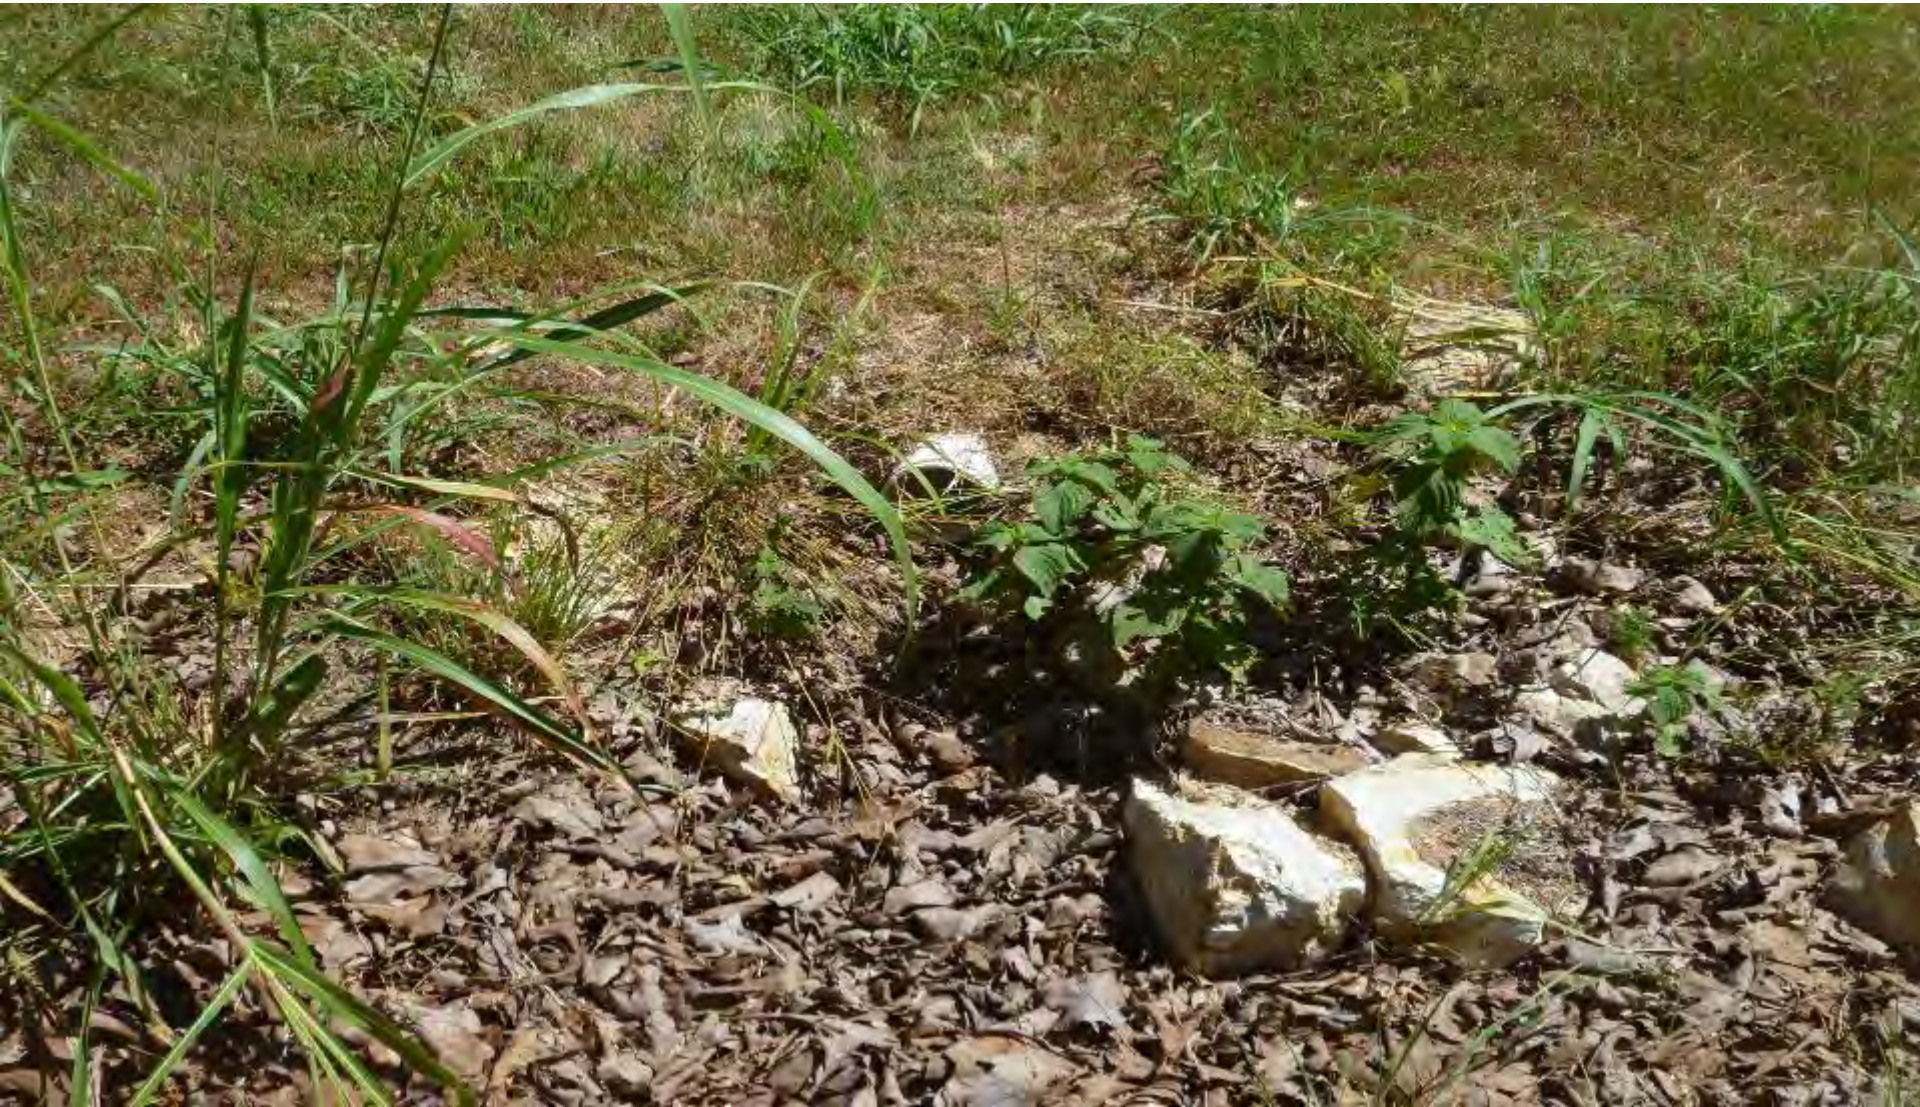
# Photo W20-1. AES Technology Cedar Creek, MO

July 2019. The summary of the field evaluation observed no current surfacing effluent over any part of the system, nor evidence of past surfacing. There was no surfacing of sewage with pressure of footwear. No straight pipe discharges were found and no visible signs of malfunction were observed (Table 1 and Appendix A, Table W20). There was no effluent odor within 10 feet of the system, which had good vegetative cover with no striping. The water level was below the outlets in the distribution box (Photo W20-4) and there was a need to have a surface diversion to redirect run-on water away from the AES system. The occupants of this home were not available for an interview (Appendix A, Table W20).
