## **Final Report**

### **Field Performance Assessment of the Advanced Enviro-Septic Wastewater Treatment and Dispersal System in Missouri, 2022**

**Dr. Randall J. Miles, Soil Scientist, Emeritus Associate Professor**

**February 7, 2023**

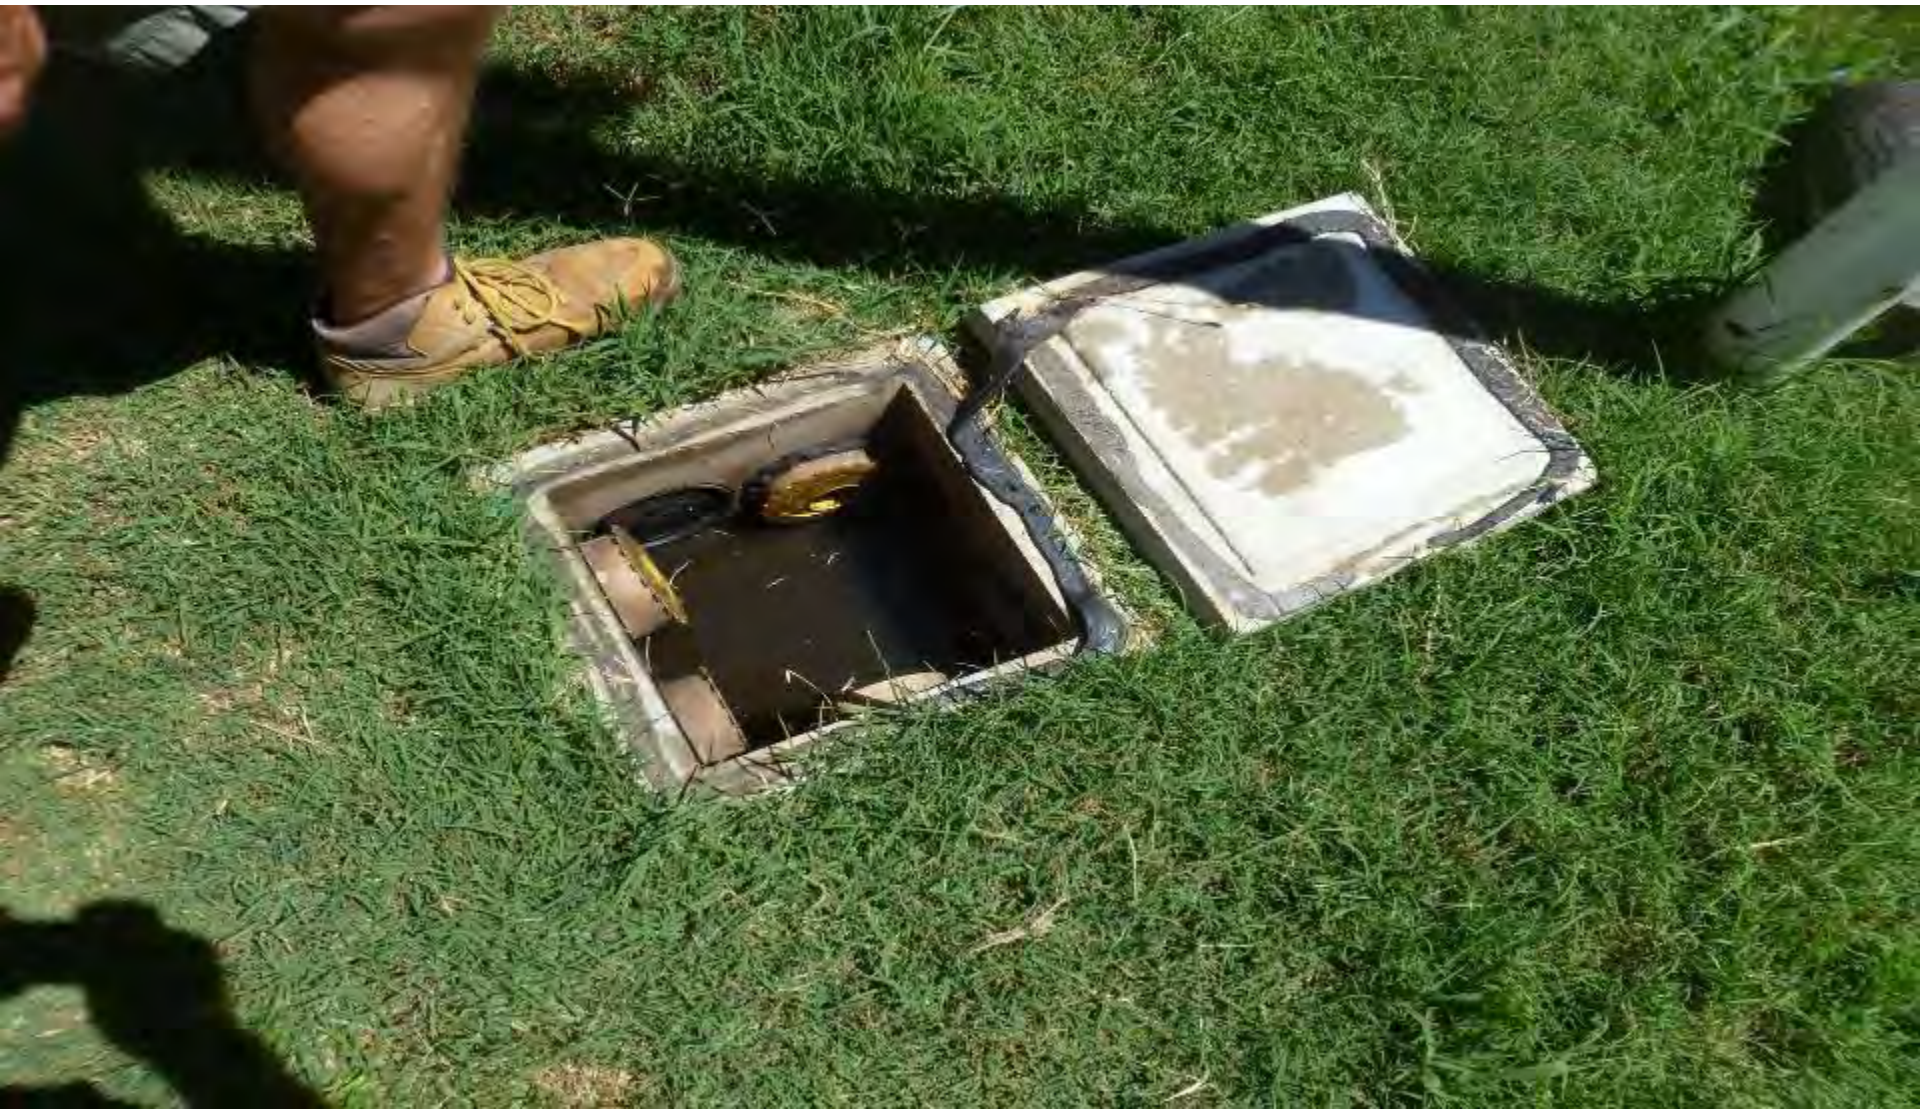
# Photo W21-1. AES Technology Cedar Creek, MO

Site W21 located at 132 Route OO, Cedar Creek, MO had a design soil loading rate of 0.25 gpd/sqft and 100 linear feet of AES (2 lines of 50 ft of product) (Table 1). Photos of this site and system are provided in photos W20-1 through W20-3 (Appendix B). This system was installed in June 2019. The summary of the field evaluation observed no current surfacing effluent over any part of the system, nor evidence of past surfacing. There was no surfacing of sewage with pressure of footwear. No straight pipe discharges were found and no visible signs of malfunction were observed (Table 1 and Appendix A, Table W21). There was no effluent odor within 10 feet of the system and no vegetation striping. There is some Johnsongrass and Bermuda grass over the system. A surface diversion could be placed above the system to divert surface run-on away from the AES technology. The homeowner was available to be interviewed and expressed no problems with the system (Appendix A, Table W21).

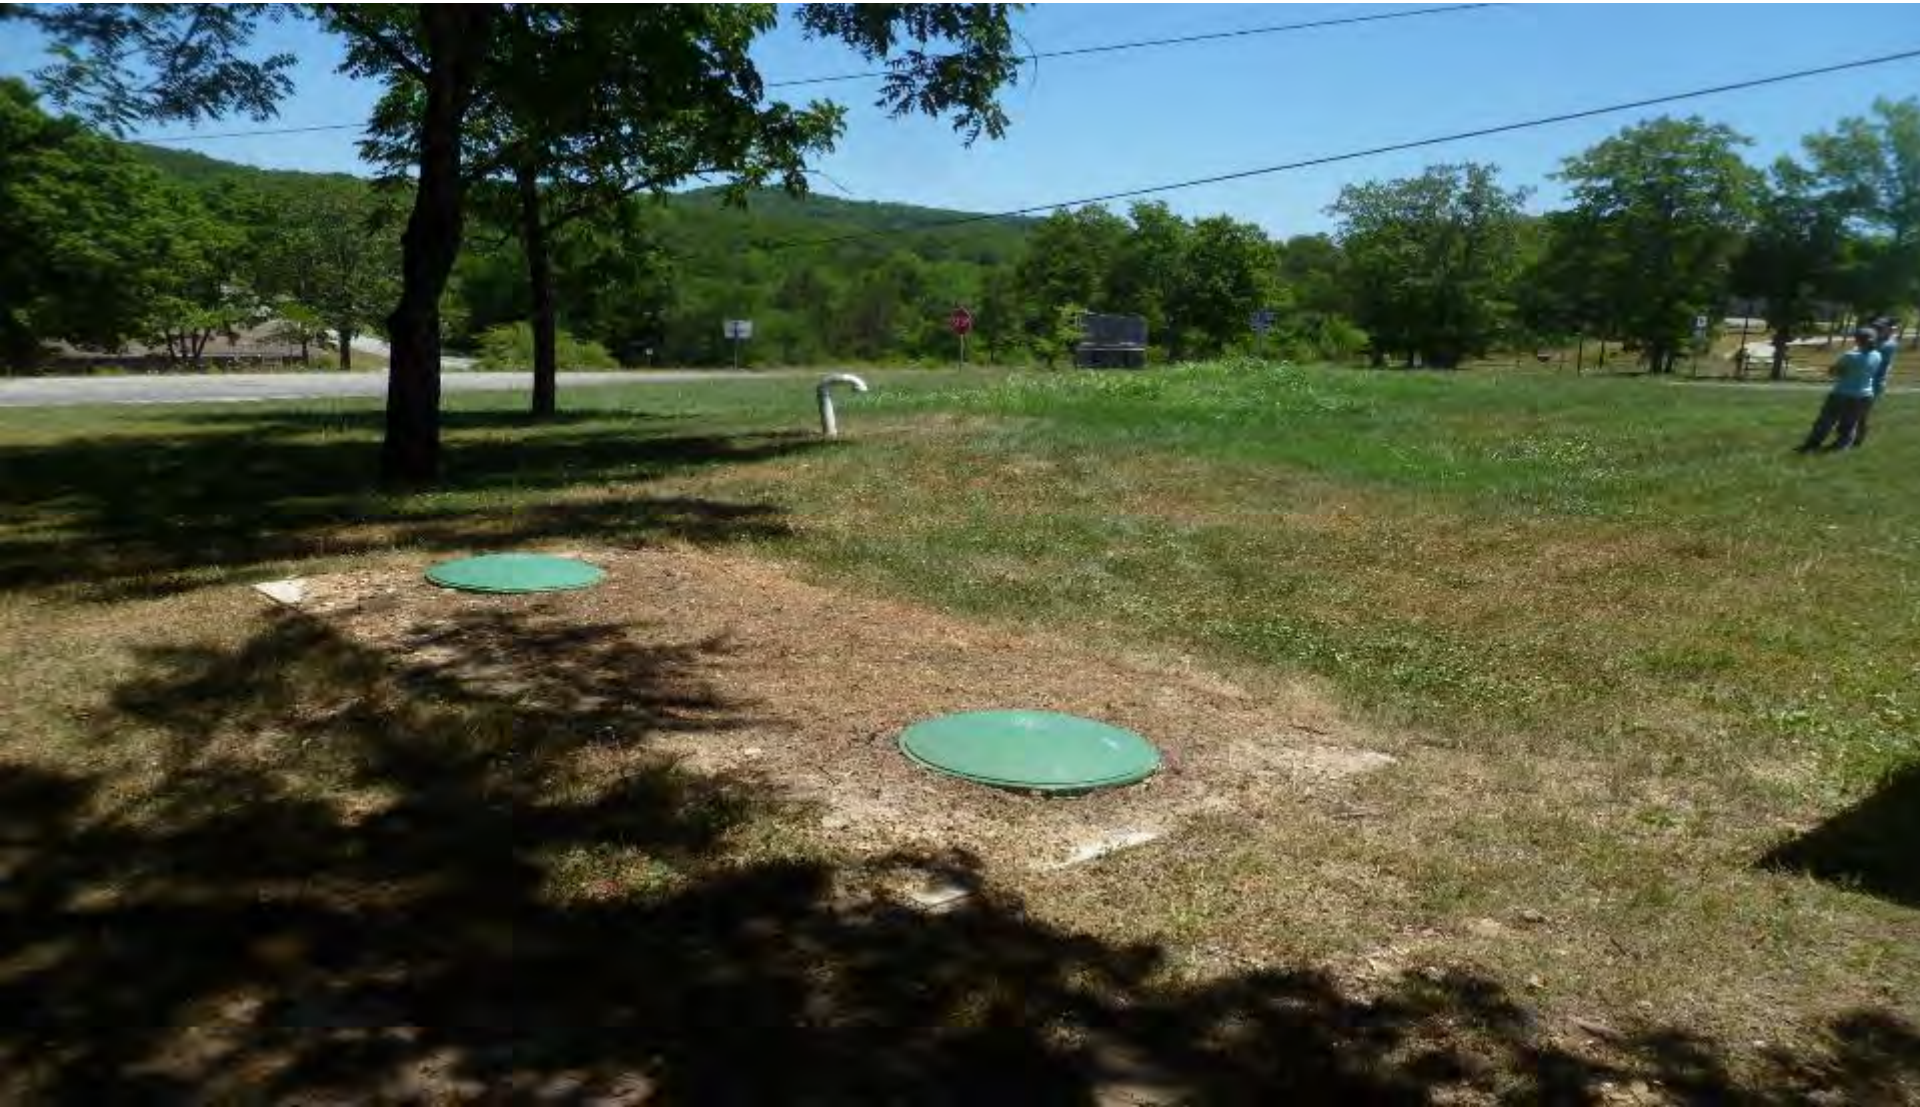
# Photo W22-1. AES Technology Cedar Creek, MO

Site W22 located at 1189 A. B. Fine, Cedar Creek, MO had a design soil loading rate of 0.30 gpd/sqft and 140 linear feet of AES (2 lines of 70 ft of product) (Table 1). Photos of this site and system are provided in photos W20-1 through W20-5 (Appendix B). This system was installed in December 2015. The summary of the field evaluation observed no current surfacing effluent over any part of the system, nor evidence of past surfacing. There was no surfacing of sewage with pressure of footwear. No straight pipe discharges were found and no visible signs of malfunction were observed (Table 1 and Appendix A, Table W22). There was no effluent odor within 10 feet of the system and no vegetation striping. Greater vegetative cover could be used on the downhill side of the AES technology. Upslope trees shade the system, thus likely decreasing evapotranspiration of water from the dispersal field. There was no high vent on this system. A surface diversion could be placed above the system to divert surface run-on away from the AES technology (Photo W22-2). The homeowner was available to be interviewed and expressed no problems with the system. (Appendix A, Table W22).

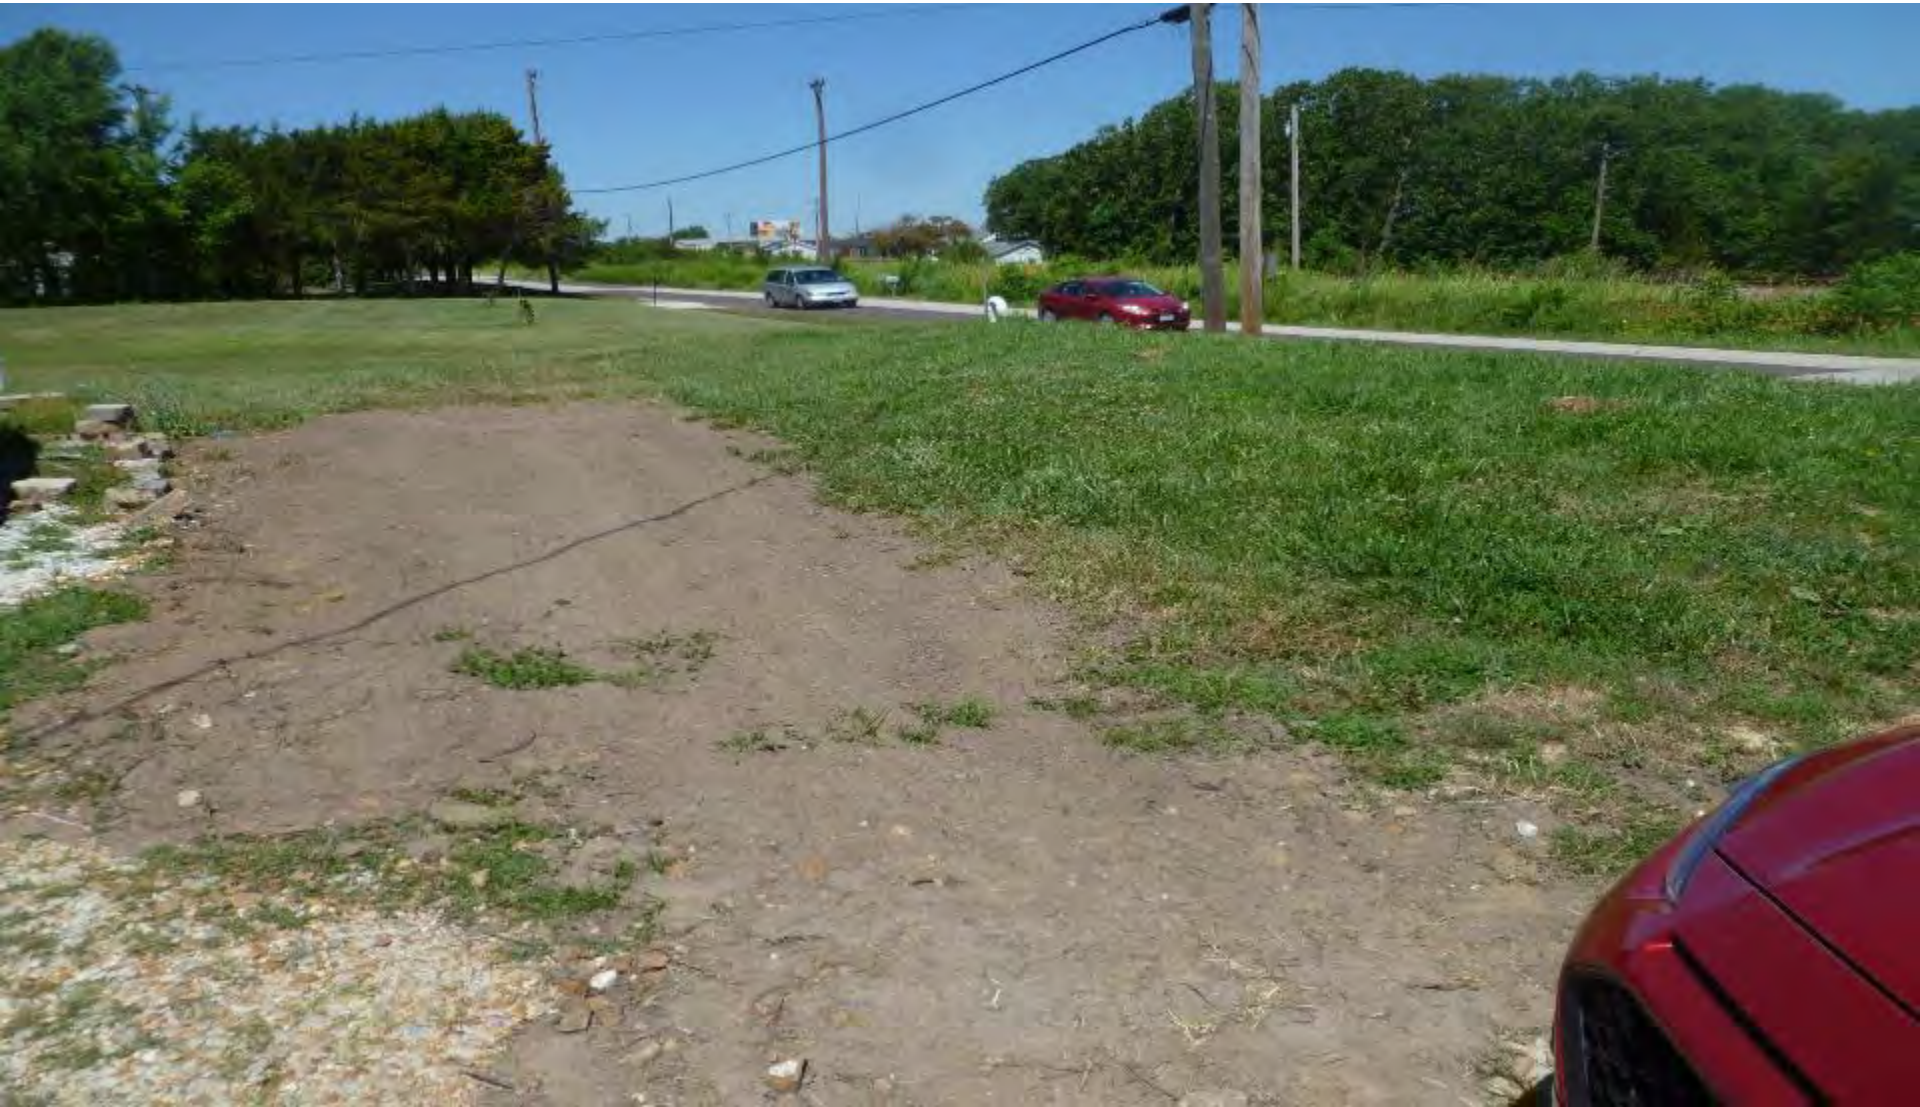
# Photo R24-4. AES Technology and Parking Area St. Claire, MO

reported by Infiltrator personnel, many of these follow-up activities were later addressed by Infiltrator personnel following the change in ownership of Presby Environmental, Inc. in 2019. One system that had a lesser than expected performance is site R24, which used a 0.65 gpd/sqft soil loading rate. This soil loading rate is much greater than expected for the soils of this area based on the distribution and prevalence of soil textures in Missouri. The parking of vehicles on the upslope side of this system as noted earlier could have contributed to the poor performance of the system. A third consideration was that this installation had a downslope topography greater than the 3 to 1 slope required per the manufacturer's installation instructions. Two of the other systems in the area that have reported less than expected performance (sites R27 and R28) three years prior to this field performance

up to 6 years old, with 15 systems evaluated. The 2-to-4 and 6-to-9 year age groups contained 7 and 8 systems, respectively. Site R24, which was the only system to demonstrate evidence of failure during the field performance assessment, was in the oldest age group, at 7.2 years old.

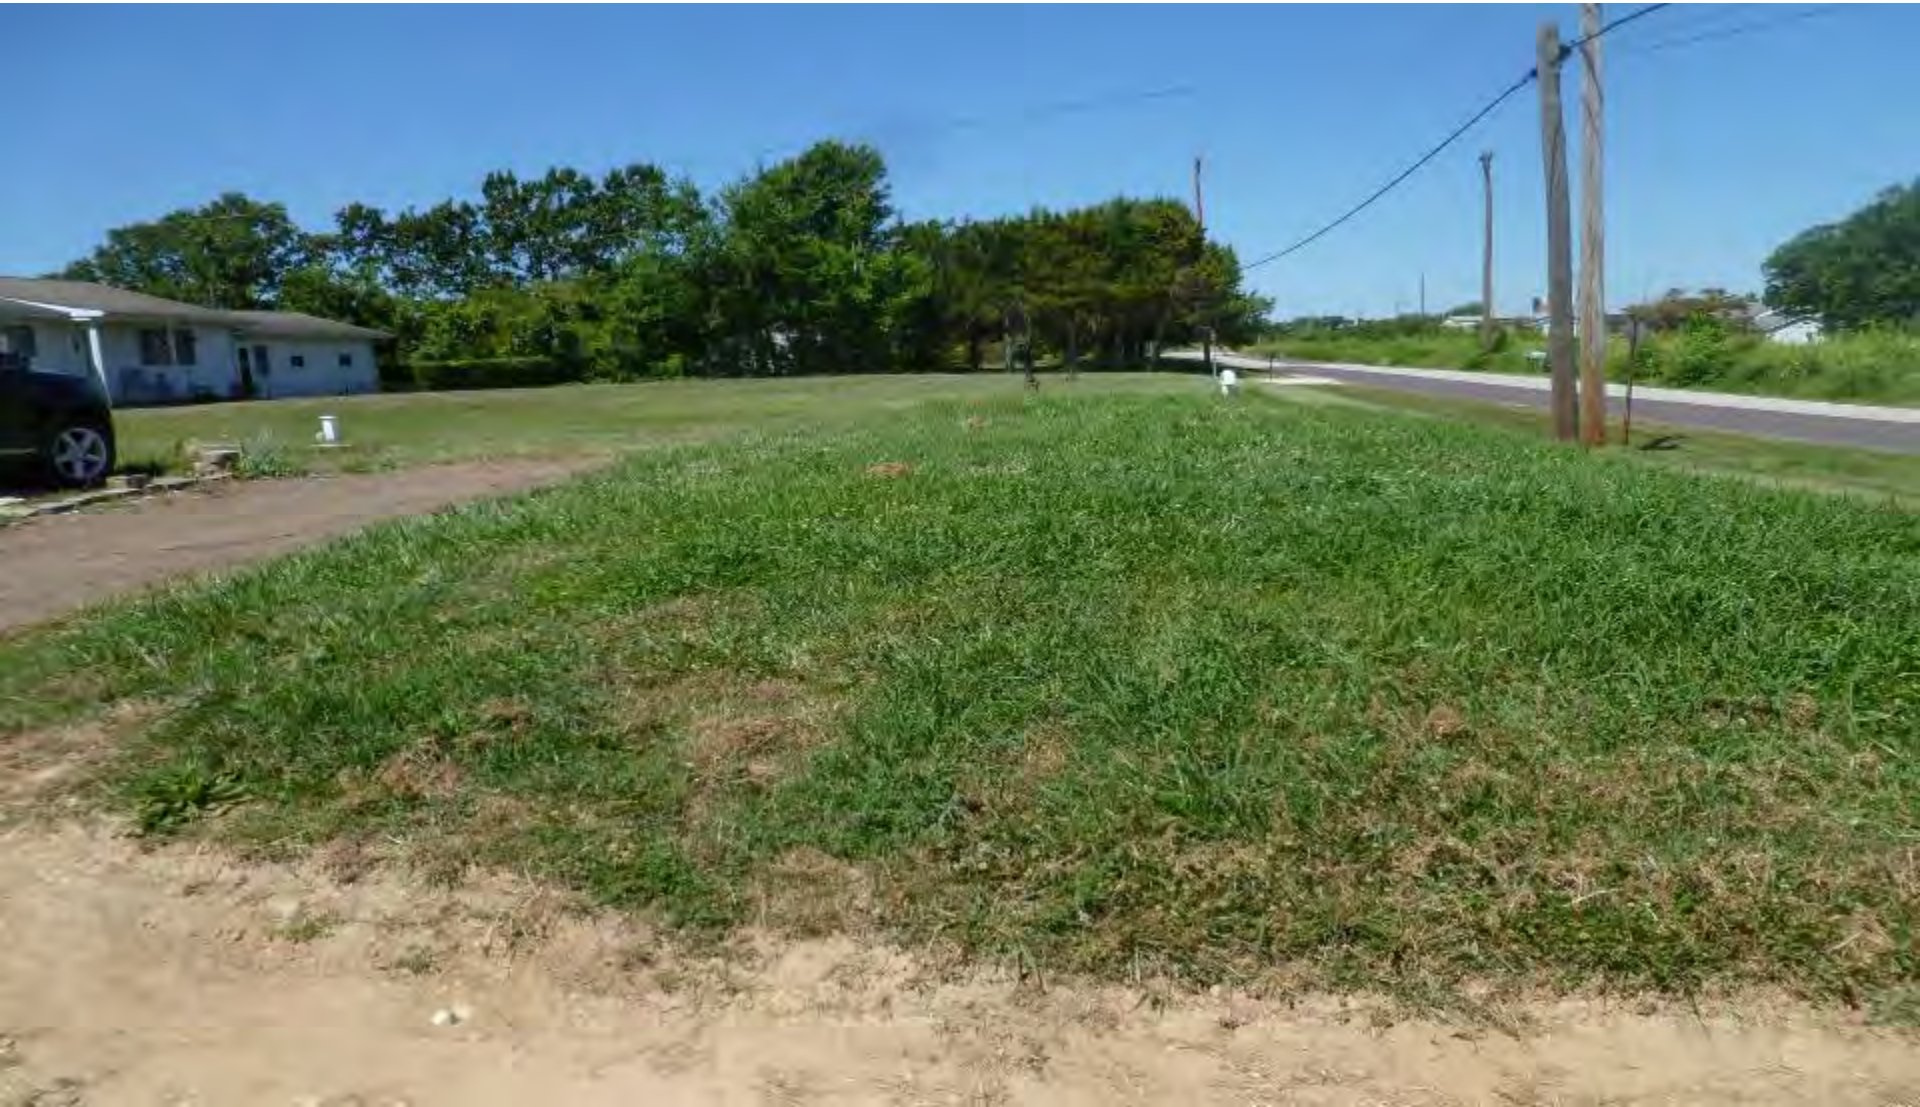
# Photo R24-5. AES Technology Breakout St. Claire, MO

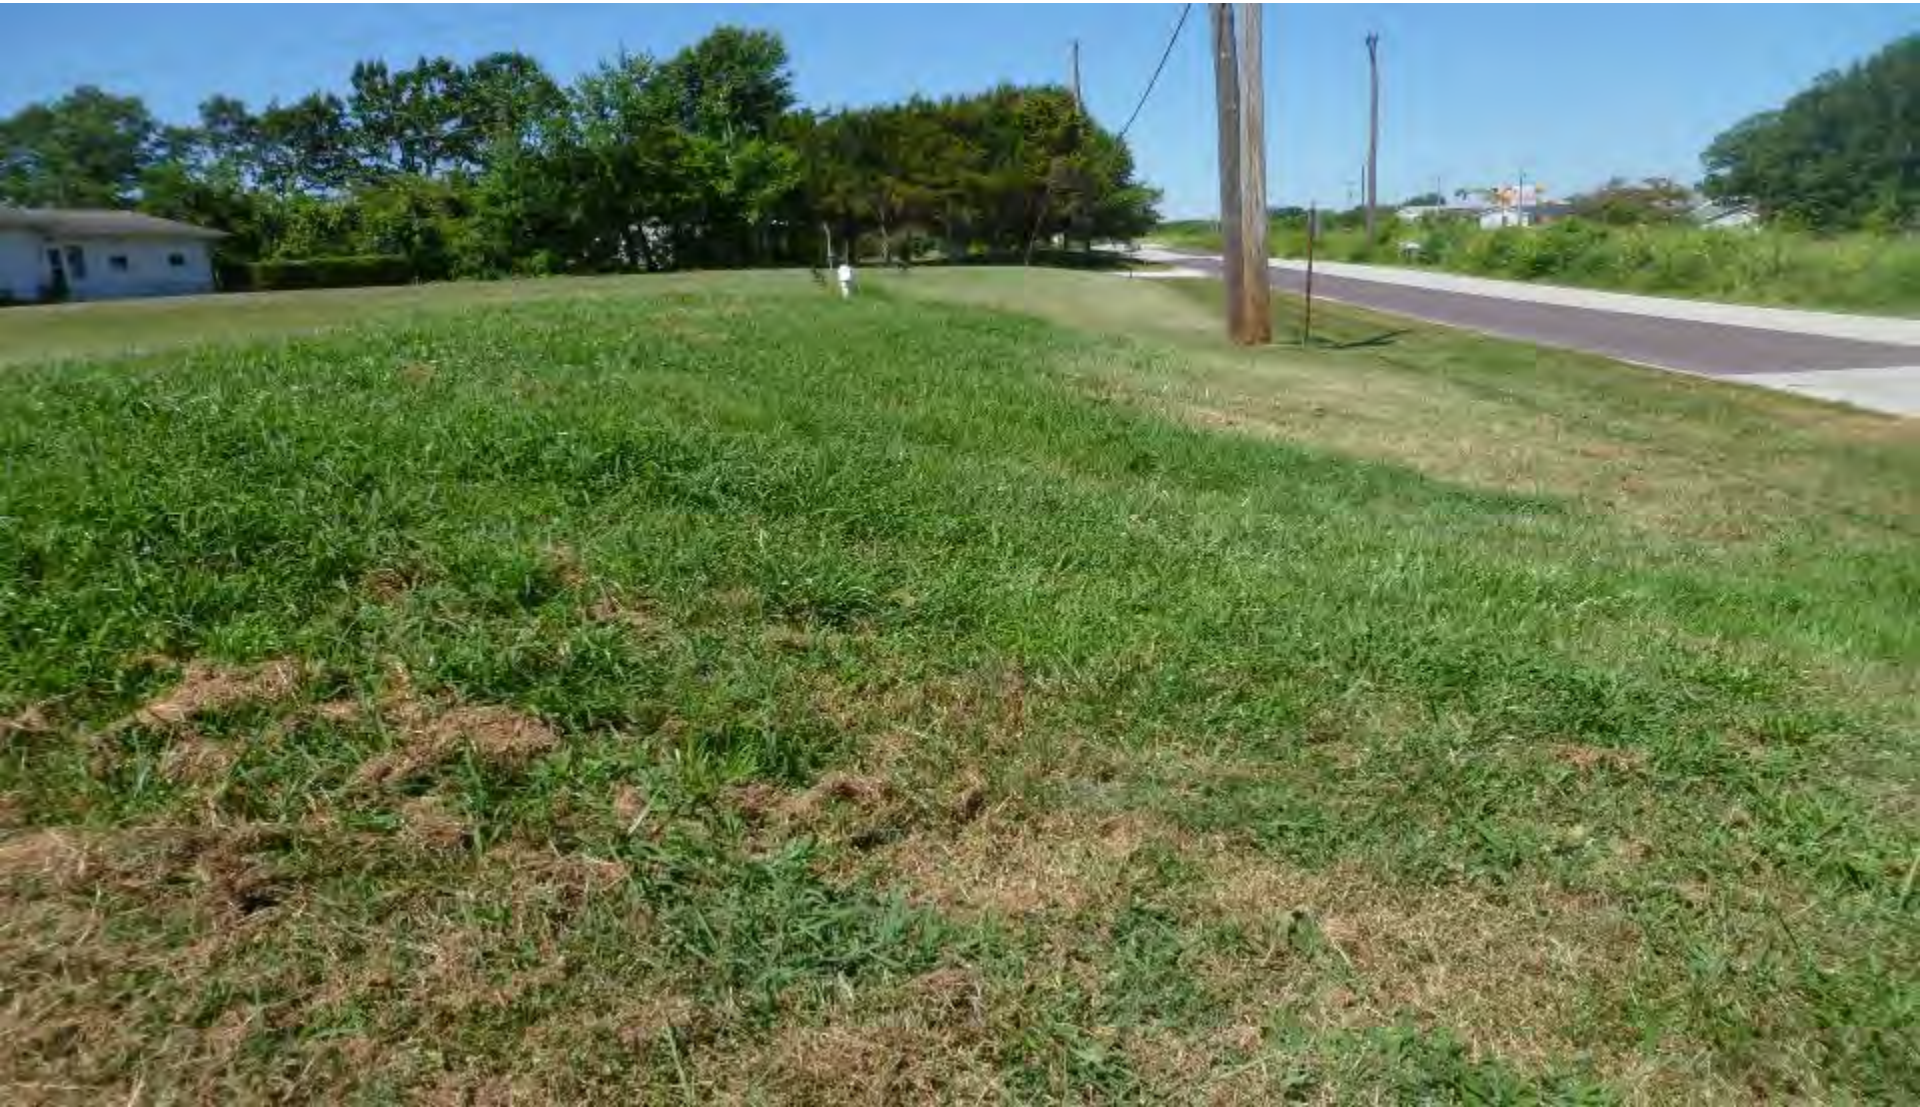
# Photo R24-6 AES Technology Breakout St. Claire, MO

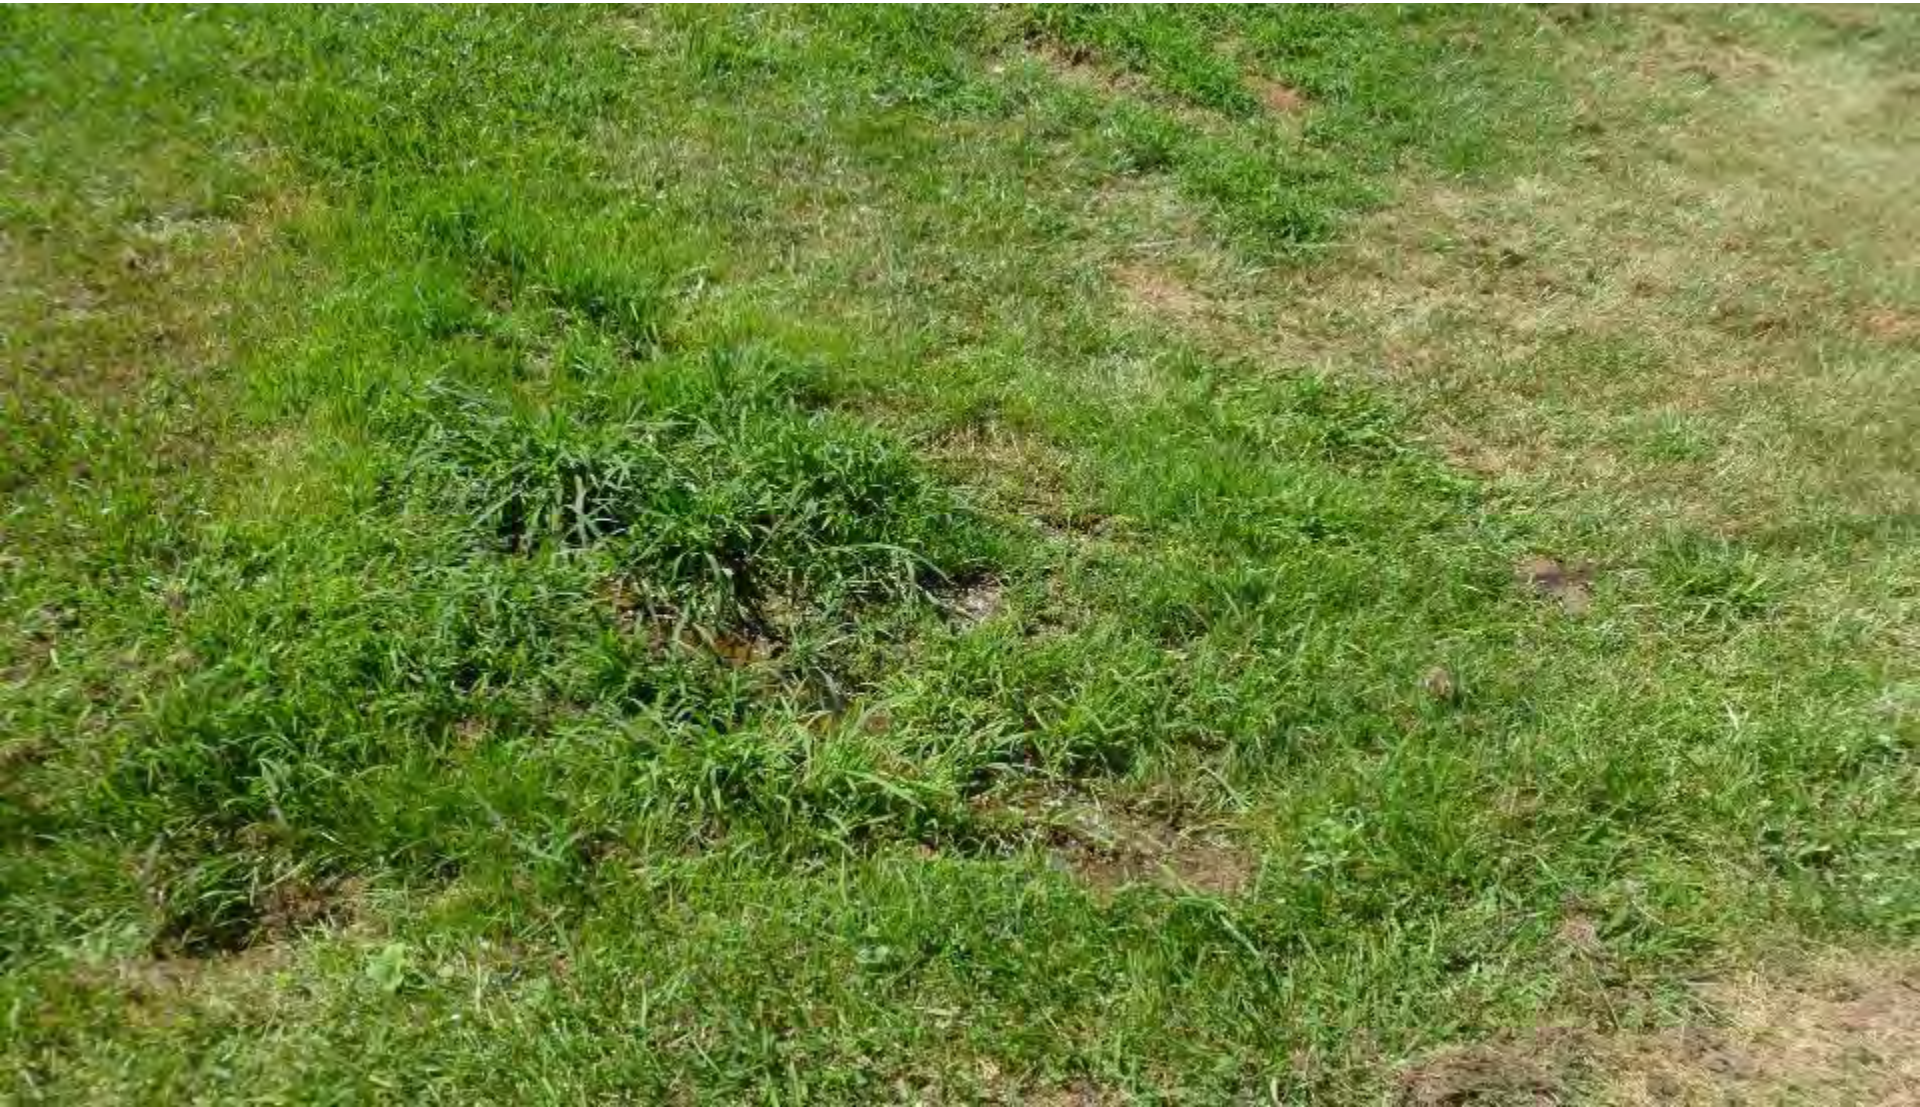
# Photo R24-7 AES Technology Breakout St. Claire, MO

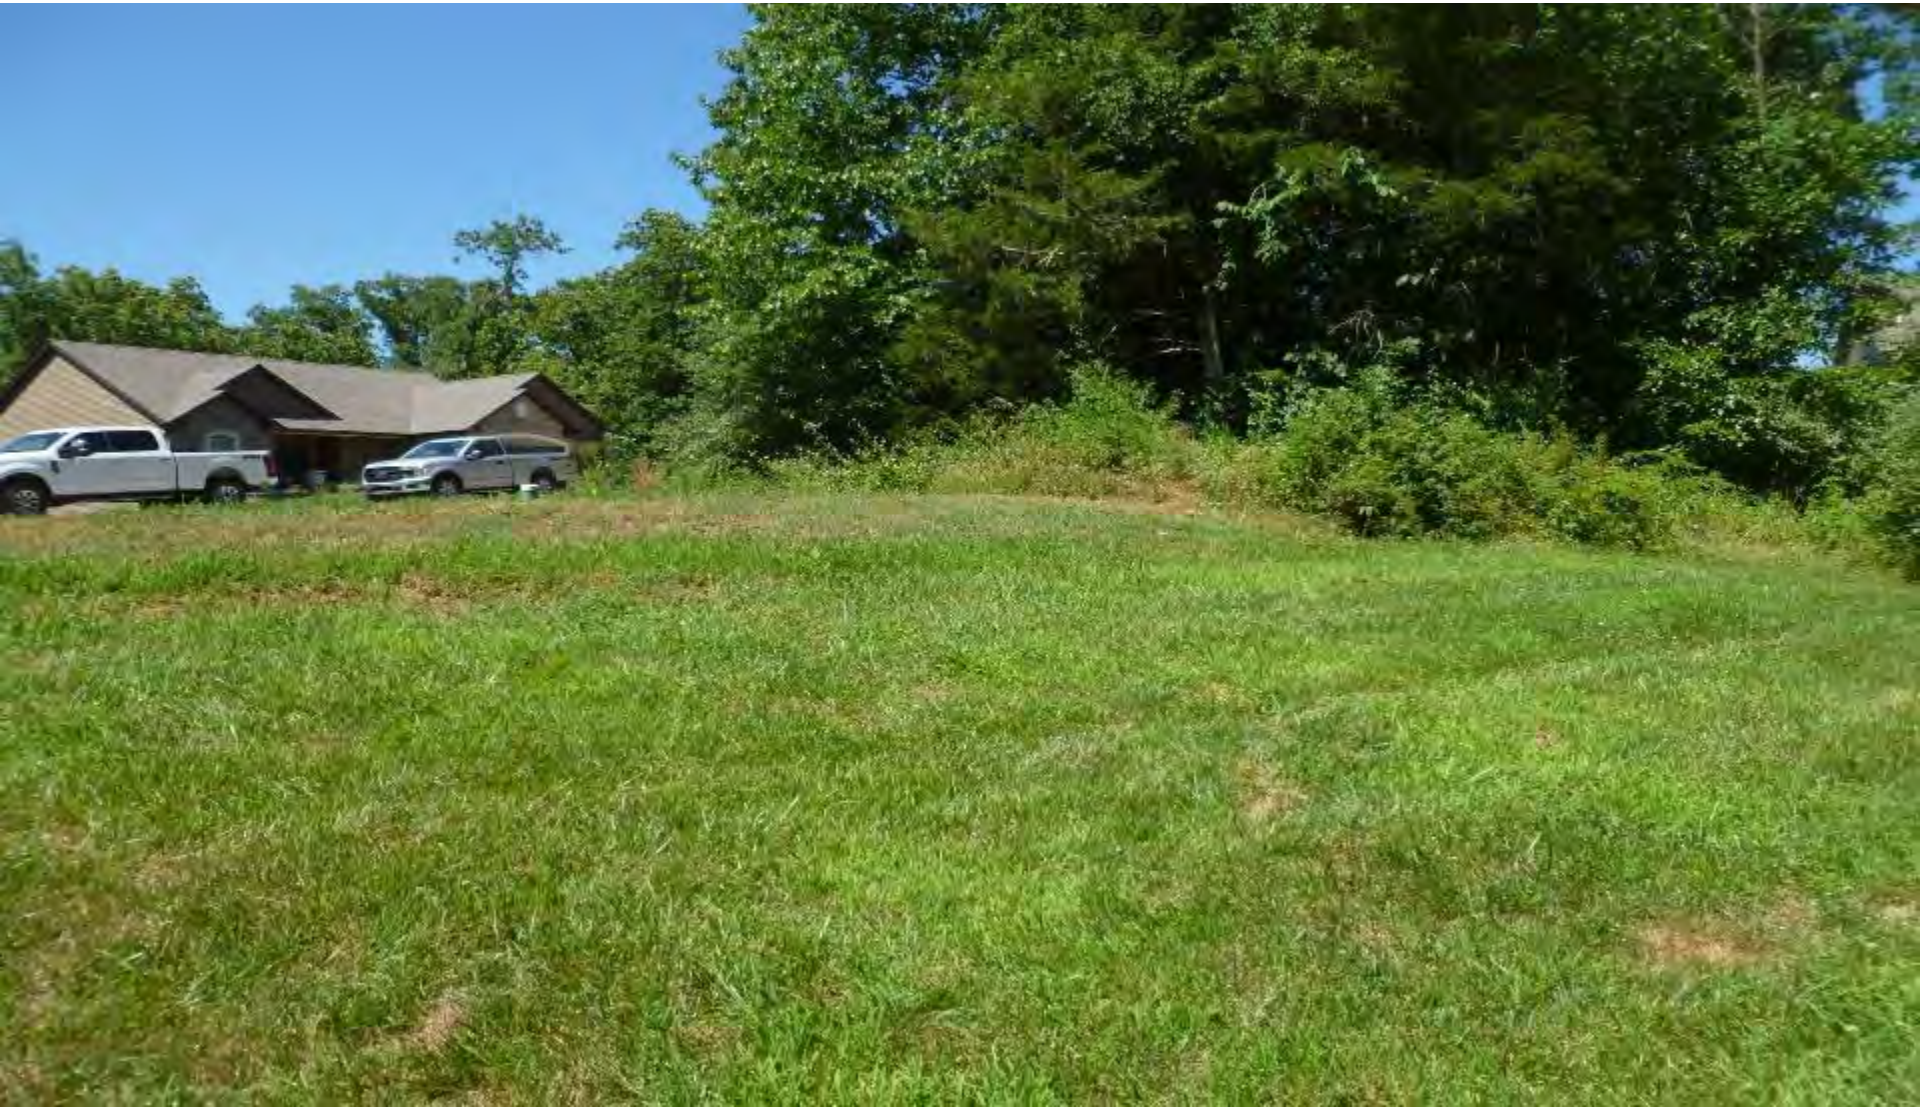
# Photo R27-4. Past Breakout Area Troy, MO
