Pipe Operation & Maintenance Manual

Thermoplastic Pipe Overview

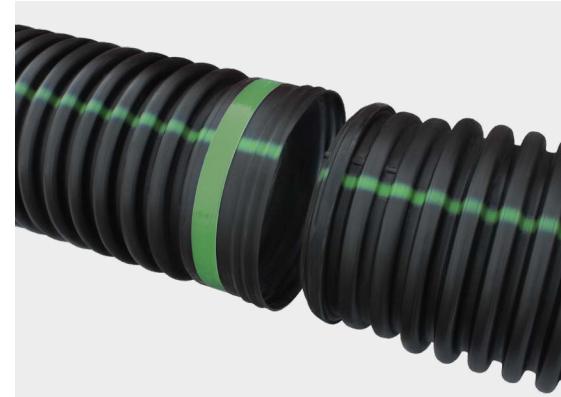
N-12 Dual Wall Pipe

ADS manufactures several pipe products, including Single Wall, N-12®, HP Storm, and SaniTite® HP, using high-density polyethylene (HDPE) and/or polypropylene (PP). Black pipe is made from HDPE. If the interior is corrugated, the product is Single Wall; if the interior is smooth-lined, the product is N-12 Dual Wall. Both Single Wall and Dual Wall N-12 pipe offer soil-tight or watertight joint performance. A pipe connected with an external coupler functions as a “plain-end” soil-tight joint. A pipe with an integral bell and spigot can provide either soil-tight or watertight performance, depending on the gasket type and bell reinforcement. Identifying this requires inspection of the gasket or the external portion of the bell.

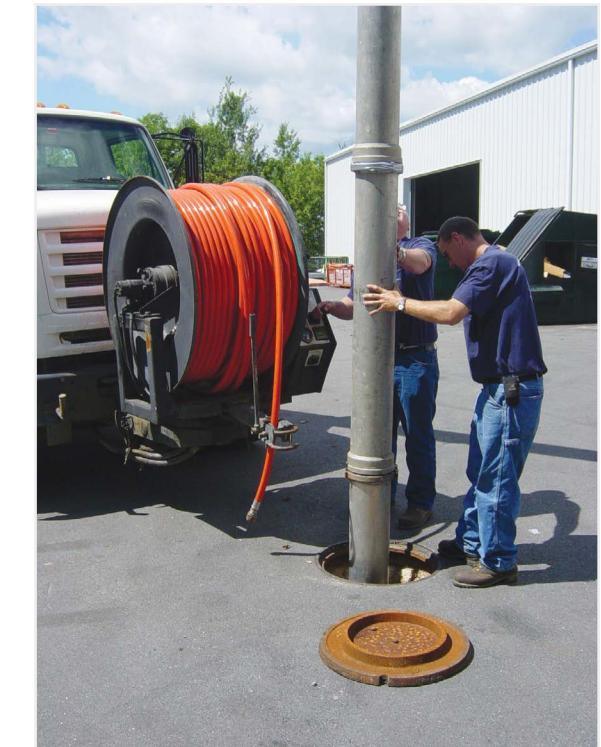
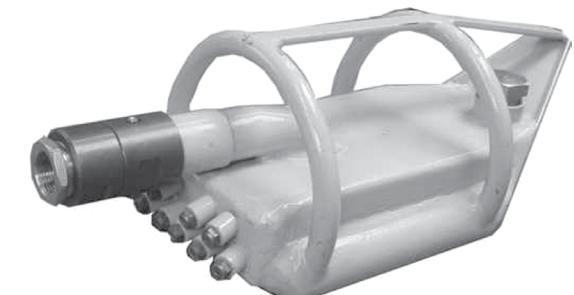
An important choice to make when water jetting is to determine the type of jetting nozzle to use, as different jet types are recommended for certain applications. A flushing nozzle is typically used for general cleaning purposes.

These types of nozzles are best when removing small deposits of debris which are not hardened or calcified, and a very economical option for cleaning prior to performing an inspection. Flushing nozzles will typically utilize larger nozzle sizes and prioritize a higher flow rate over operating pressure. Penetrating nozzles, also known as unblocking or clearing nozzles, are designed to maximize operating pressure to clean debris and larger deposits from the sewer.

When performing inspections, the pipe should be clean and free of large debris which may impede the inspection equipment. The use of a vacuum truck and jet nozzle is recommended to remove smaller debris, such as deposited sediment, leaves, and smaller root obstructions. **ADS recommends the jet nozzle should operate at no higher than 2000 psi.**
