CASE STUDY

Washed-Out Road Reopened with Fast **HP Storm Installation** Needville, TX

Fort Bend County, Needville, TX

40' (12 m) of 36" (900 mm) HP Storm

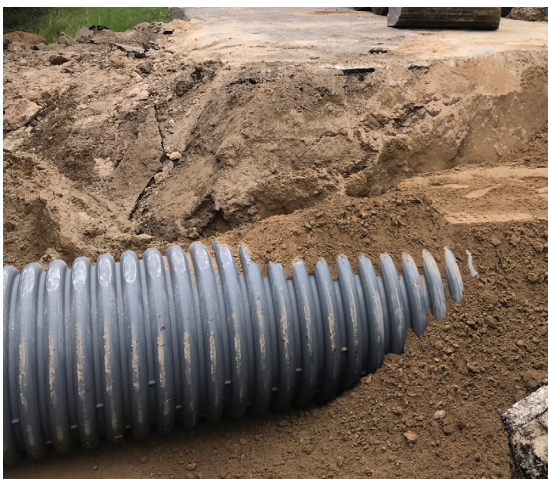
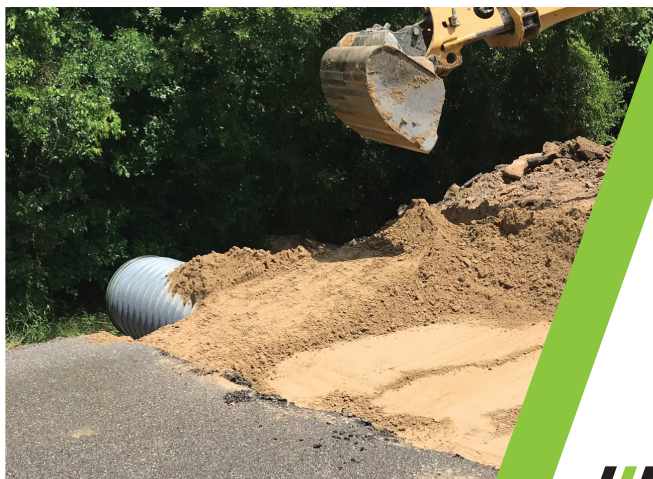
Corroding corrugated metal pipe (CMP) in a culvert caused a washout and sink hole in Routt Road's pavement. The road is a heavily-traveled rural road, so the repairs needed to be completed quickly to maintain traffic.

HP Storm offered the performance and durability needed for the replacement. Its corrosion resistance, long service life, and immediate availability made it an ideal solution. Thanks to its light weight and ease of handling, the installation was completed in just one day. Since this project, Fort Bend has continued to use HP Storm and keeps the pipe stocked in its yard.
