REBUILDING OF PARADISE COUNTS ON HDPE PIPE

CALIFORNIA TOWN CONQUERING MASSIVE CONFLAGRATION

January 2021 Vol. 7 Issue 1

civil + structural ENGINEER

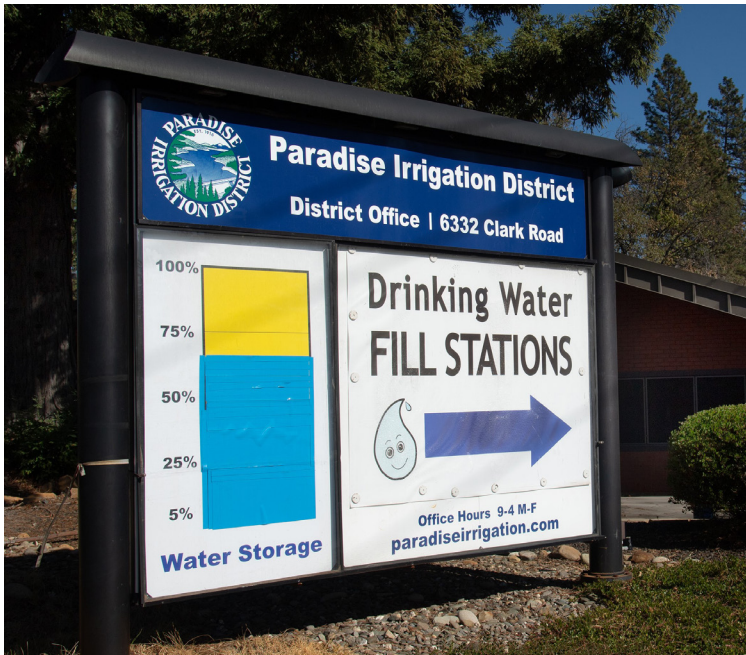
The Paradise Irrigation District will eventually replace 315,000 feet of water service lines using high-density polyethylene (HDPE) tubing.

The Paradise Irrigation Department is replacing all water service lines using high-density polyethylene (HDPE) PE 4710 pipe in diameters of one to two inches. The pipe, PolyFlex™ CTS potable water service tubing from Advanced Drainage Systems, Inc. (ADS) (NYSE: WMS), is resistant to rot and corrosion, can be easily installed and is consistent with industry specifications for potable water.

found the buried polyethylene was undamaged from direct contact with heat. The issue we found was contamination in the majority of service laterals which served burned structures, regardless of material type, so we needed to replace those service lines. It (the HDPE pipe) also gave us the ability to come back and upsize those service lines to support the rebuild and meet with customers' requirements for their meters and fire service. PE seems to be the best product to meet those needs. Seismically, it's flexible and can handle the movement up here. It's easy to pull in trenchless which makes it beneficial for the rebuild process.
