## Tuscaloosa Airport Solves a Sinkhole Problem

BY STEVE COOPER ON JUN 27, 2018

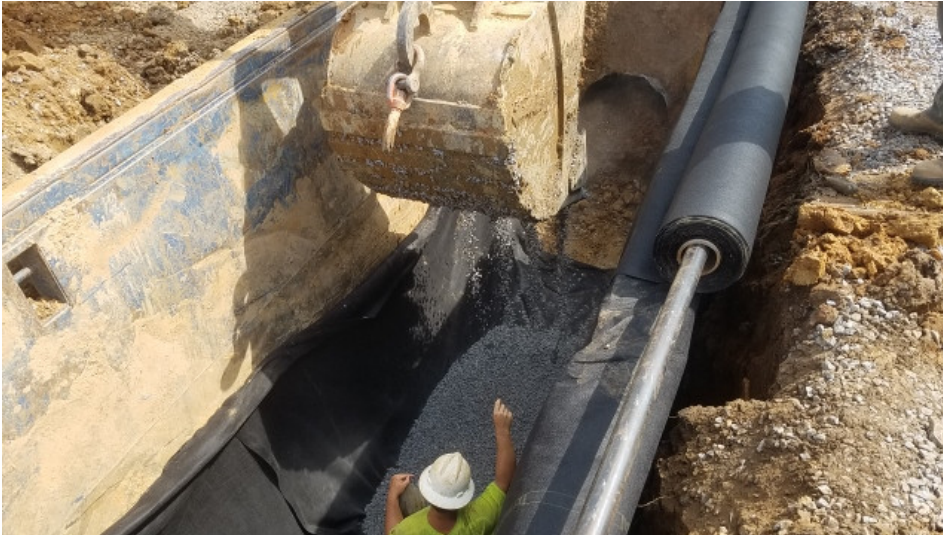
*An initial layer of crushed stone bedding material was placed on top the geotextile, which was held in place on the side of the steel trench box with magnets.*
