CASE STUDY

Runway Drainage Pipe Sliplined

South Haven, MI

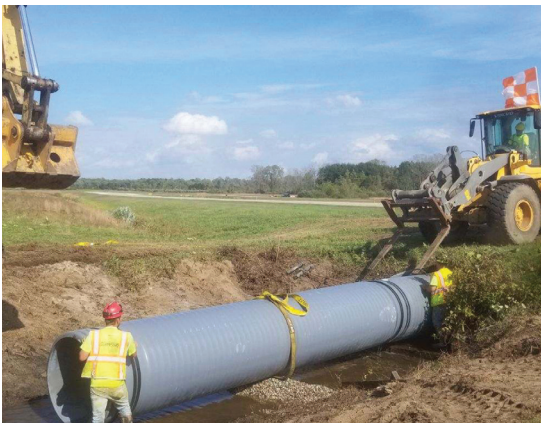
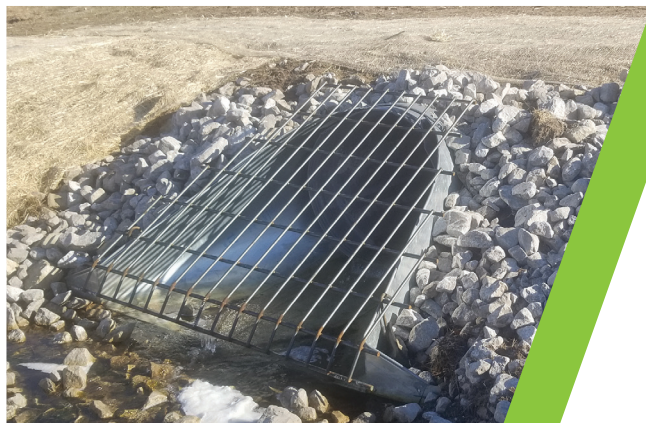
A 60" (1500 mm) corrugated metal pipe, which was part of a county drainage ditch, was beginning to show holes and gaps under the South Haven Area Regional Airport's main runway. The situation needed to be remediated to avoid a runway collapse.

SaniTite HP, in a 48" (1200 mm) diameter, was used to slipline the deteriorated CMP. The pipe's smooth interior wall would not impact the water flow and the pipe meets Federal Aviation Authority (FAA) regulations.

After SaniTite HP was sliplined, the space between the pipes was filled with controlled low-strength material flowable fill grout and grates were attached at each end.
