## CASE STUDY

# Sanitary Sewer Emergency Repair

## Town of Grand Island, NY

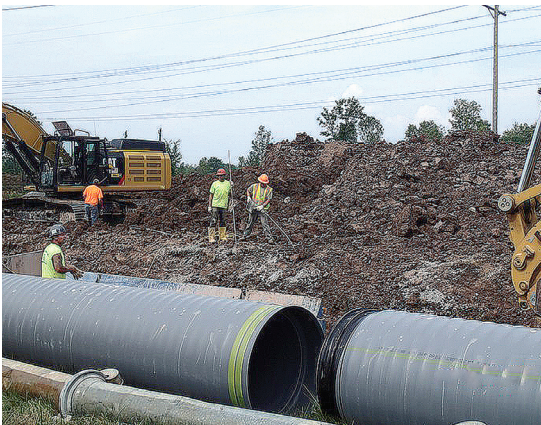
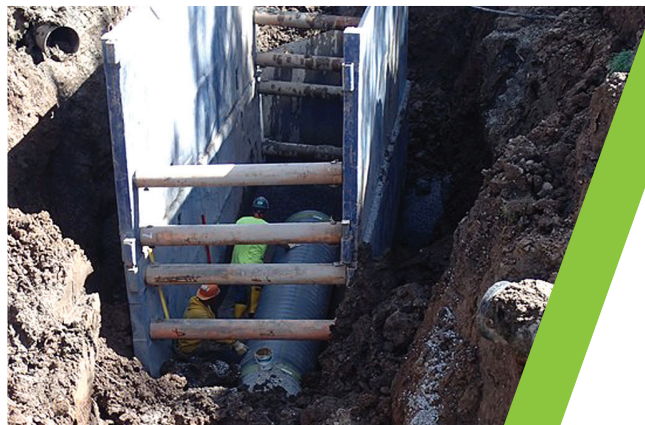
A sinkhole developed under Whitehaven Road, a main east-west street, due to the failure of a 35-year-old, 30" (750 mm) asbestos cement pipe. The failure occurred due to hydrogen sulfide gas, a naturally occurring result of decomposing sewage present in all sanitary sewers.

SaniTite HP is a triple-wall design with smooth inner and outer walls to provide pipe stiffness, which was required as the pipe was buried 22'-24' (6.7-7.3 m) deep. SaniTite HP was also chosen because its 20' (6 m) length made it quick and easy to install on the emergency repair.

SaniTite HP, manufactured from polypropylene, was chosen as it is inert to the effects of hydrogen sulfide and makes SaniTite HP a recommended choice to replace deteriorating infrastructure.
