## CASE STUDY

# SaniTite® HP Used for Drainage & Connection to Irrigation System

## Madera, CA

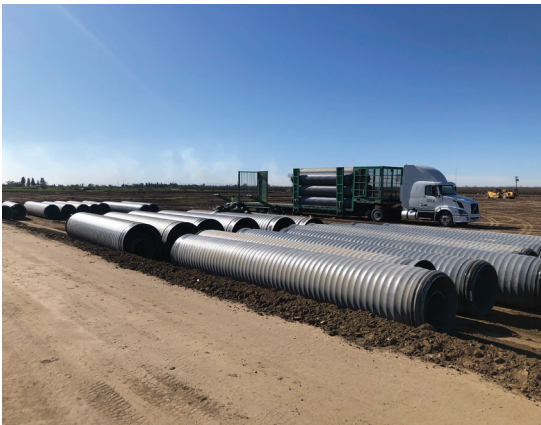
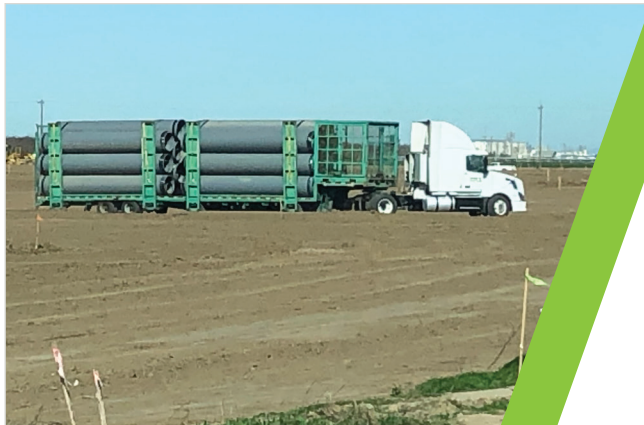
Madera Irrigation District excavated the CIP concrete pipe and replaced it directly with the SaniTite HP, which was specified for the project, in the same trench. By utilizing this method, the Madera Irrigation District was able to install 300' (91 m) of pipe per day.

SaniTite HP was utilized for the conveyance due to the connectivity of the storm drain to the irrigation network. System pressure fluctuations within the irrigation network required SaniTite HP to be used due to its strength and patented extended, reinforced bell with polymer composite bands and dual gaskets that allow for an additional factor of safety within each joint.
